Re: AHC 13-0740
Cultural Resource Assessment
Cane Creek Mine
Walker County, Alabama

A PHASE I CULTURAL-RESOURCES SURVEY
FOR THE PROPOSED CANE CREEK MINE,
WALKER COUNTY, ALABAMA

PREPARED BY
TERRAXPLORATIONS, INC.

PREPARED FOR
PERC ENGINEERING COMPANY, INC.

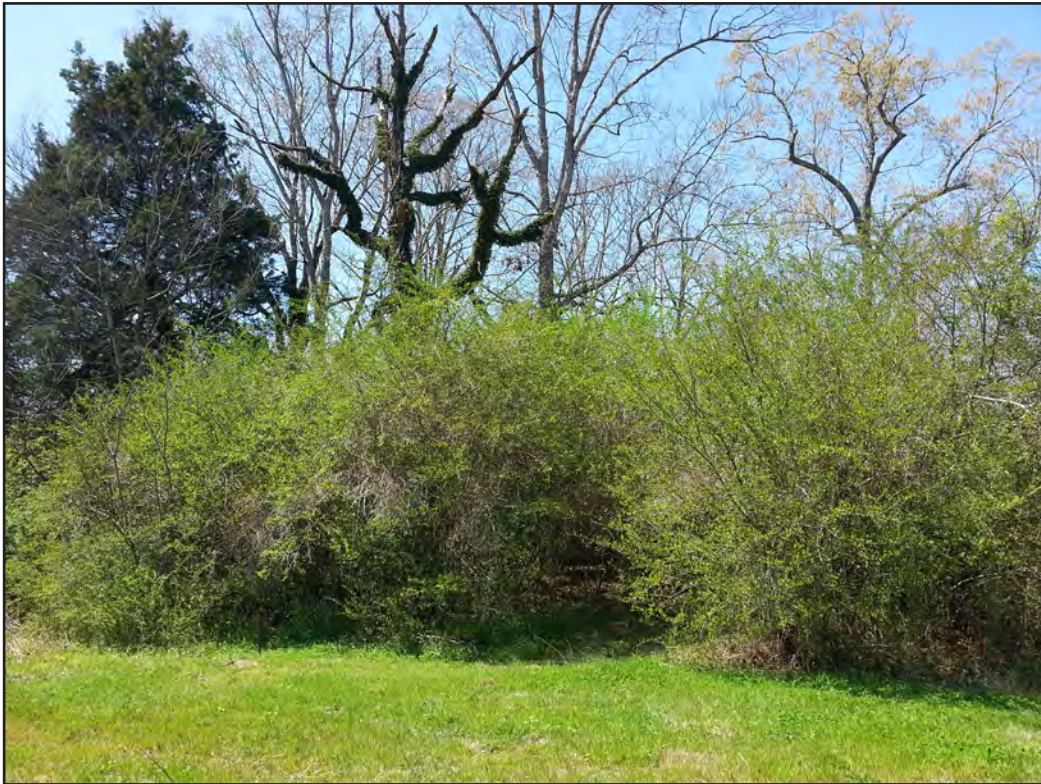
Figure 3. Southern portion of project area, looking west.

The project area is located along the peak of a ridgetop and is situated at an elevation ranging between 370 and 510 ft. above mean sea level (AMSL). The study area slopes westward toward Hay Valley Road and State Route 269. Vegetation within the project area consisted of poplar, sweetgum, hickory, red oak, and pine, with briars, brush, and vines comprising the understory. The vegetation ran along the slopes of the ridge top and stood in the western portion of the survey area, while the ridgetop itself was clear cut, with little to no standing vegetation (Figures 3 and 4).

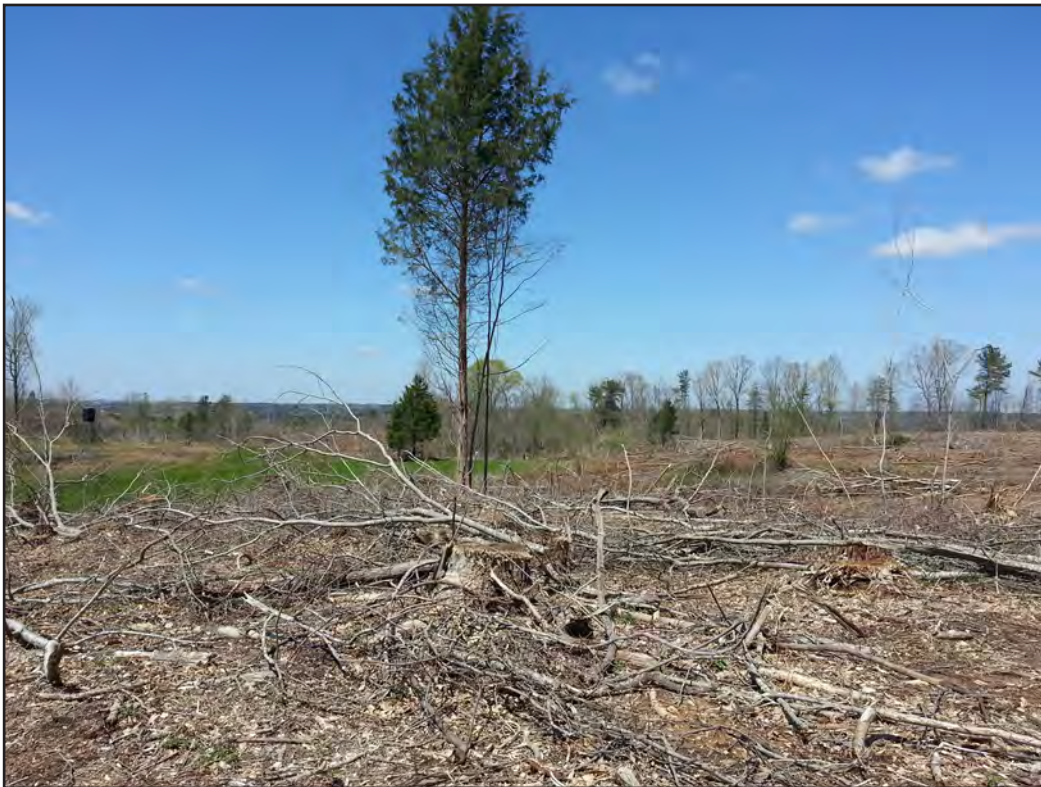
Figure 4. Eastern portion of project area, looking northwest.

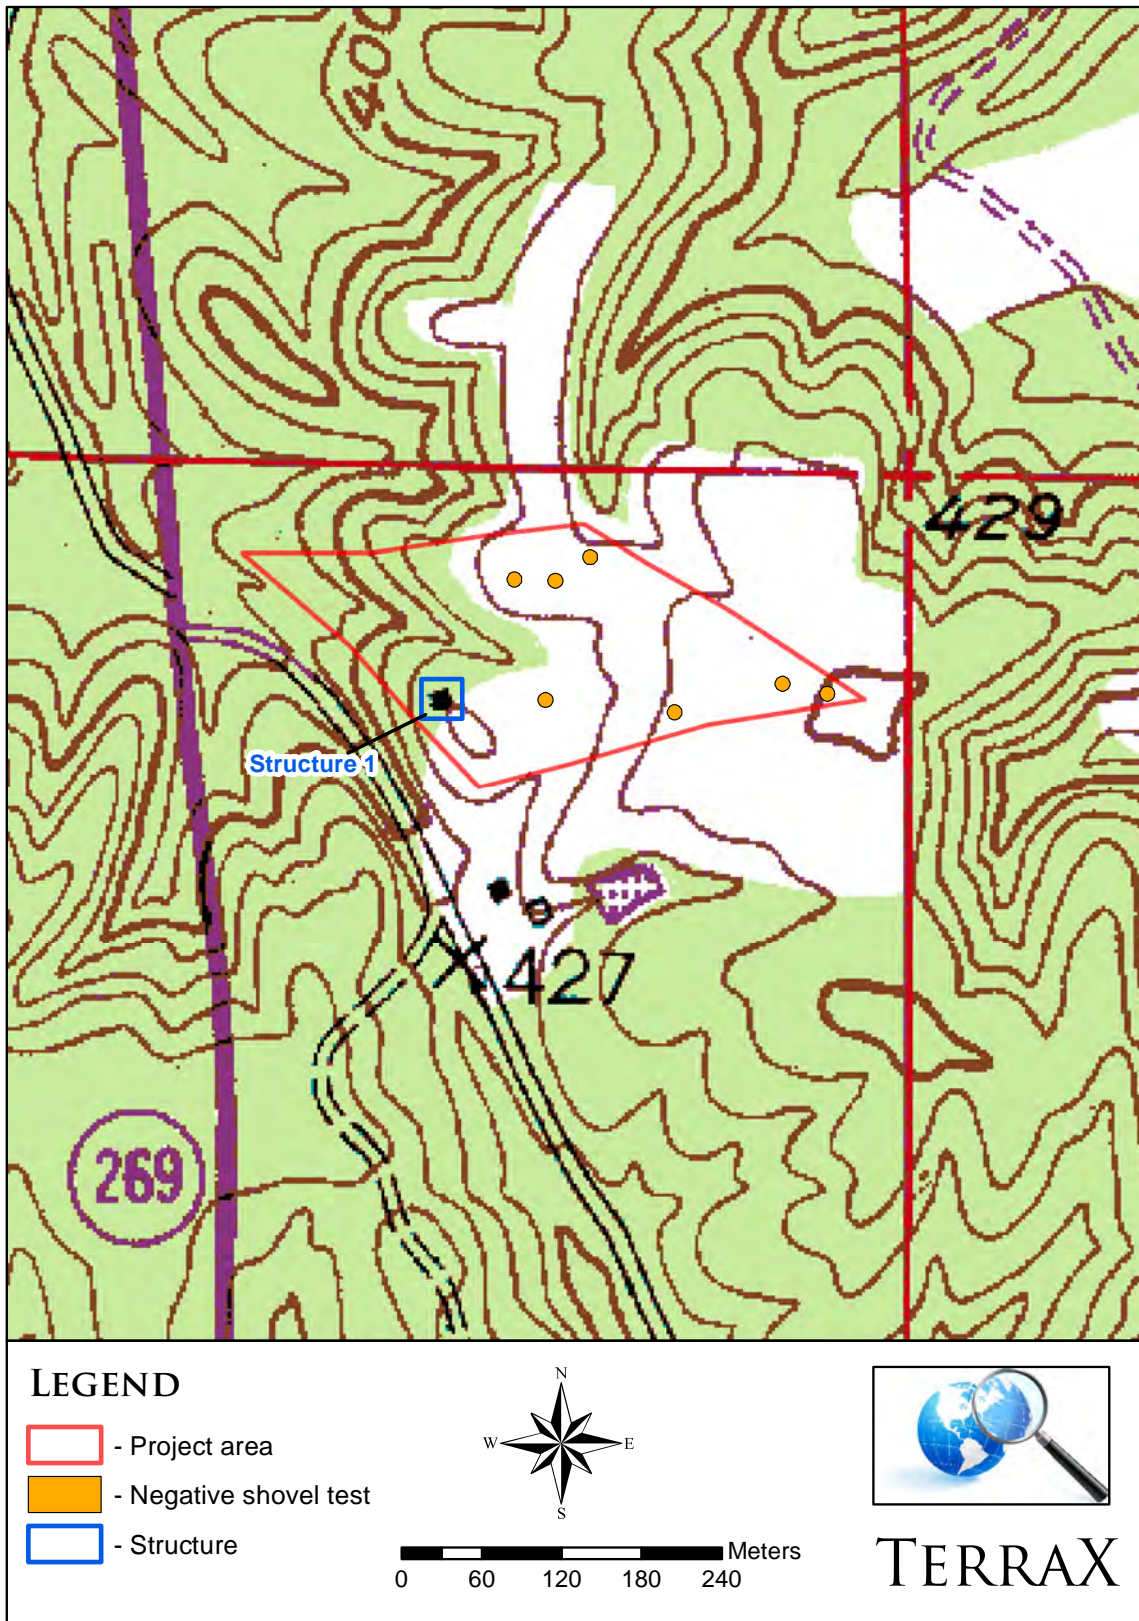
The investigation included both subsurface and surface inspections of the subject property. A total of seven judgmental shovel tests were placed in areas of least disturbance on what appeared to be higher, terraced areas, atop slopes and drainages (Figure 5). All seven tests produced negative results exposing shallow soils. Shovel test profiles consisted of 3 to 15 cm of yellowish brown silt loam above a strong brown to reddish brown silty clay subsoil. Eroded sandstone and shale were encountered in each shovel test. Visual examinations failed to identify any cultural material on exposed surfaces.

Figure 5. Map showing structure and shovel test locations within the project boundaries (based on the 1949 [photorevised 1981] Jasper, Alabama, USGS 7.5' series topographic quadrangle).

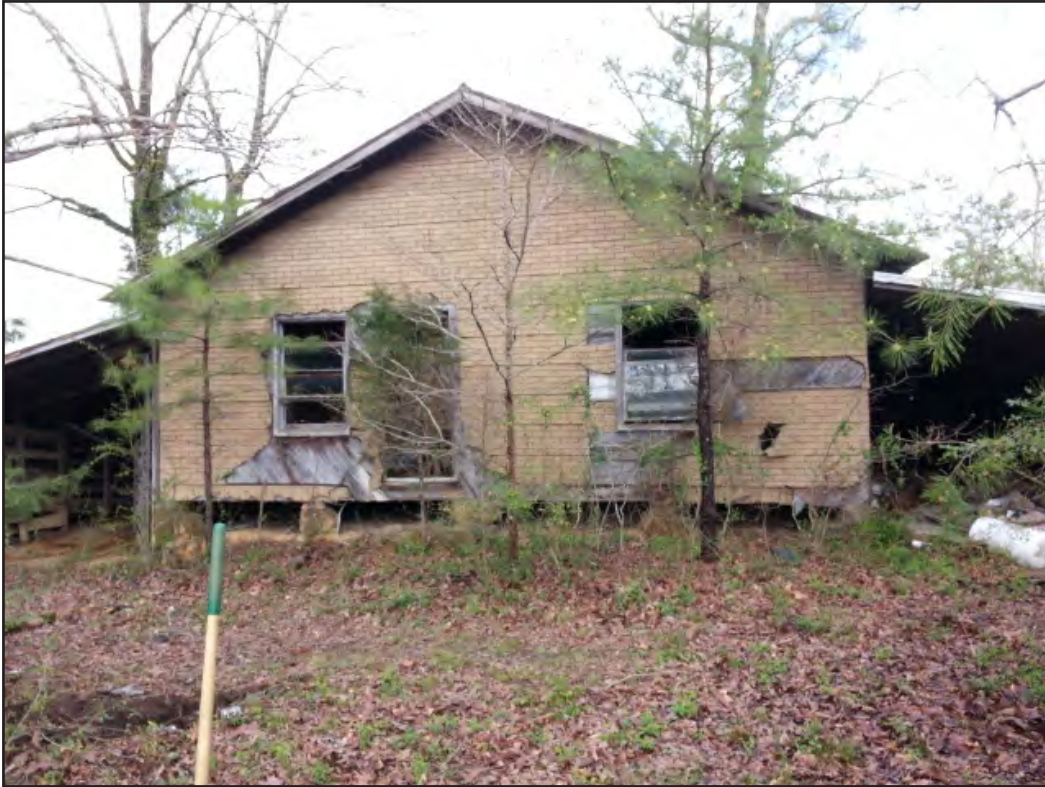
Although no archaeological sites were discovered, a structure was identified and recorded during the course of this survey. Structure 1 (Burton House) is of wood frame construction built between 1920 and 1960, based on the style of the house and exterior materials (Figures 6 and 7) (Appendix B). Additionally, this structure is seen on the 1949 (photorevised 1981) Jasper, Alabama 7.5' topographic quadrangle (see Figure 5). This building is a wood frame bungalow style house with a front-gable roof of standing seam metal. Asphalt siding resembling bricks covers the exterior, covering a vertical plank outside wall. Stacked stone foundation pillars, evenly placed around the outside wall, support the structure. The north, east, and west side of the structure is surrounded by a wood post and standing seam metal roof utilitarian sheds. The east side contains a garage attached to the back porch. The west side of the structure contains a livestock ramp, which leads to the covered area on the north side of the structure, which has completely collapsed due to a falling tree. Two outbuildings are also associated with the structure; a wood frame chicken house located on the east side of the structure, and a wood frame livestock pen located off the northwest corner (Figures 8 and 9). After consideration under Criteria C, and applying seven aspects of integrity, it is determined that the Burton House is not eligible for the Alabama Register or the National Register. Although the house retains some its integrity of location, design, materials, and workmanship, the house is in such a state of disrepair that the remaining integrity has been compromised. Therefore, the determination of effects is no historic properties affected.

Figure 6. View of Structure 1 (Burton House), looking north.

Exterior Architectural Description:	This is a square, one story, wood frame hall-and-parlor bungalow-style house. The roof is front gable with standing seam metal. The exterior is covered in rolled asphalt siding that resembles brick. The house is open underneath and supported by large rocks balanced by a brick. The wood, double hung windows are 1/1 and 6/6.		
Description of Setting:	The house is located in a rural area of Walker County on Hay Valley Road which is located off Highway 269 south of Jasper. The immediate area surrounding the house is overgrown with vegetation, and the house is accessed by a grassy, dirt road. Adjacent to the property is an occupied brick Ranch-style house.		
Historical Notes:

Appears Eligible for Alabama Register:	<input type="checkbox"/> Yes	<input checked="" type="checkbox"/> No	<input type="checkbox"/> would contribute to a district	<input type="checkbox"/> Undetermined
Appears Eligible for National Register:	<input type="checkbox"/> Yes	<input checked="" type="checkbox"/> No	<input type="checkbox"/> would contribute to a district	<input type="checkbox"/> Undetermined
AR Criteria:	<input type="checkbox"/> A	<input type="checkbox"/> B	<input checked="" type="checkbox"/> C	<input type="checkbox"/> D <input type="checkbox"/> Undetermined
NR Criteria:	<input type="checkbox"/> A	<input type="checkbox"/> B	<input checked="" type="checkbox"/> C	<input type="checkbox"/> D <input type="checkbox"/> Undetermined
Level of Significance:	<input type="checkbox"/> Local	<input type="checkbox"/> State	<input type="checkbox"/> National	<input type="checkbox"/> Undetermined
Justification of Eligibility/Ineligibility:	This house was evaluated under Criteria C, Architecture. Although the building maintains most its integrity of location, design, materials, and workmanship, the house is in such a state of disrepair that the remaining integrity has been compromised.

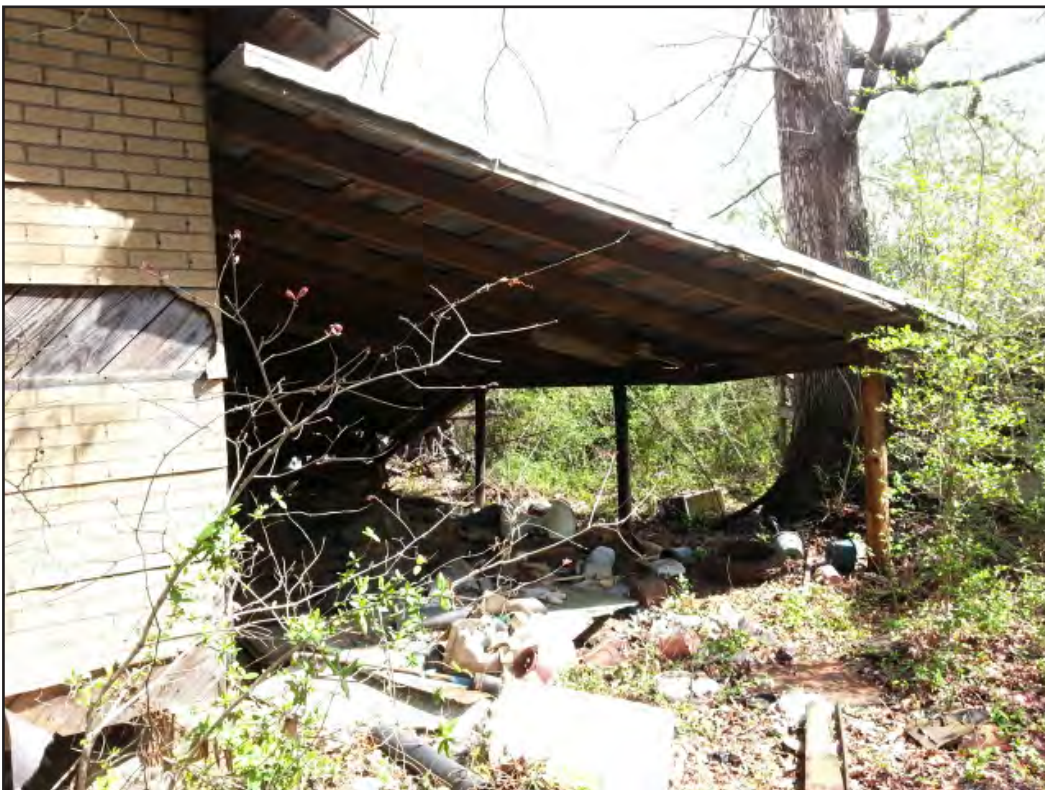
Figure 7. View of Structure 1 (Burton House) garage, looking northeast.

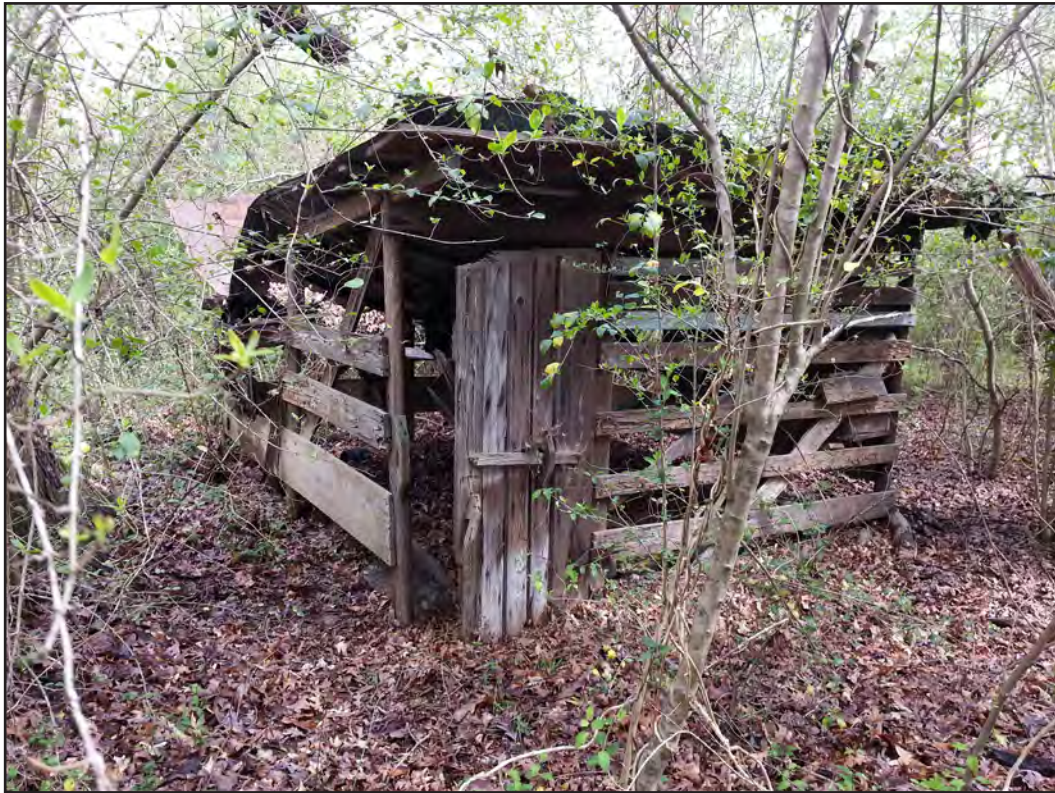
Figure 8. View of chicken house associated with Structure 1 (Burton House), looking northeast.

Construction date:	c. 1920-1960	Source:	architectural evidence
Alteration date:	unknown	Source:	
Architect/Builder:	unknown	Contractor:	unknown
Physical condition: (Excellent, Good, Fair, Poor, Ruinous)	Poor	Remaining historic fabric: (High, Medium, Low)	Low
No. of stories:	One		
Historic use of property:	Dwelling		
Current use of property:	Vacant		
Architectural style category:	None	Architectural style sub-category:	None
Basic typology:	Bungalow	Basic shape:	Square
Basic floor plan:	Hall-and-Parlor	Historic Construction material(s):	Wood frame
Current exterior wall material(s)	Asphalt	Roof finish material(s):	Metal
Main roof configuration:	Front gable	Foundation material:	Rock supports
Porch type:	Rear porch		
Window type and materials:	1/1, wood, double hung; 6/6, wood, double hung		
Describe alterations:	W side: shed with livestock ramp; N side wood frame shed; E side wood frame carport		
Number and type of all outbuildings: (if significant, fill out separate survey form)	Wood frame with metal roof livestock pen and chicken house - very poor condition

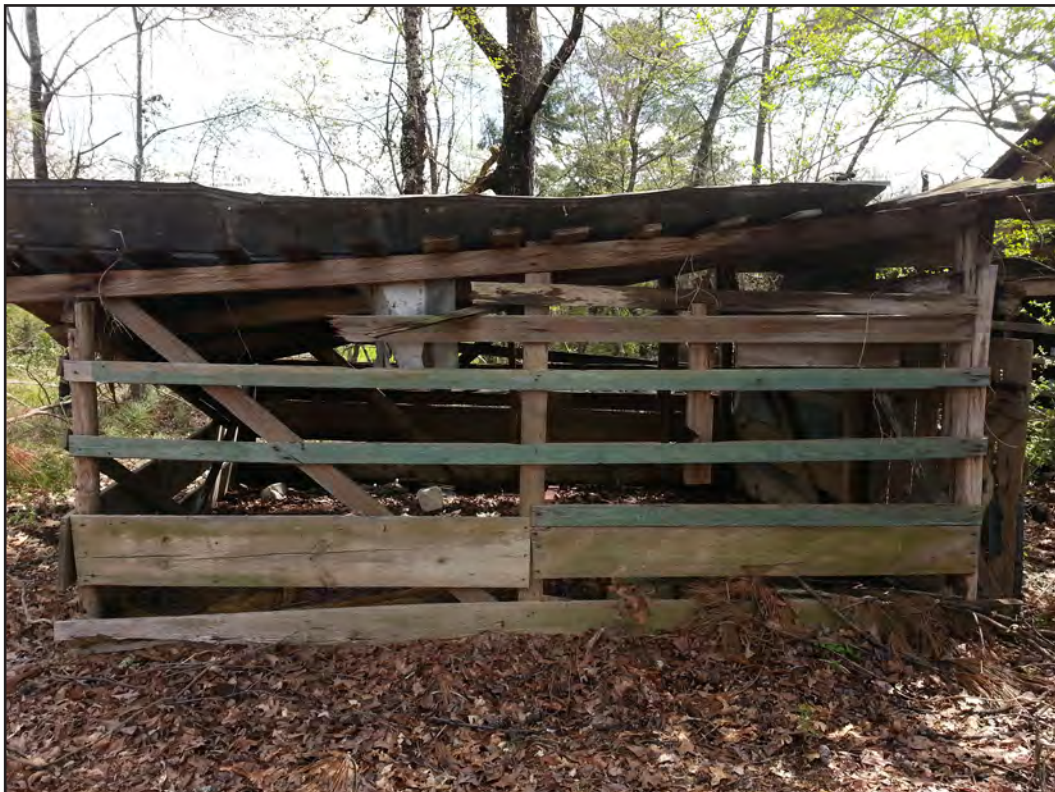
Figure 9. View of livestock pen associated with Structure 1 (Burton House), looking northeast.
