DEPARTMENT OF THE ARMY
U.S. ARMY ENGINEER DISTRICT, MOBILE
CORPS OF ENGINEERS
BIRMINGHAM FIELD OFFICE
218 SUMMIT PARKWAY, SUITE 222
HOMEWOOD, ALABAMA 35209

SUBJECT: Nationwide Permit Authorization; SAM-2011-00880-CHE – Little Spring Creek Mine – Haley Brothers Coal, Inc.

**Haley Brothers Coal, Inc.
Little Spring Creek Mine
Walker County, Alabama**

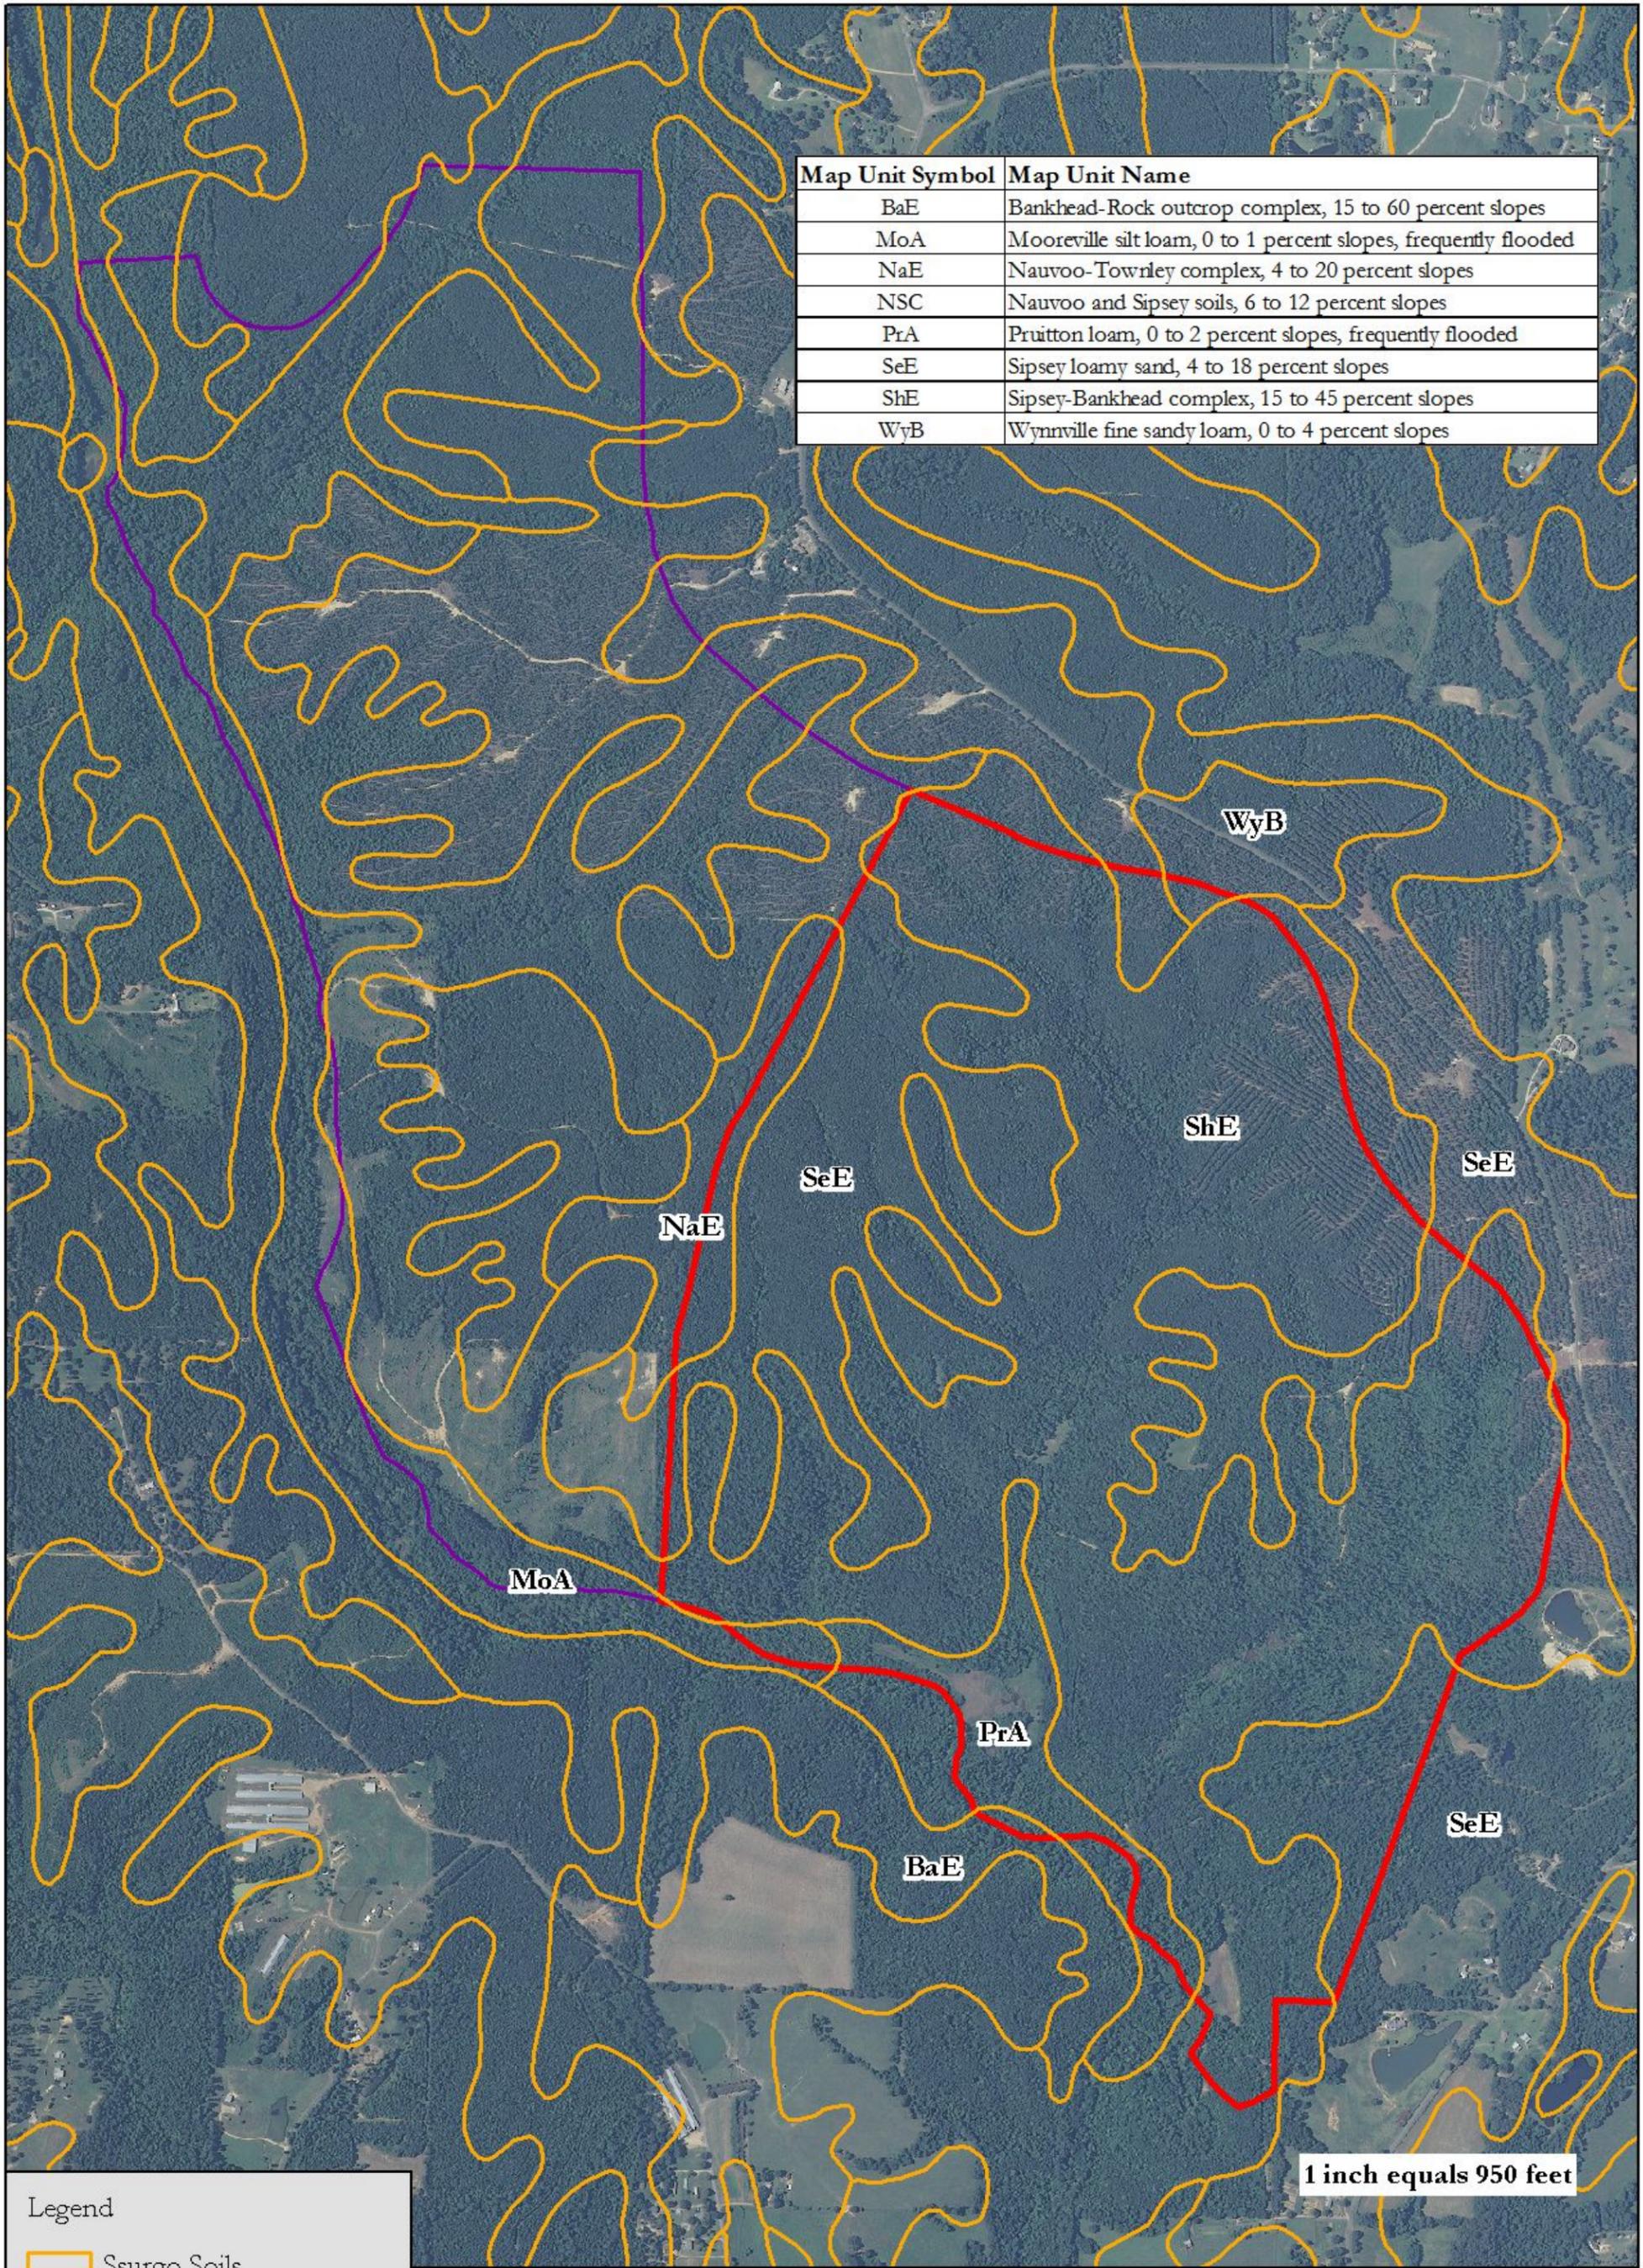
Soils Map

Map Unit Symbol	Map Unit Name
BaE	Bankhead-Rock outcrop complex, 15 to 60 percent slopes
MoA	Mooreville silt loam, 0 to 1 percent slopes, frequently flooded
NaE	Nauvoo-Townley complex, 4 to 20 percent slopes
NSC	Nauvoo and Sipsy soils, 6 to 12 percent slopes
PrA	Pruitton loam, 0 to 2 percent slopes, frequently flooded
SeE	Sipsy loamy sand, 4 to 18 percent slopes
ShE	Sipsy-Bankhead complex, 15 to 45 percent slopes
WyB	Wynville fine sandy loam, 0 to 4 percent slopes

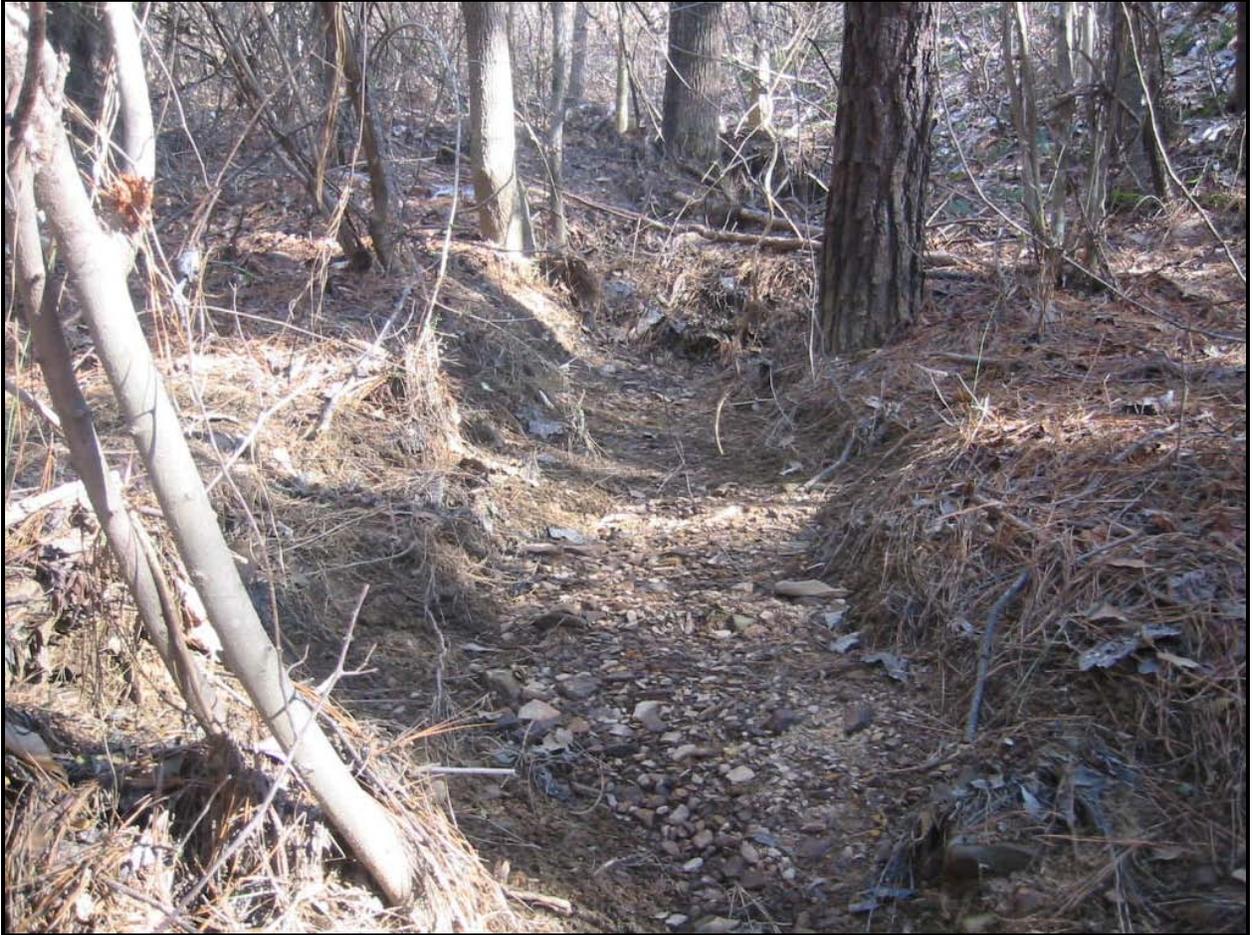
Photo ID WFP # 3 mid reach

Precipitation event – 1 to 2 days since significant rainfall

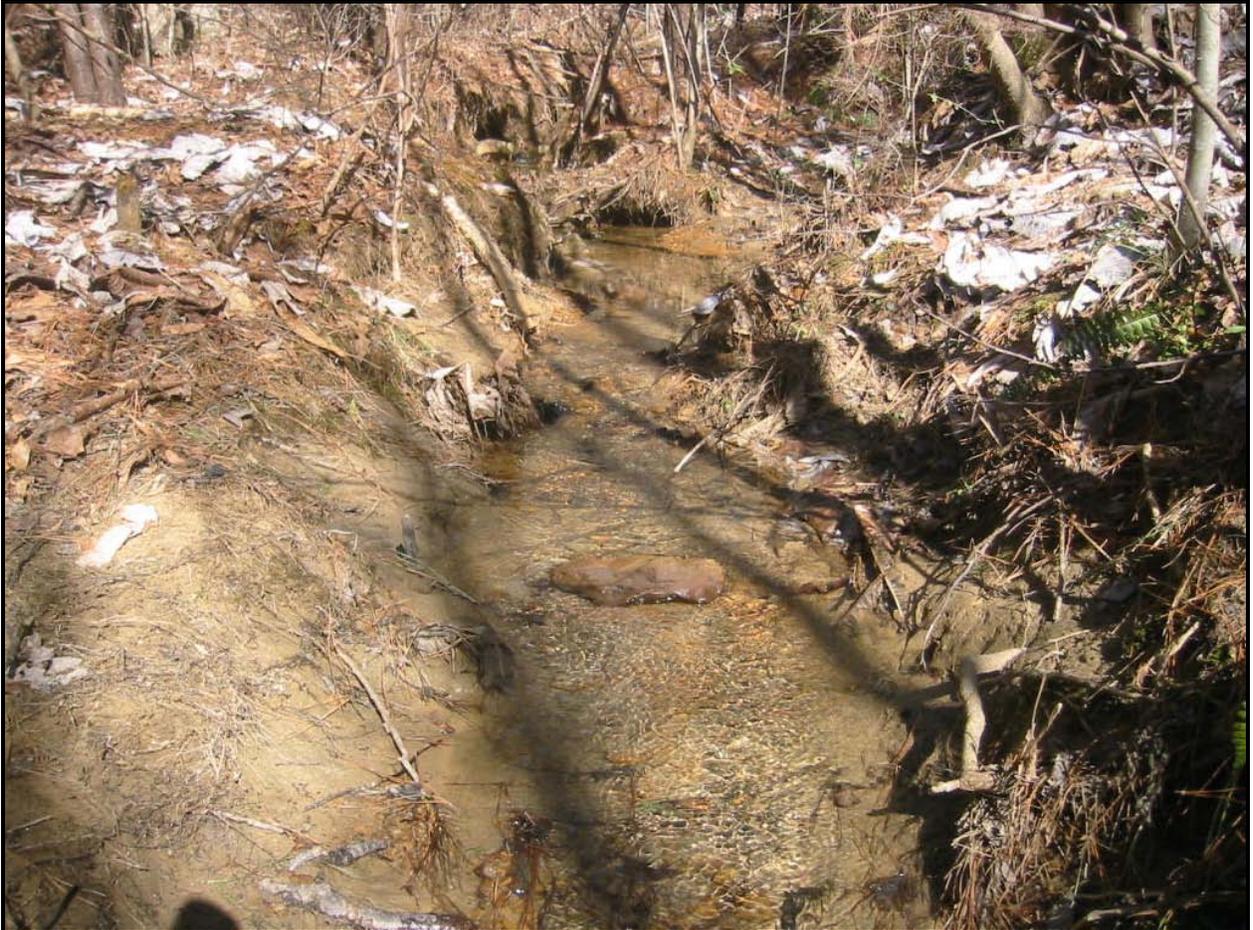
Photo ID WFP # 4 lower reach

Precipitation event – < 1 day since significant rainfall - there has been excessive rainfall during fall and winter.

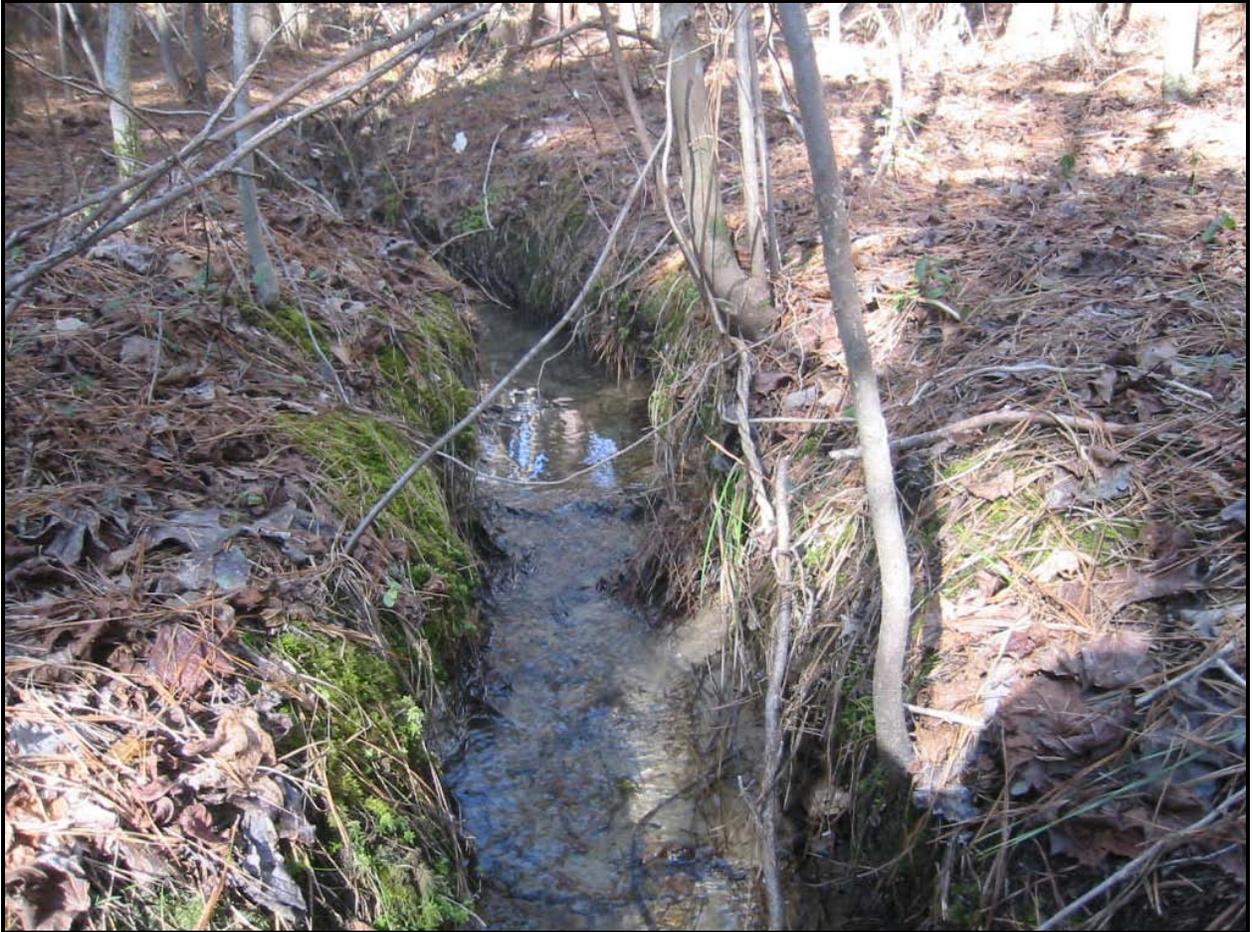
Photo ID WFP # 5 lower reach

Precipitation event – 1 to 2 days since significant rainfall – there has been excessive fall and winter rainfall.

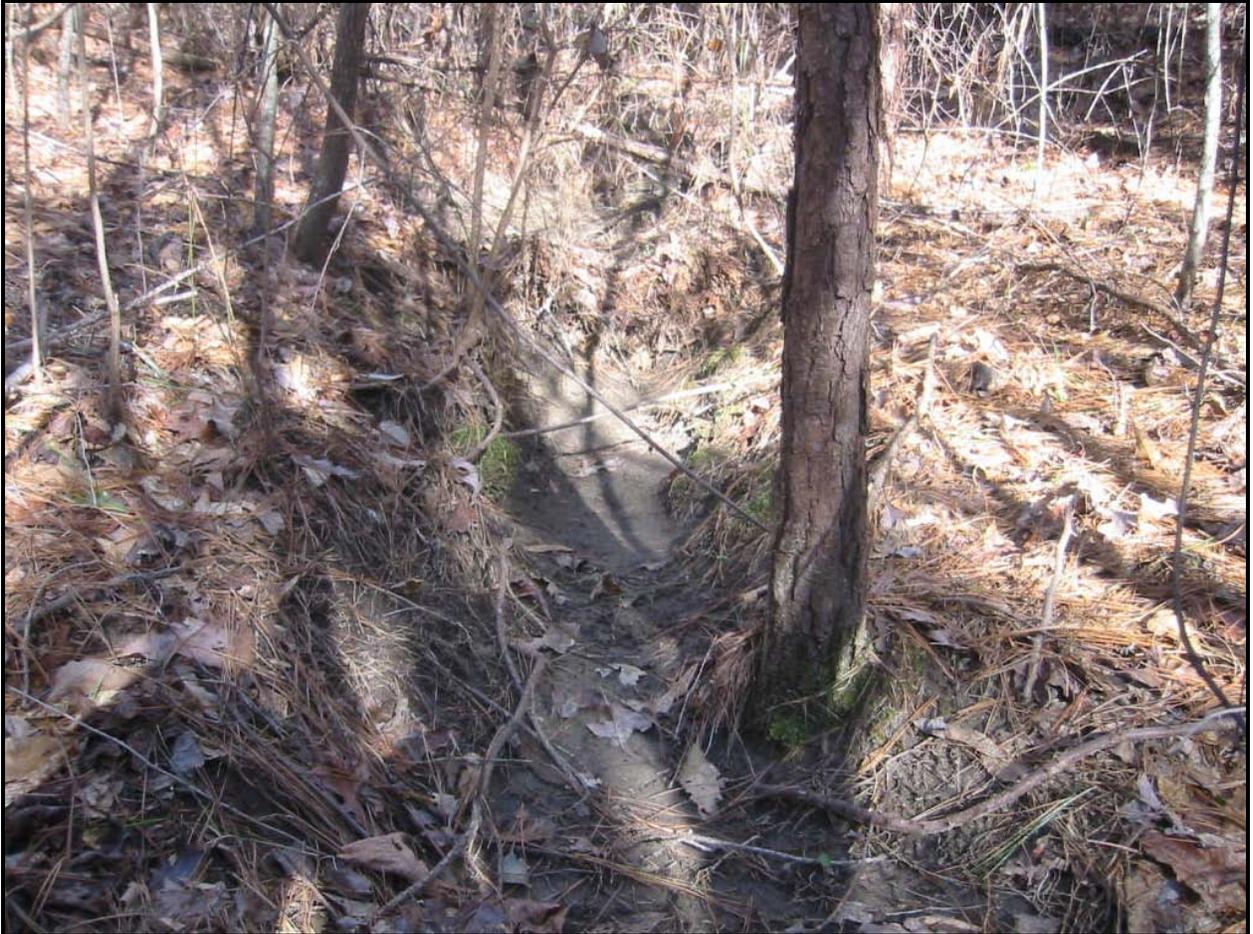
Photo ID WFP # 5 upper reach

Precipitation event – 1 to 2 days since significant rainfall - there has been excessive rainfall during fall and winter.

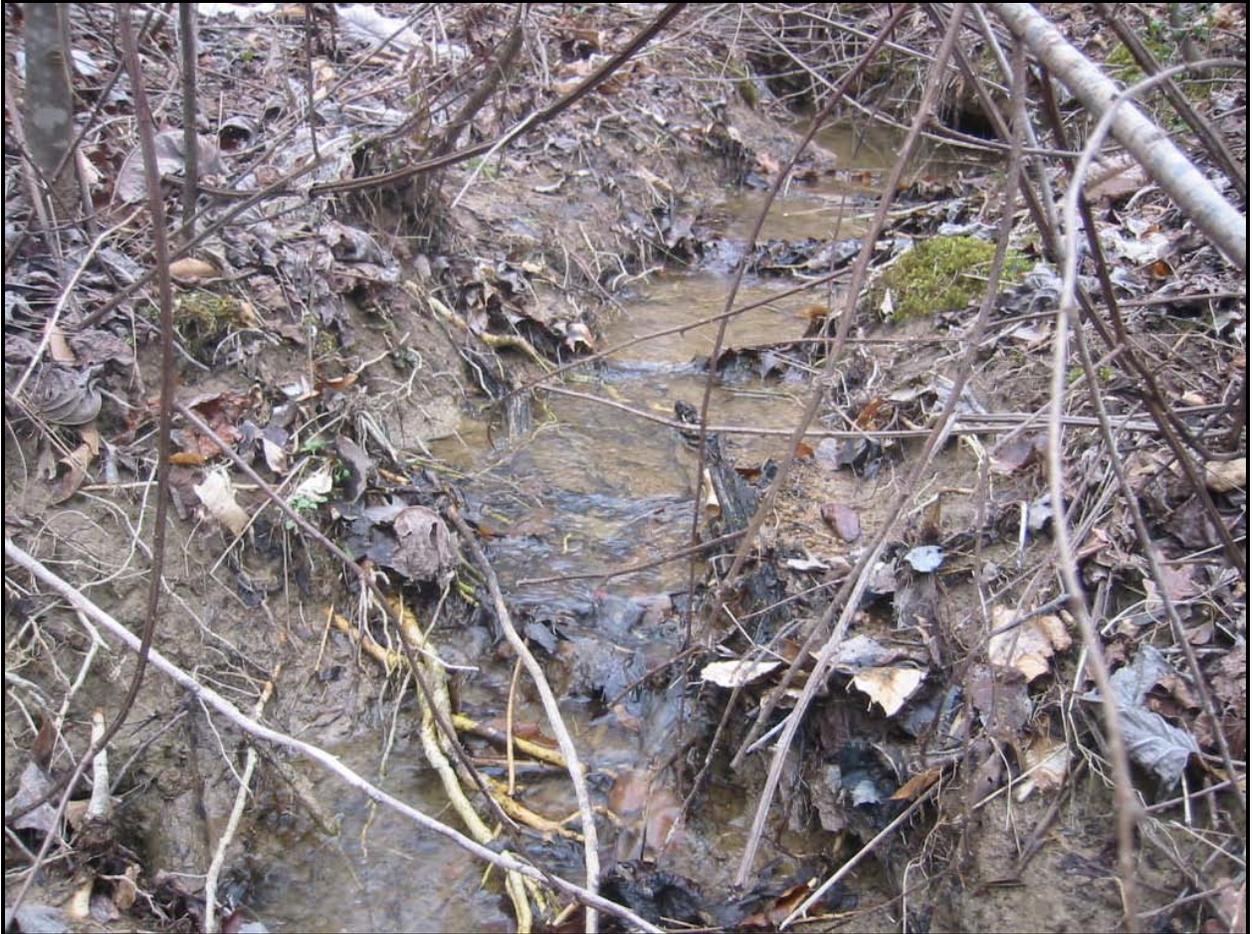
Photo ID WFP # 6 lower reach

Precipitation event – 1 day since significant rainfall – there has been excessive rainfall during fall and winter.

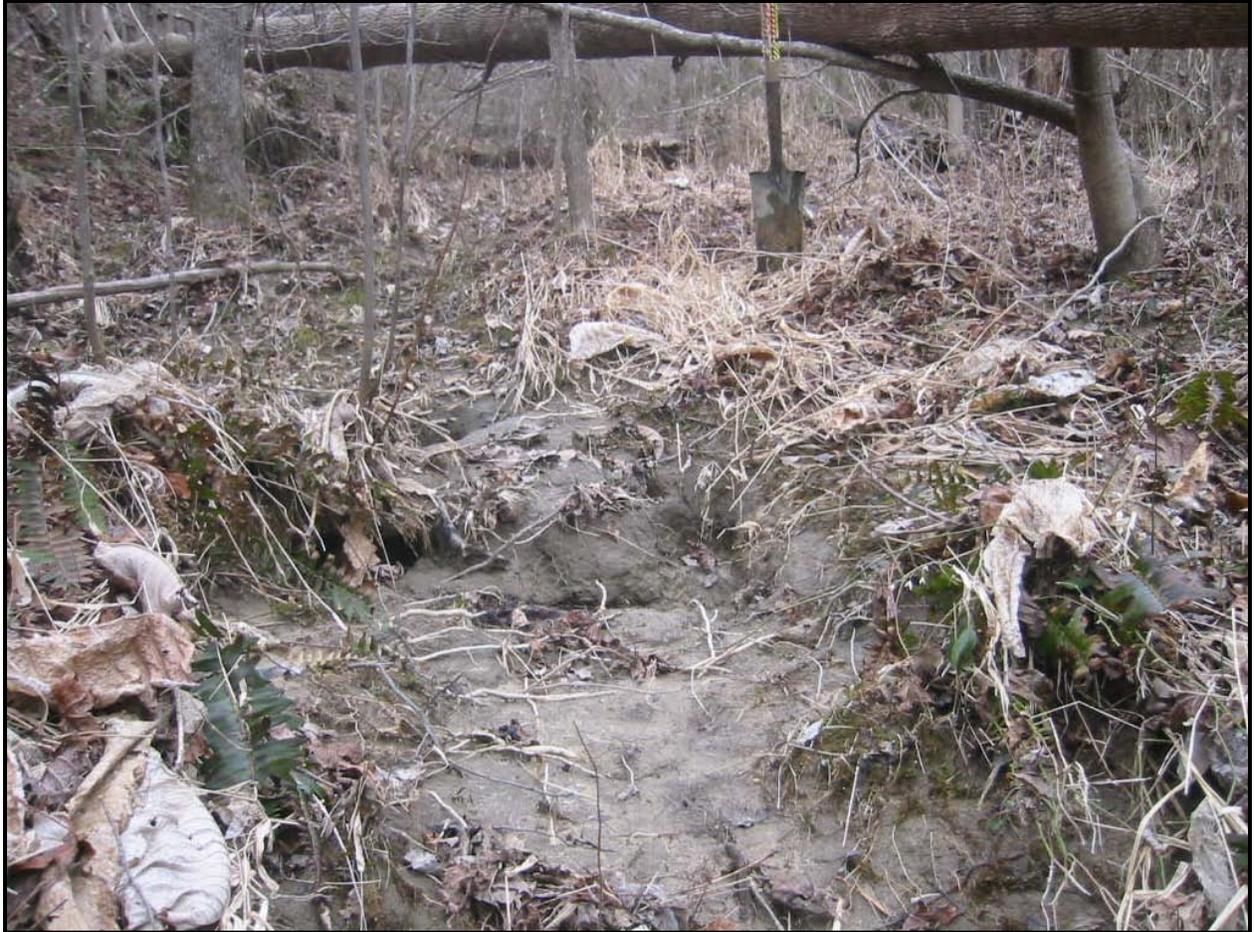
Photo ID WFP # 6 upper reach

Precipitation event – 1 day since significant rainfall – there has been excessive rainfall during fall and winter.

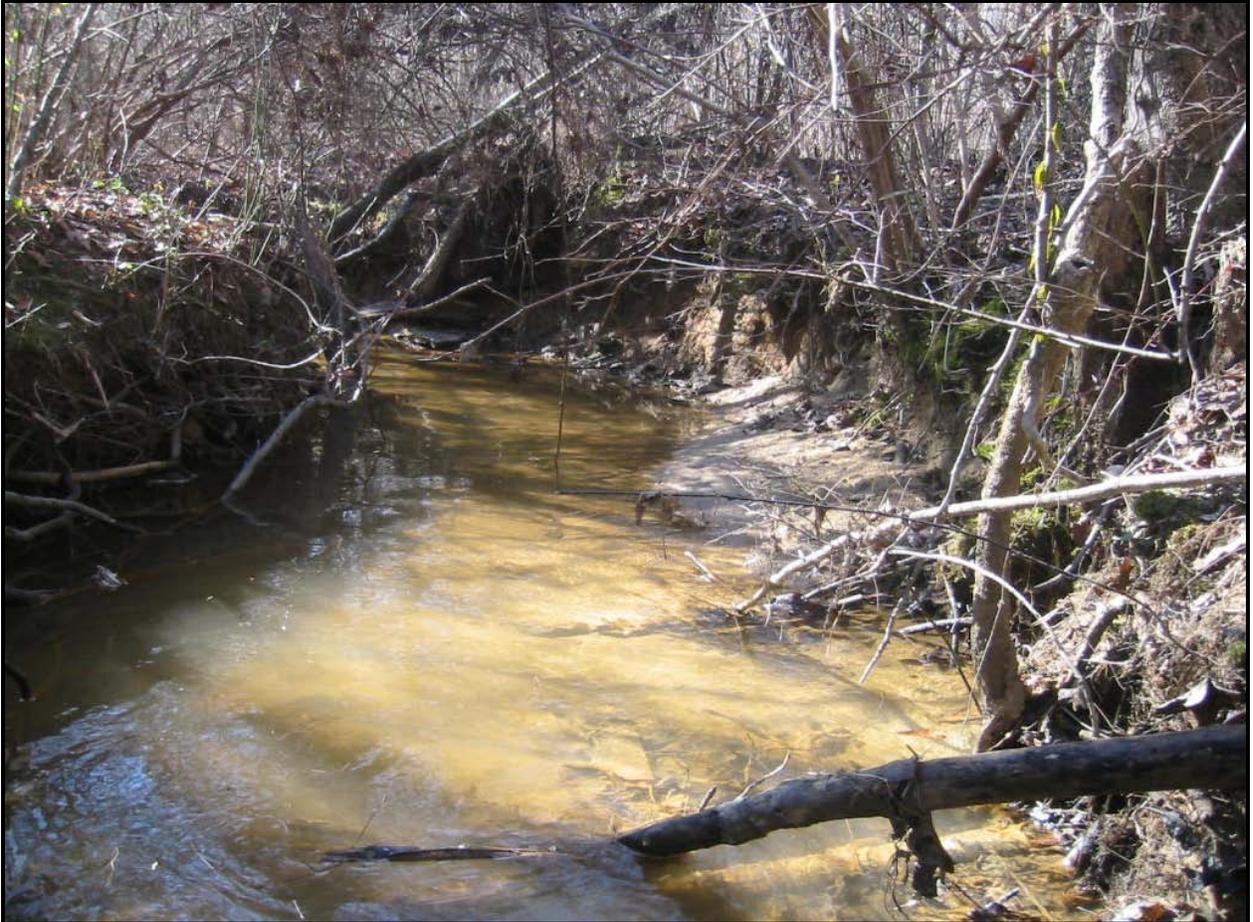
Photo ID WFP # 7 lower reach

Precipitation event –1 day since significant rainfall- there has been excessive rainfall during fall and winter.

Table A - Channel ID	Channel Condition
WFP 7	Poor
WFP 19	Poor

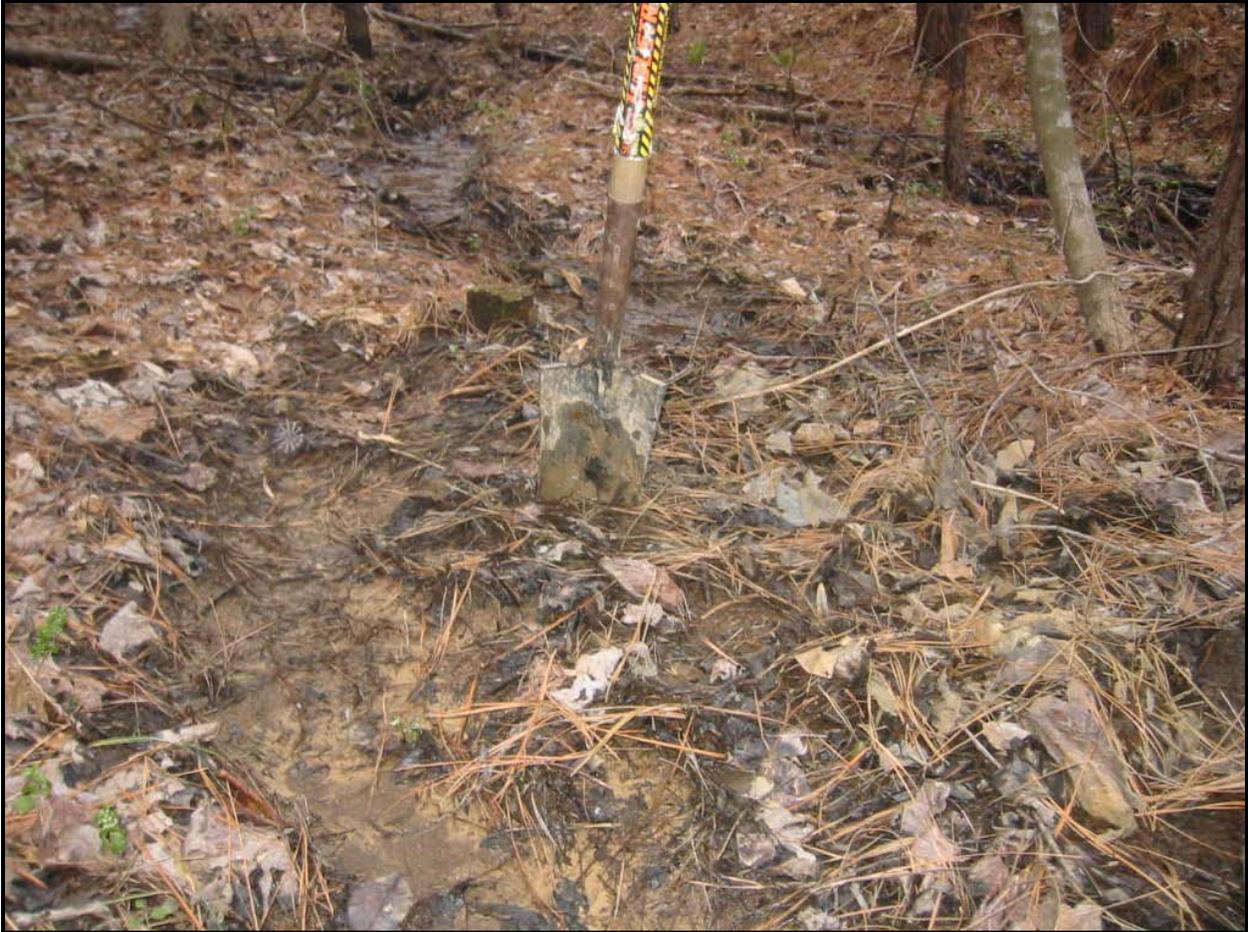
Photo ID WFP # 8 lower reach

Precipitation event – 1 to 2 days since significant rainfall – there has been excessive rainfall during fall and winter.

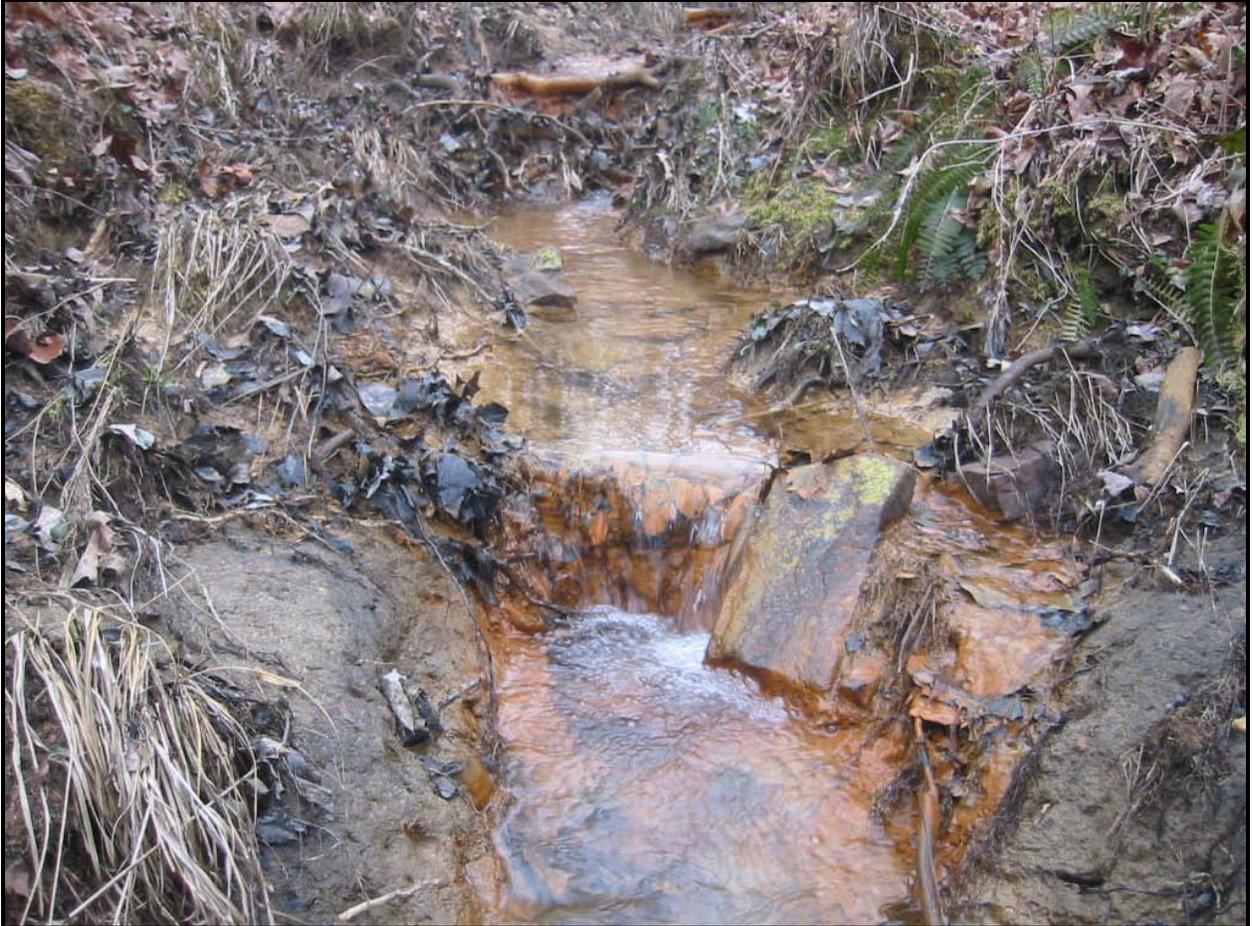
Photo ID WFP # 9 mid reach

Precipitation event – 1 day since significant rainfall – there has been excessive rainfall during fall and winter.

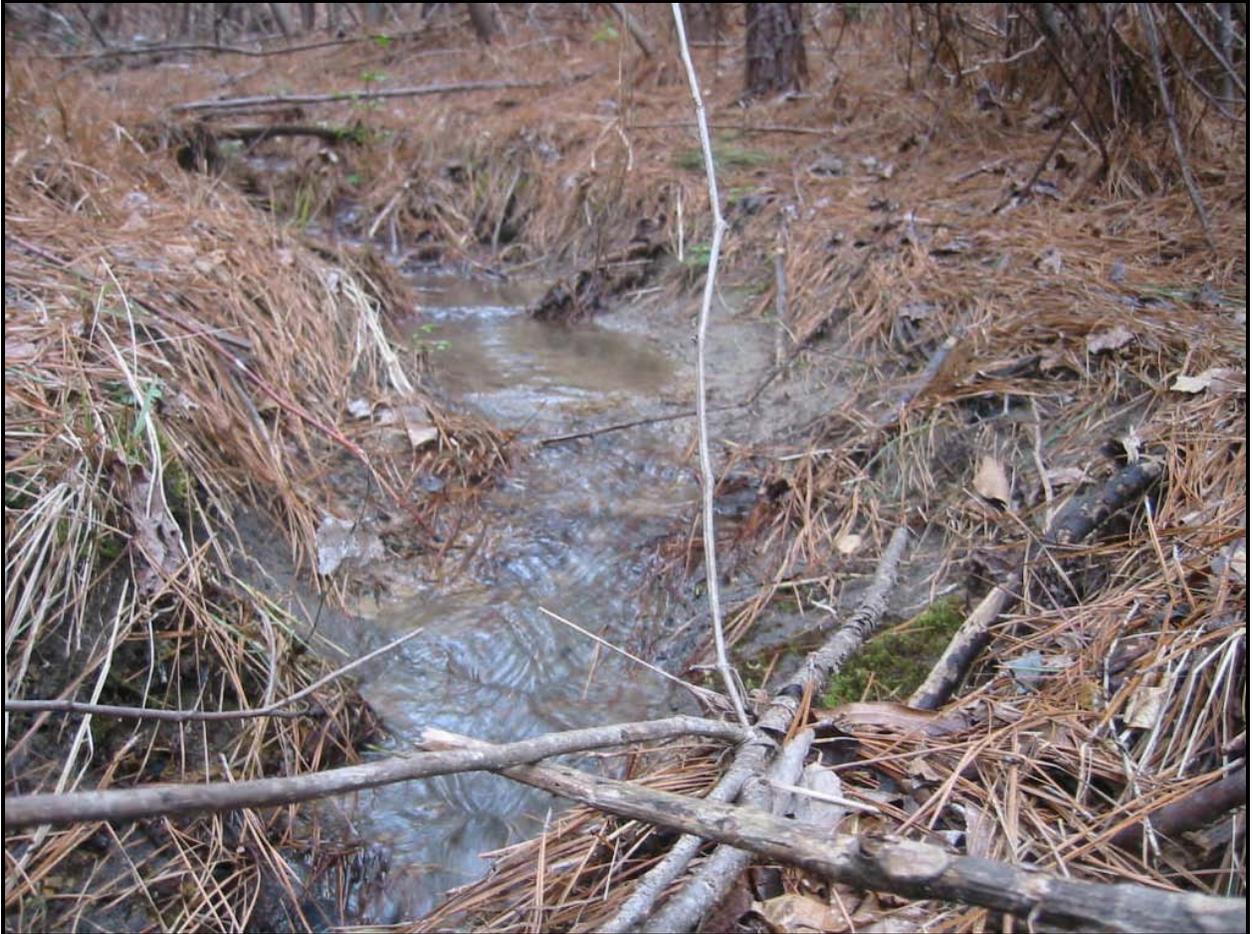
Photo ID WFP # 17 lower reach

Precipitation event – 1 2 days since significant rainfall – there has been excessive rainfall during fall and winter.

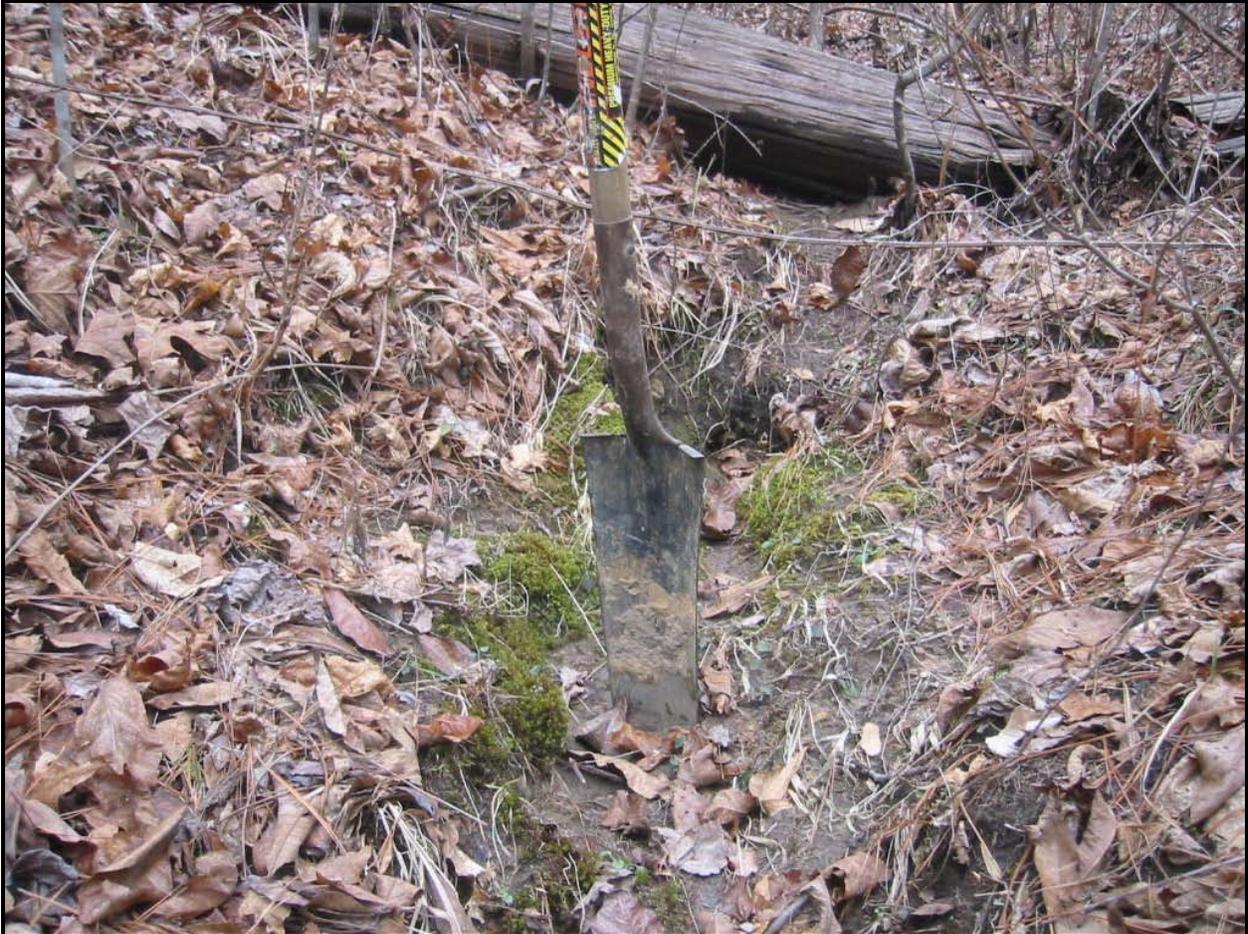
Photo ID WFP # 17 upper reach

Precipitation event – 1 to 2 days since significant rainfall

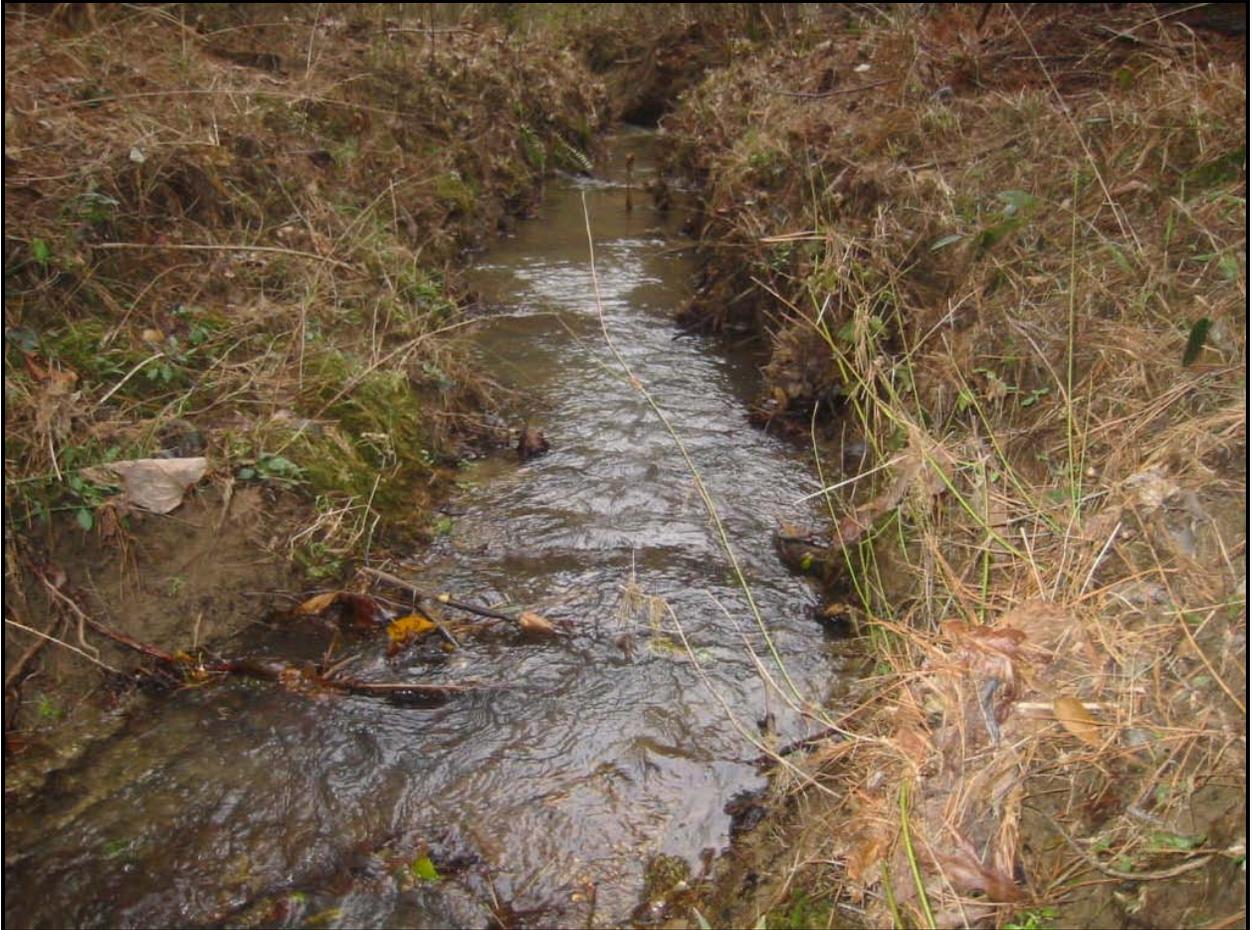
Photo ID WFP # 19 upper reach

Precipitation event – 1 to 2 days since significant rainfall – there has been excessive rainfall during fall and winter.

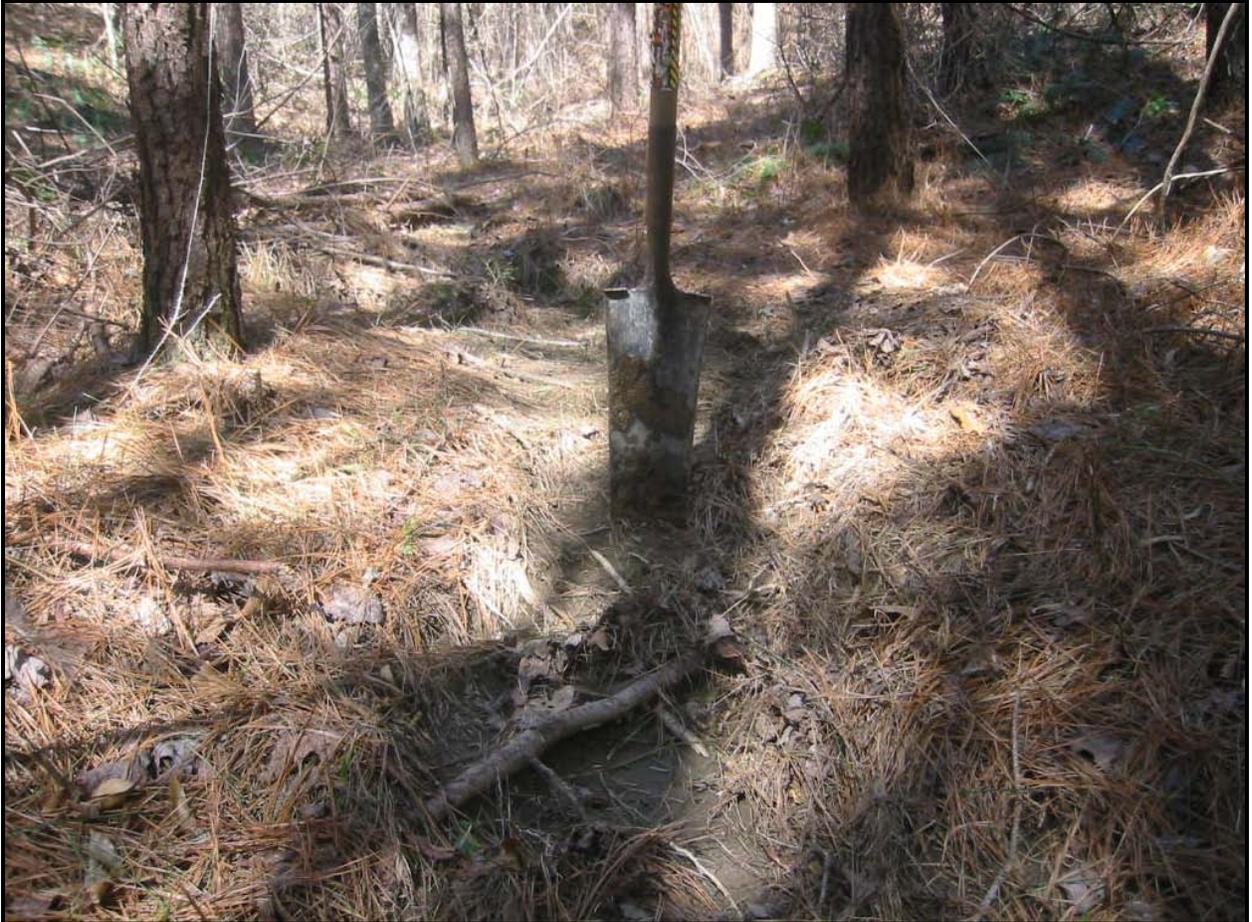
Photo ID WFP # 22 mid reach

Precipitation event – 1 to 2 days since significant rainfall

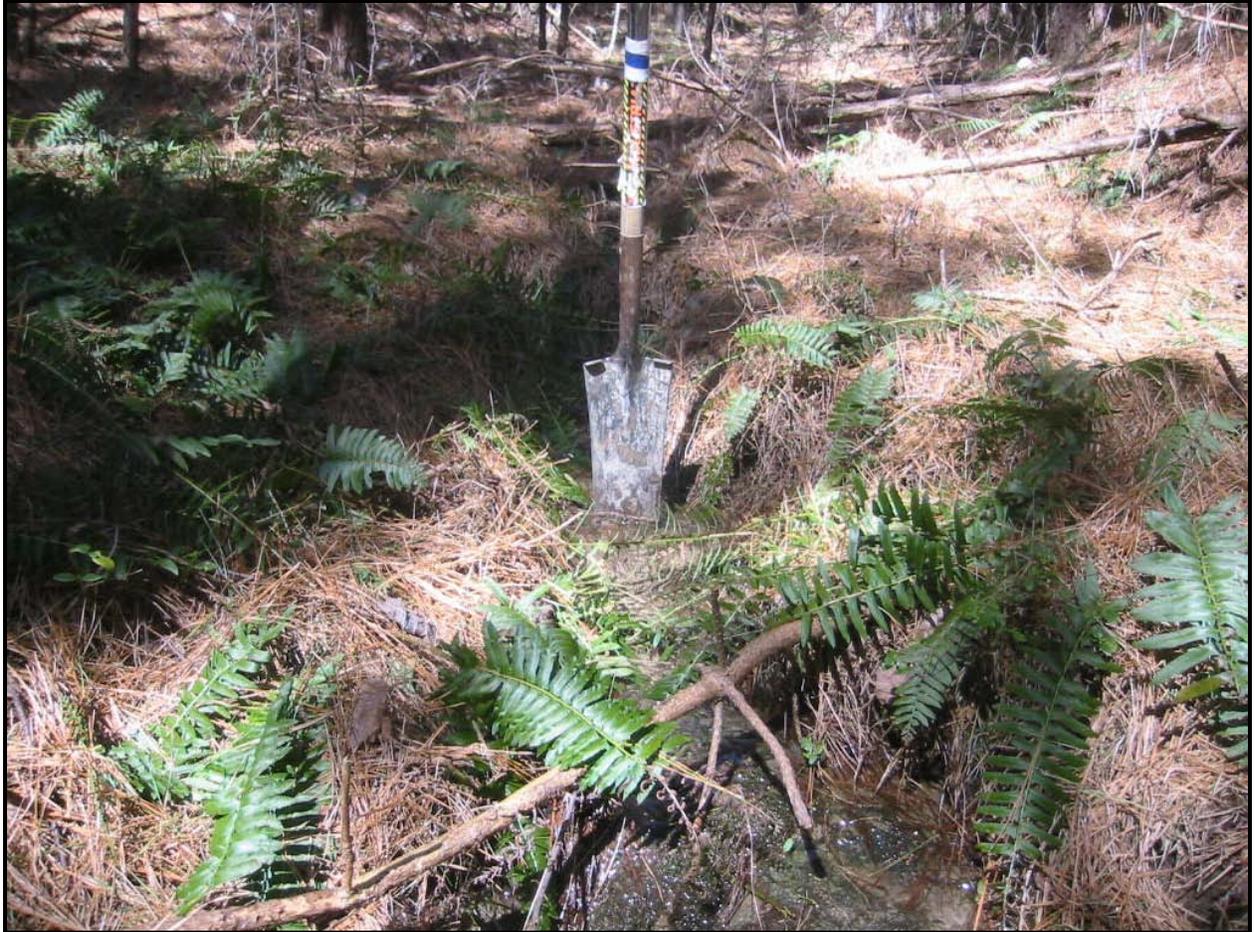
Photo ID WFP # 23 mid reach

Precipitation event – 1 to 2 days since significant rainfall

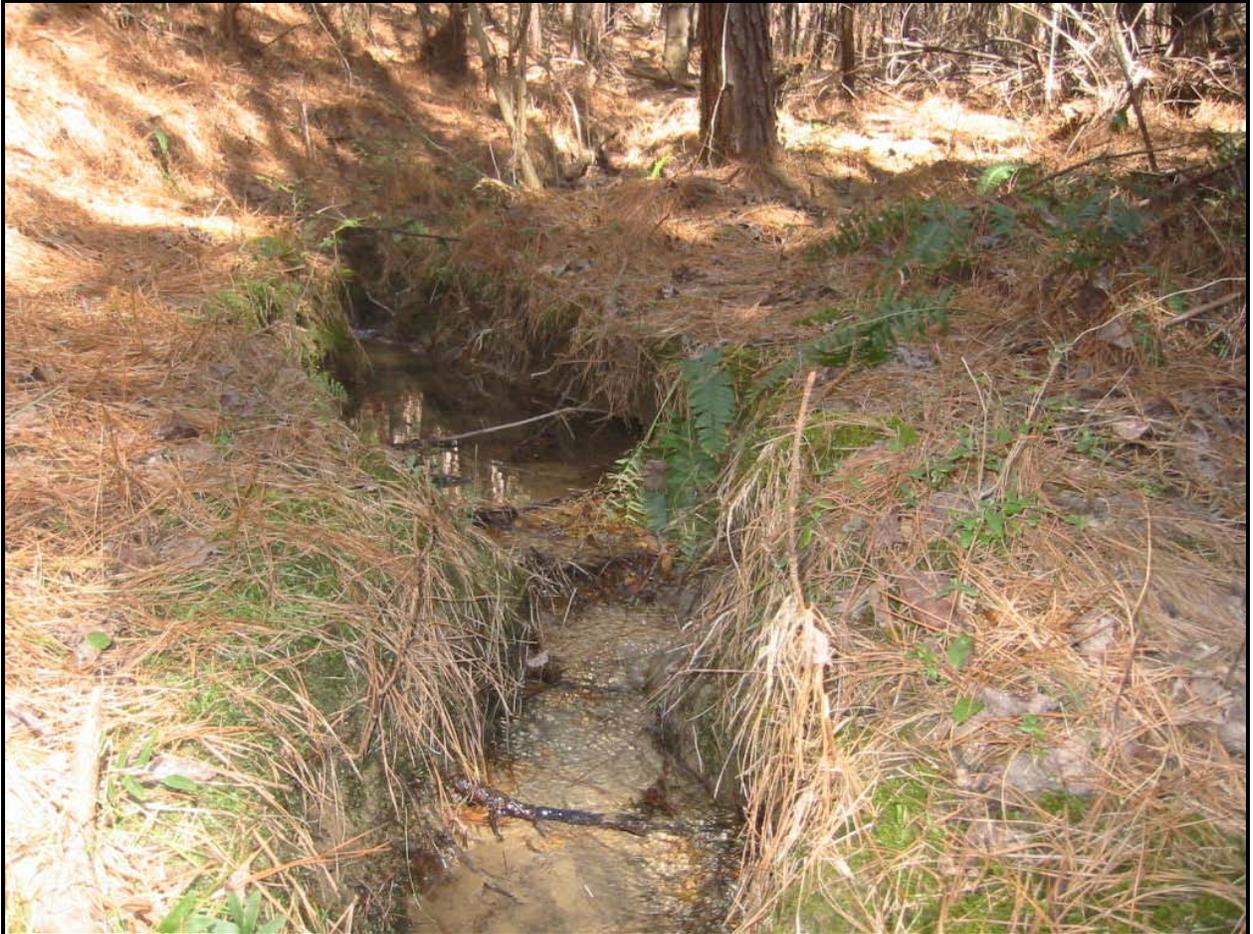
Photo ID WFP # 24 mid reach

Precipitation event – 1 to 2 days since significant rainfall- there has been excessive rainfall during fall and winter.

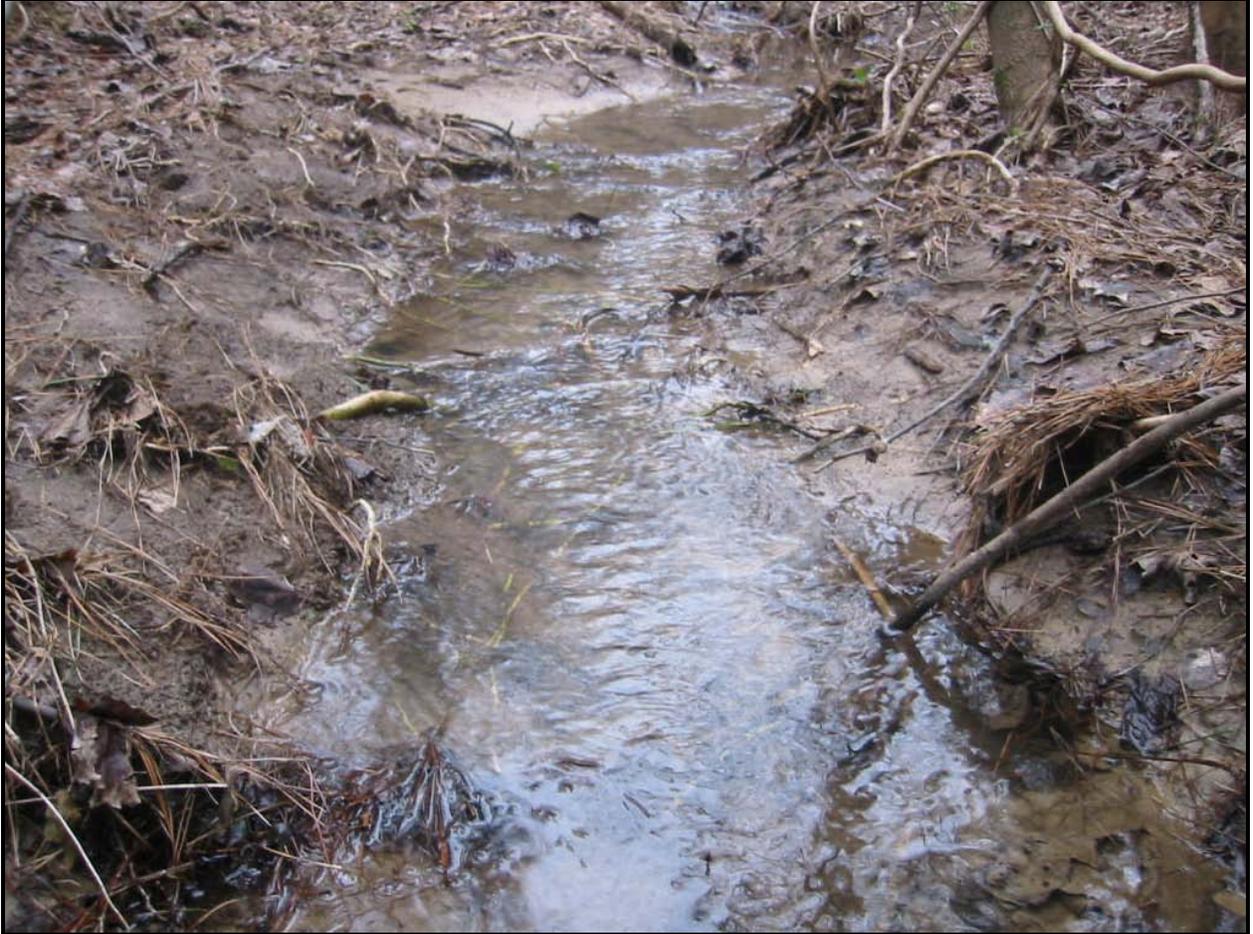
Photo ID WFP # 31 lower reach

Precipitation event – 1 day since significant rainfall – there has been excessive rainfall during fall and winter.
