DEPARTMENT OF THE ARMY
U.S. ARMY ENGINEER DISTRICT, MOBILE
CORPS OF ENGINEERS
BIRMINGHAM FIELD OFFICE
218 SUMMIT PARKWAY, SUITE 222
HOMEWOOD, ALABAMA 35209

SUBJECT: Nationwide Permit Authorization; SAM-2011-00880-CHE – Little Spring Creek Mine – Haley Brothers Coal, Inc.

**Haley Brothers Coal, Inc.
Little Spring Creek Mine
Walker County, Alabama**

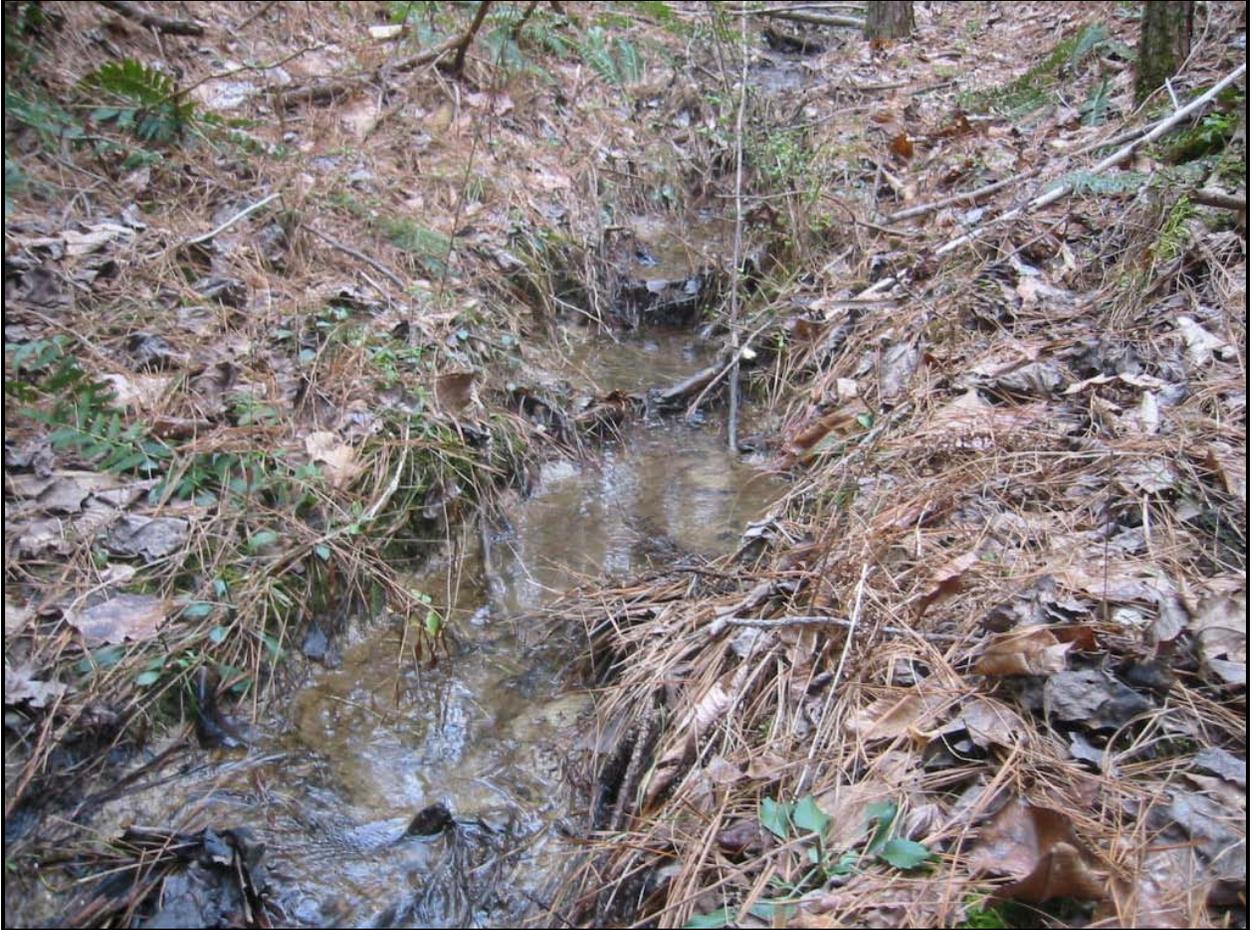
Photo ID WFP # 31 upper reach

Precipitation event – 1 to 2 days since significant rainfall – there has been excessive rainfall during fall and winter.

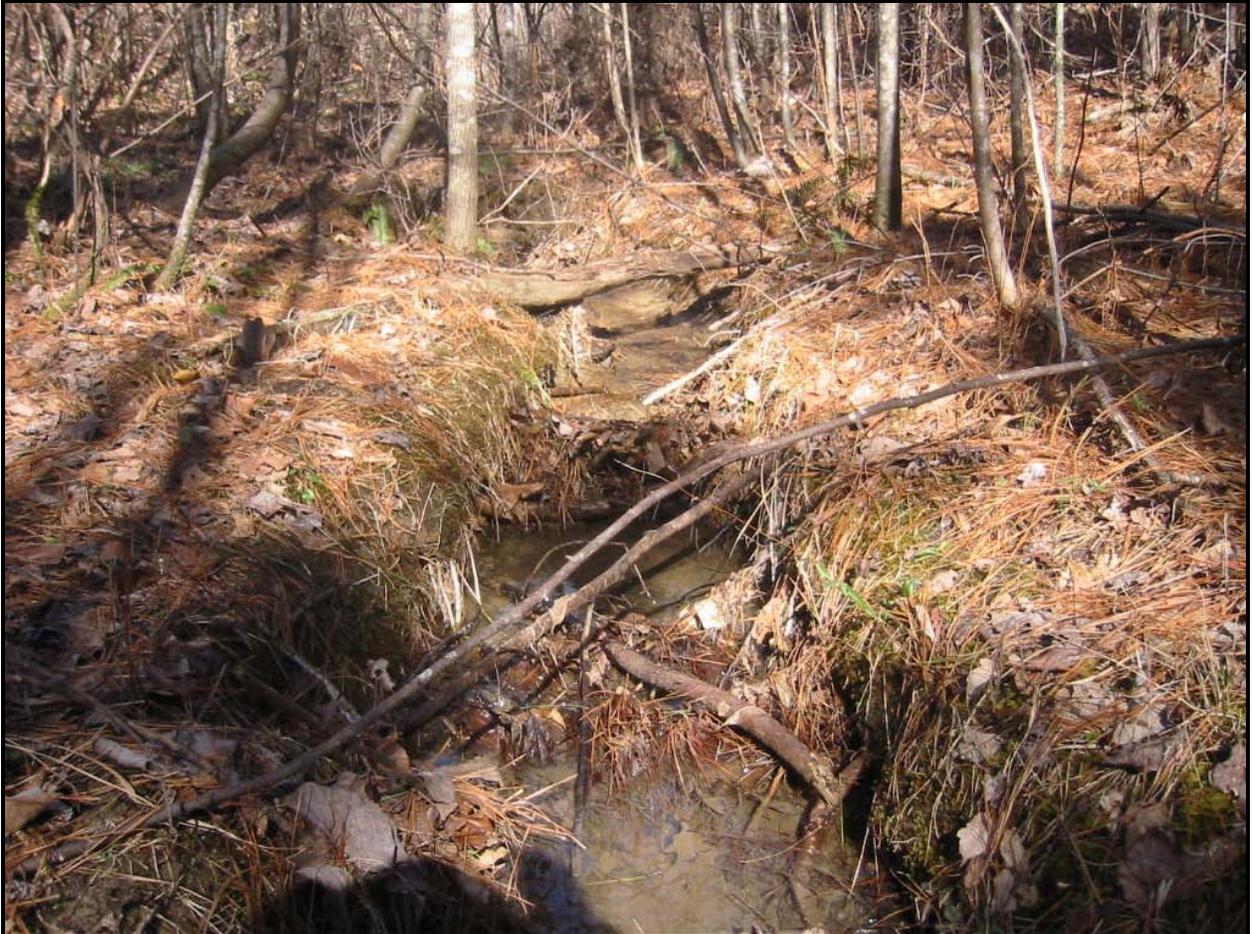
Photo ID WFP # 36 lower reach

Precipitation event – 1 to 2 days since significant rainfall – there has been excessive rainfall during fall and winter.

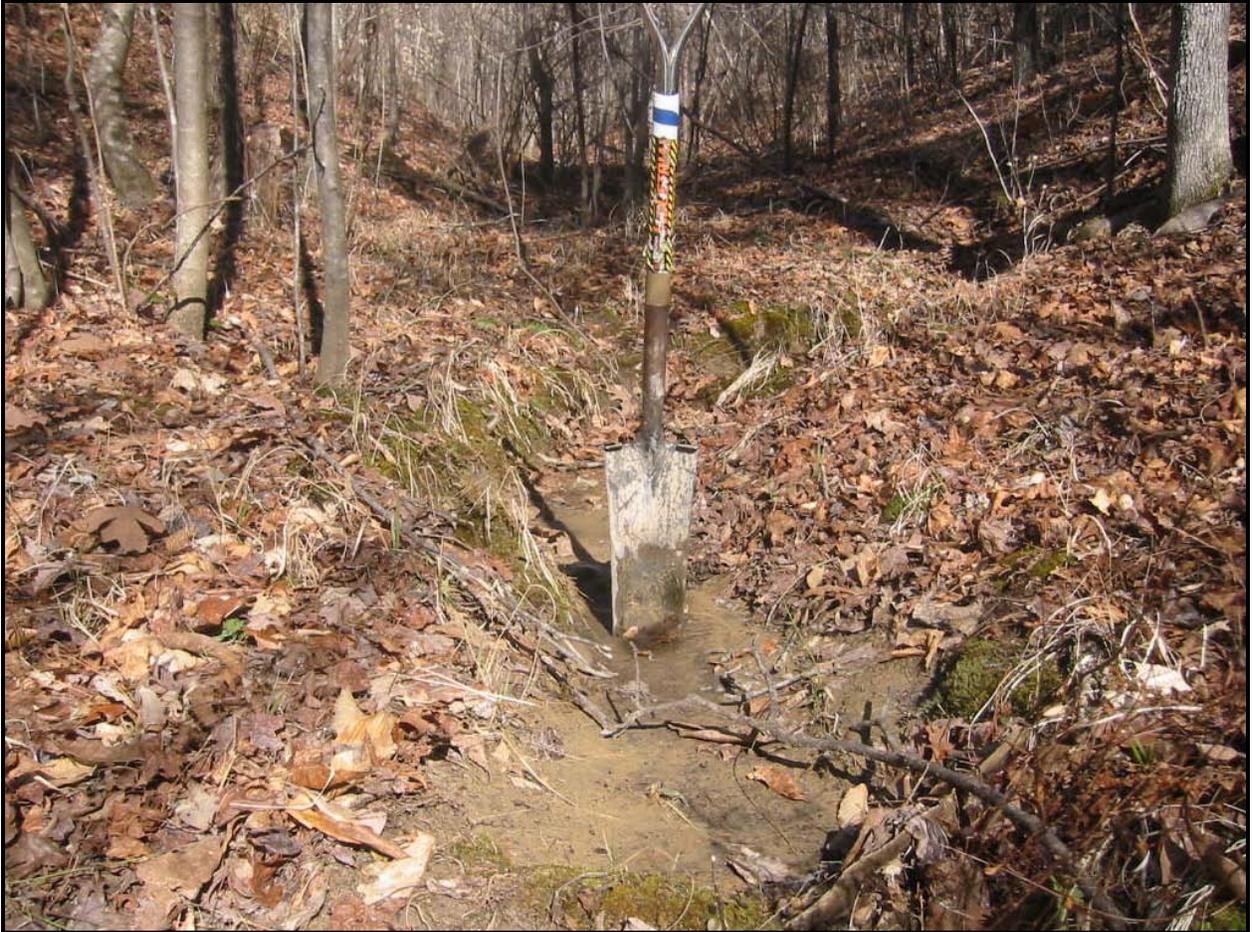
Photo ID WFP # 36 upper reach

Precipitation event – 1 to 2 days since significant rainfall

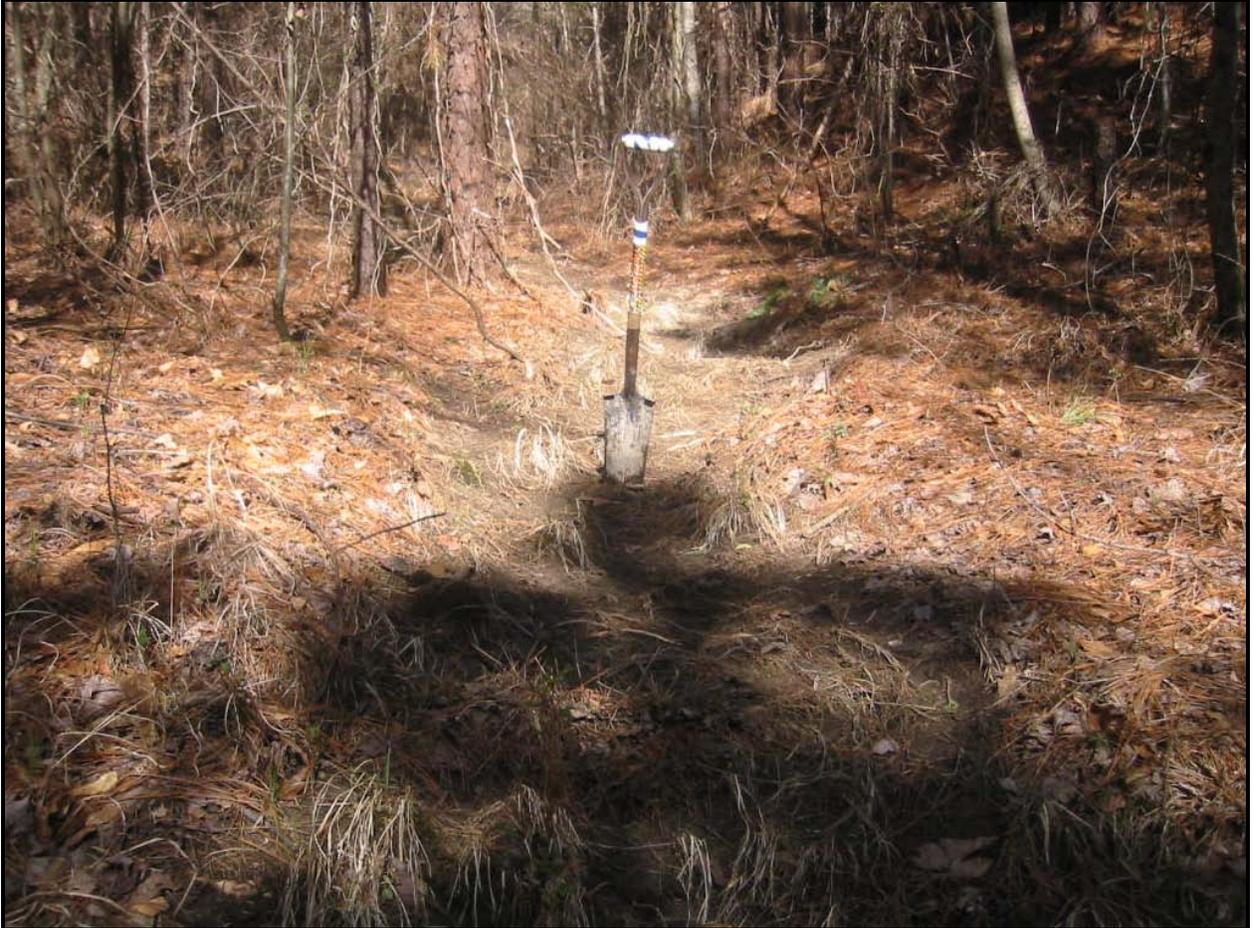
Photo ID WFP # 38 mid reach

Precipitation event – 1 to 4 days since significant rainfall

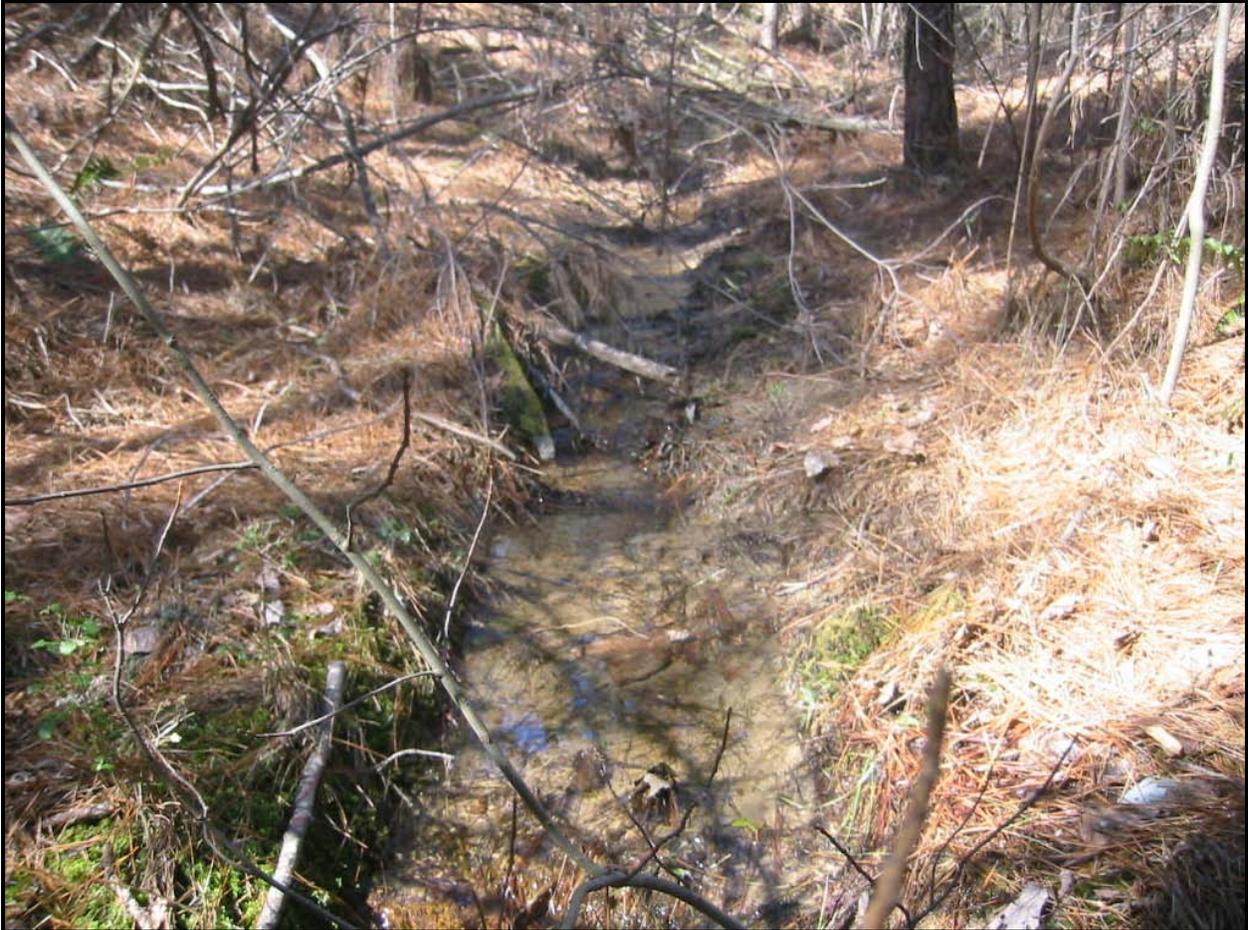
Photo ID WFP # 39 lower reach

Precipitation event – 1 to 2 days since significant rainfall – there has been excessive rainfall during fall and winter .

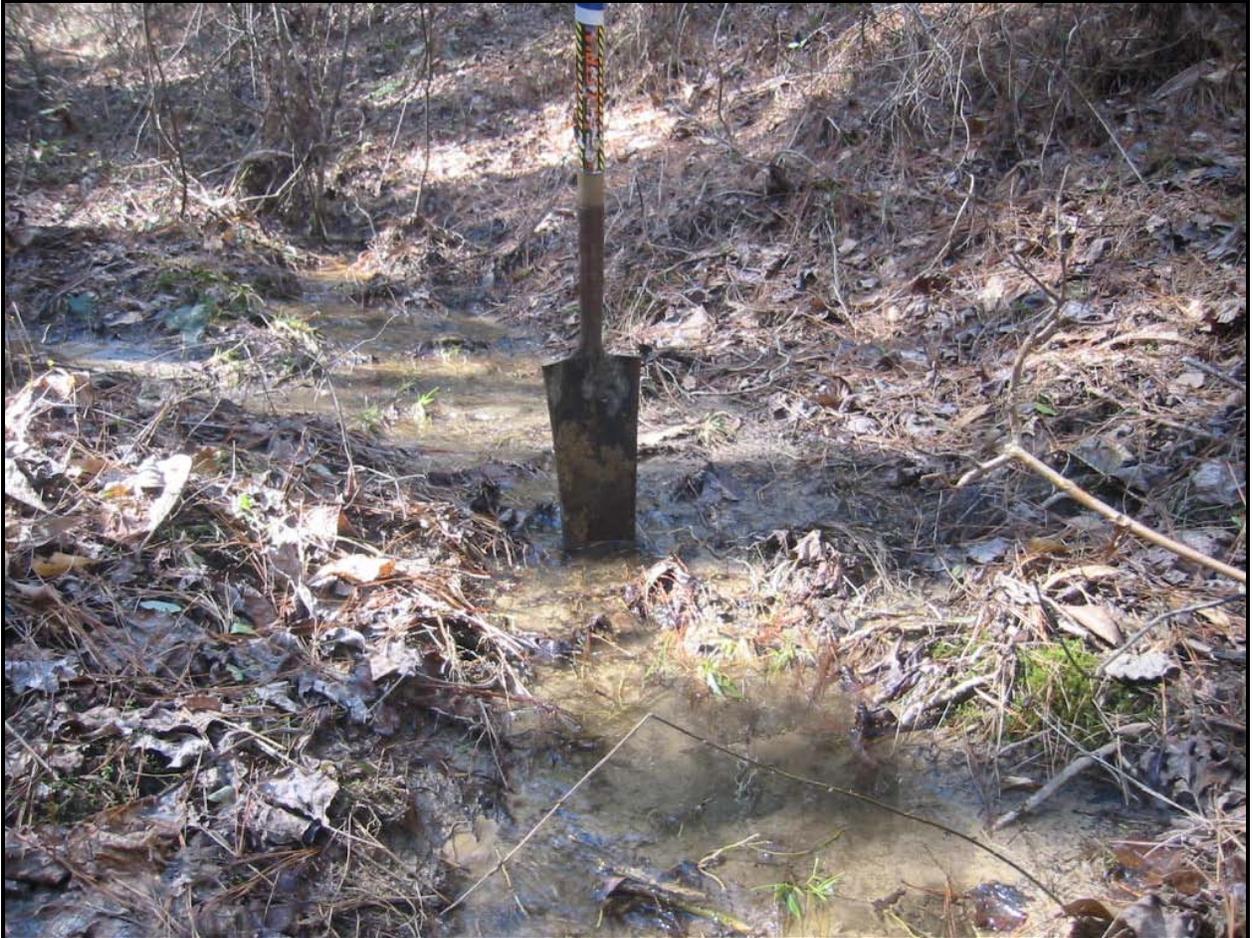
Photo ID WFP # 41 mid reach

Precipitation event – 1 day since significant rainfall – there has been excessive rainfall during fall and winter.

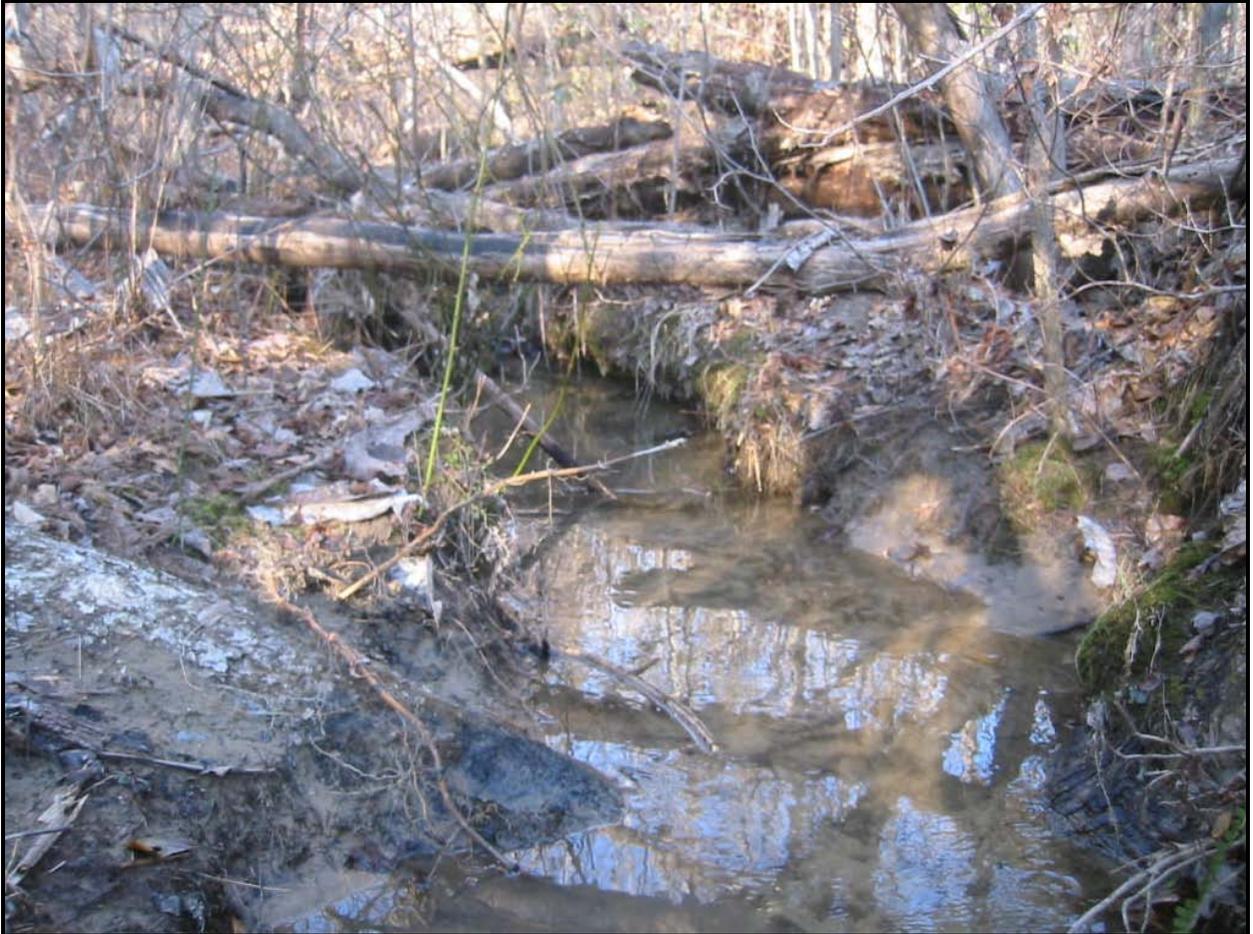
Photo ID WFP # 46 lower reach

Precipitation event – 1 to 2 days since significant rainfall – there has been excessive rainfall during fall and winter.

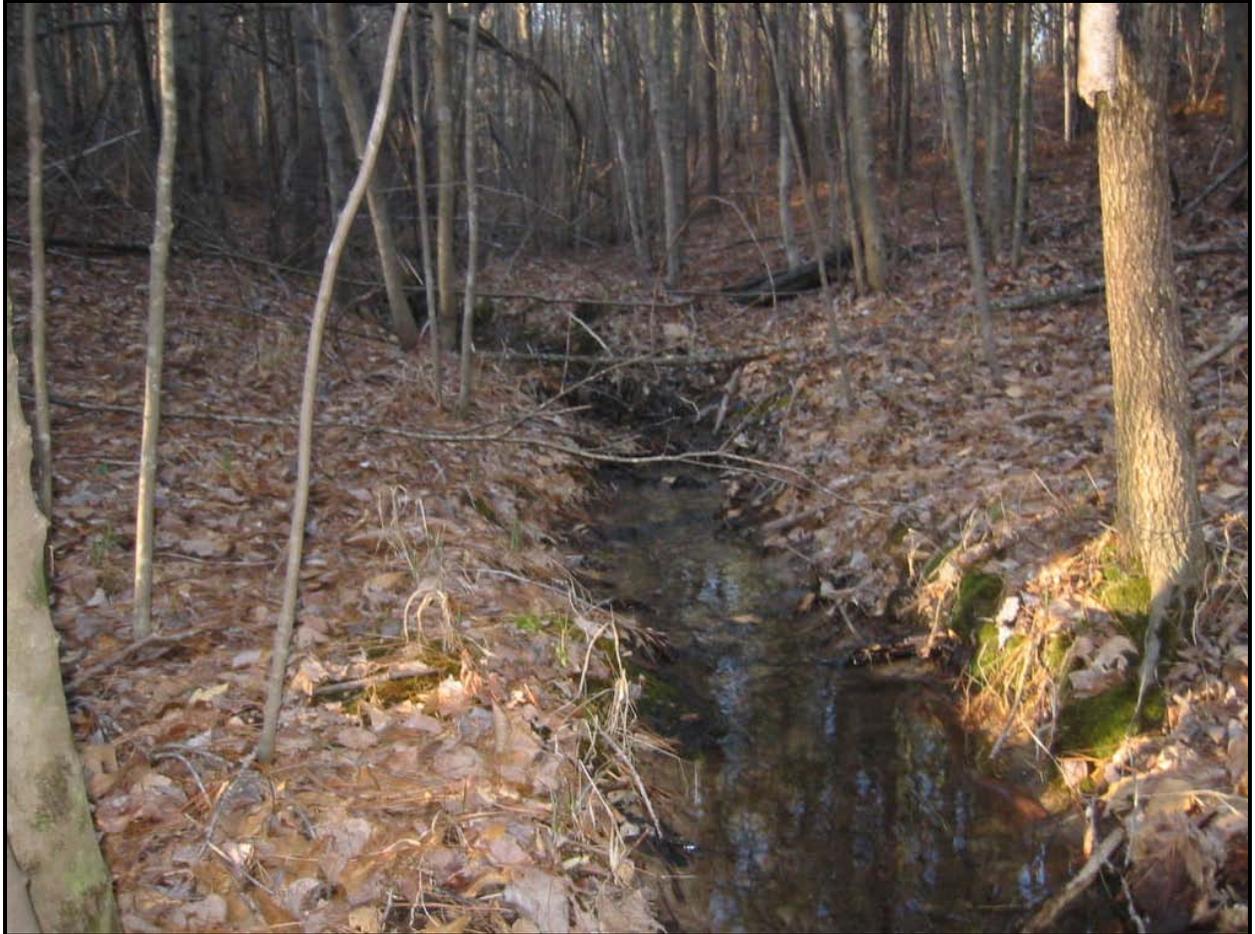
Photo ID WFP # 48

Precipitation event – 1 to 2 days since significant rainfall – there has been excessive rainfall during fall and winter.
