# **BIOLOGICAL HABITAT ASSESSMENT**

**KIMBERLY MINE**

**Prepared For:  
ALDEN RESOURCES, LLC**

**November 26<sup>th</sup>, 2013**

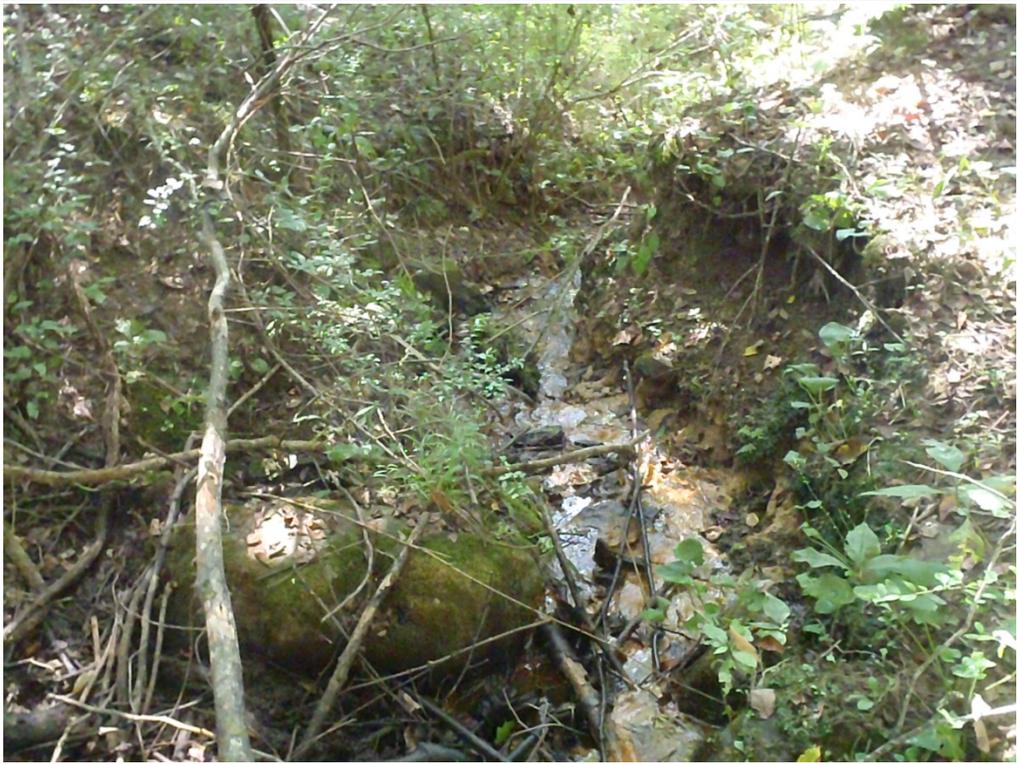
<b>Photo No.</b>	<i>P9110096</i>			
<b>Point No.</b>	A			
<b>Description:</b>				
This is a view of an intermittent drain at point A.				
<b>Dominant Vegetation:</b>				
<ul style="list-style-type: none"> <li>• <i>Ligustrum sinense</i></li> <li>• <i>Carpinus caroliniana</i></li> <li>• <i>Acer rubrum</i></li> <li>• <i>Quercus alba</i></li> <li>• <i>Liquidambar styraciflua</i></li> </ul>

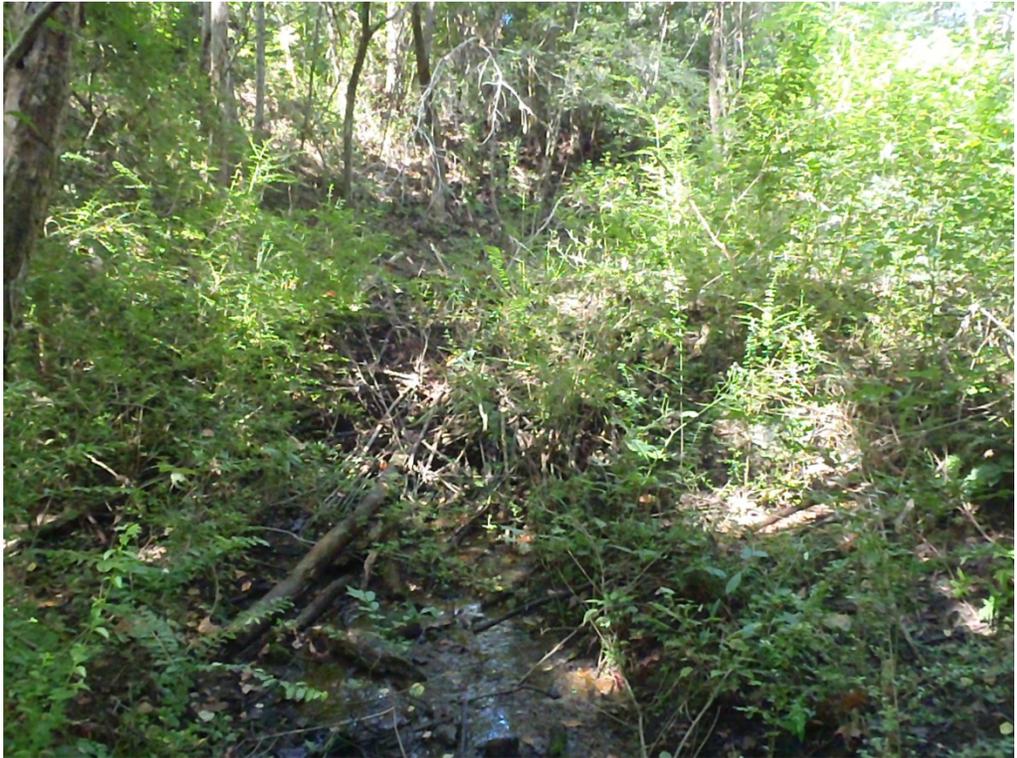
<b>Photo No.</b>	<i>P9110098</i>			
<b>Point No.</b>	A			
<b>Description:</b>				
This a view of the vegetation at point A.				
<b>Dominant Vegetation:</b>				
Same as above.

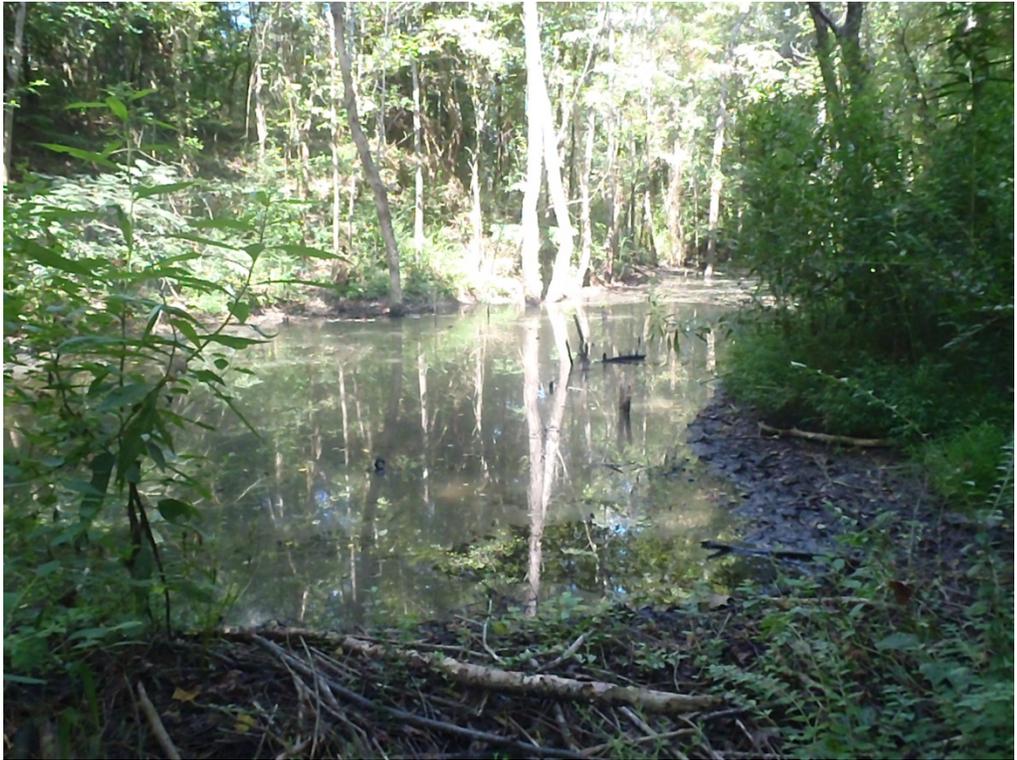
<b>Photo No.</b>	<i>P9110099</i>		
<b>Point No.</b>	<i>B</i>		
<b>Description:</b> This is a view of a pond at point B.			
<b>Dominant Vegetation:</b> <ul style="list-style-type: none"> <li>• <i>Acer rubrum</i></li> <li>• <i>Albizia julibrissin</i></li> <li>• <i>Ligustrum sinense</i></li> <li>• <i>Liquidambar styraciflua</i></li> <li>• <i>Liriodendron tulipifera</i></li> <li>• <i>Lonicera japonica</i></li> <li>• <i>Salix nigra</i></li> </ul>

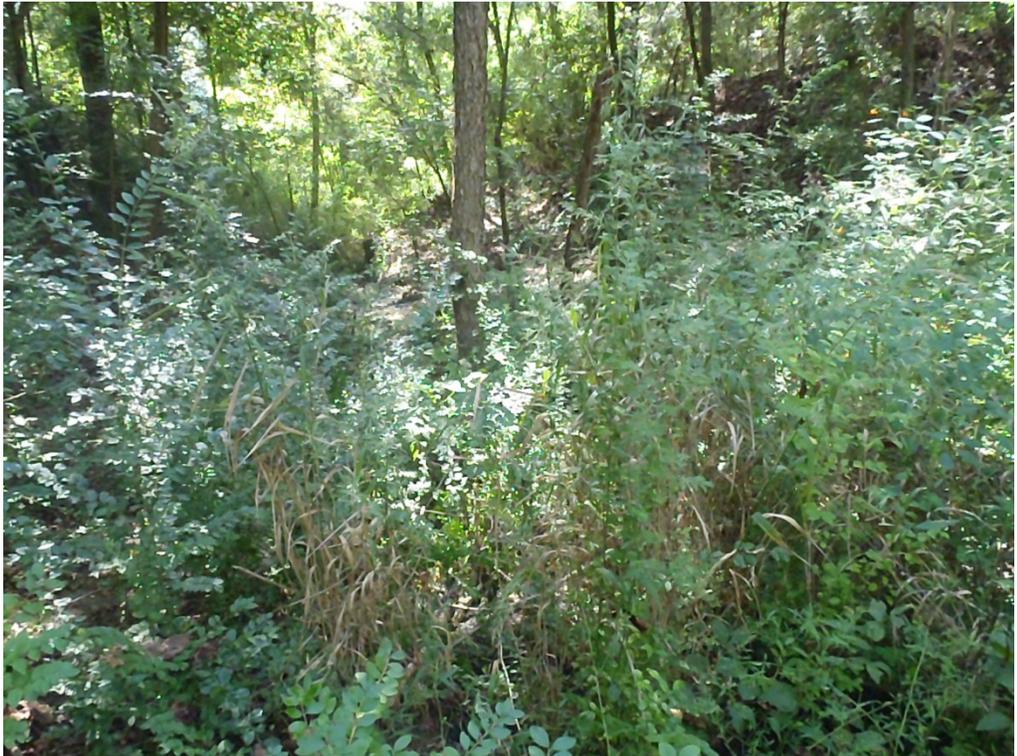
<b>Photo No.</b>	<i>P9110101</i>		
<b>Point No.</b>	<i>B</i>		
<b>Description:</b> This is a view of the vegetation at point B.			
<b>Dominant Vegetation:</b> Same as above.

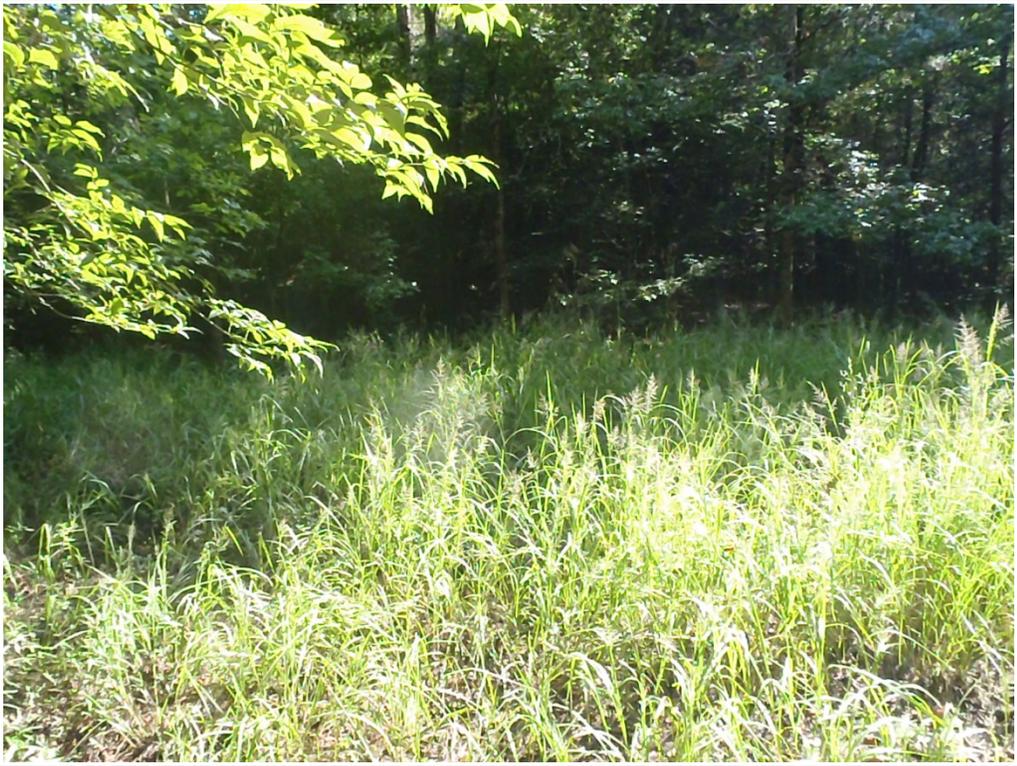
<b>Photo No.</b>	<i>P9110087</i>			
<b>Point No.</b>	<i>C</i>			
<b>Description:</b> This is a view of a wetland area at point C.				
<b>Dominant Vegetation:</b> <ul style="list-style-type: none"> <li>• <i>Acer negundo</i></li> <li>• <i>Pinus taeda</i></li> <li>• <i>Scirpus cyperinus</i></li> <li>• <i>Liquidambar styraciflua</i></li> <li>• <i>Quercus alba</i></li> <li>• <i>Leersia oryzoides</i></li> </ul>

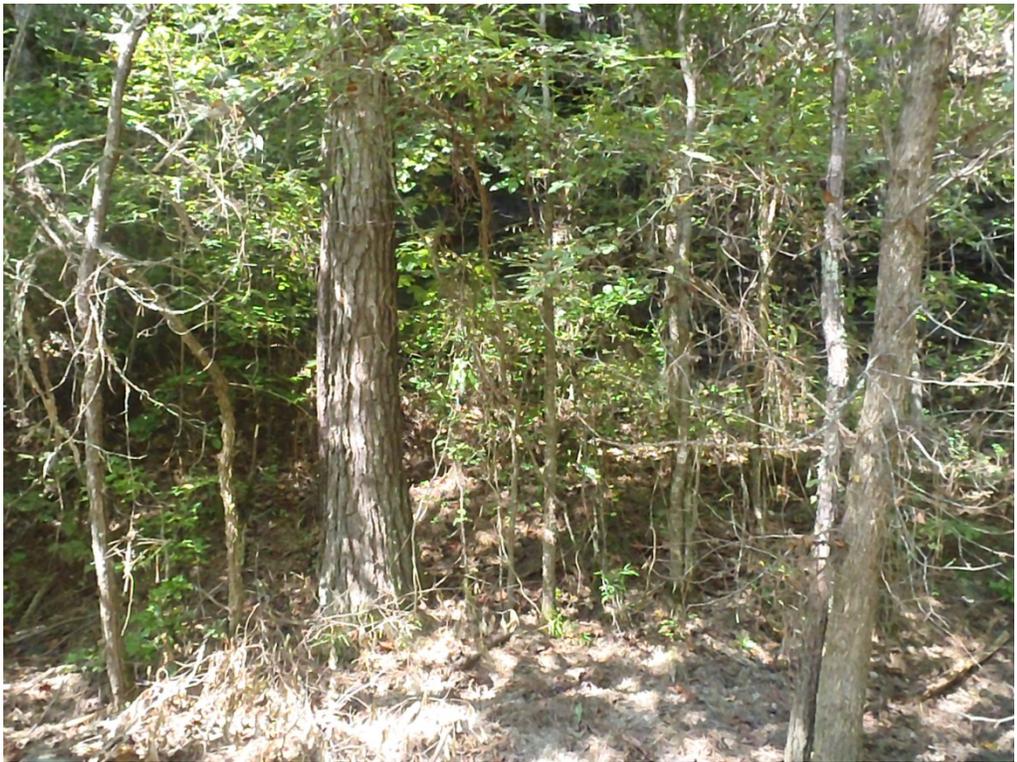
<b>Photo No.</b>	<i>P9110090</i>			
<b>Point No.</b>	<i>C</i>			
<b>Description:</b> This is a view of the vegetation at point C.				
<b>Dominant Vegetation:</b> Same as above.

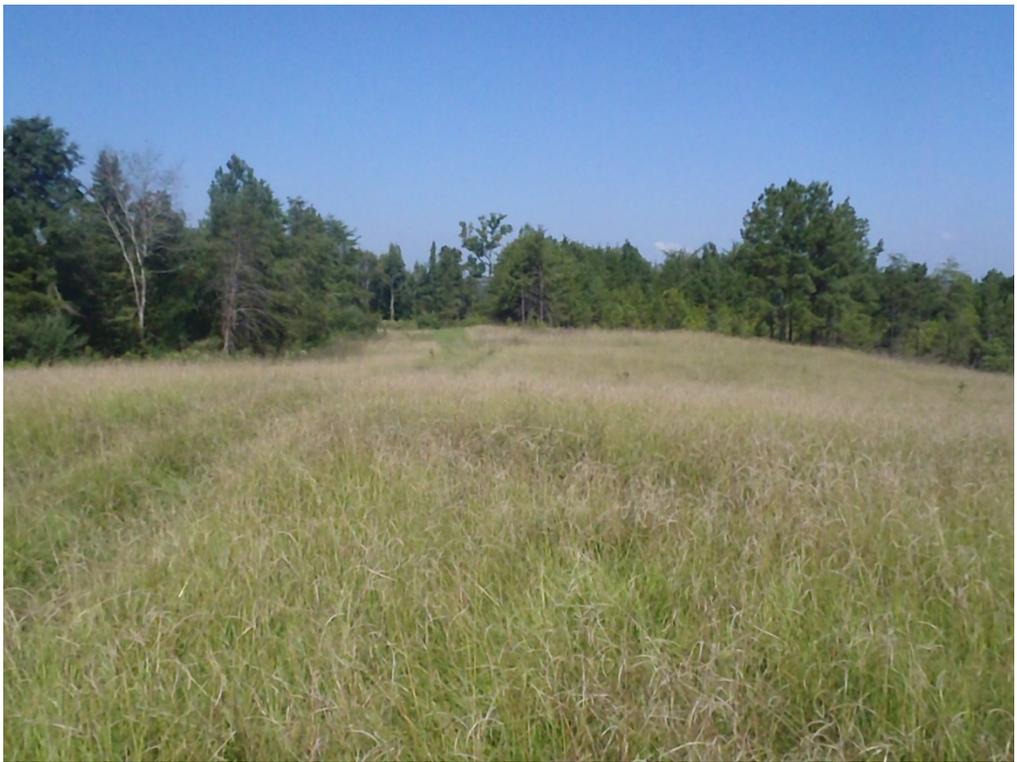
<b>Photo No.</b>	<i>P9110108</i>			
<b>Point No.</b>	<i>D</i>			
<b>Description:</b> This is a view of the upland terrain at point 004.				
<b>Dominant Vegetation:</b> <ul style="list-style-type: none"> <li>• <i>Sorghastrum nutans</i></li> <li>• <i>Tripsacum dactyloides</i></li> </ul>

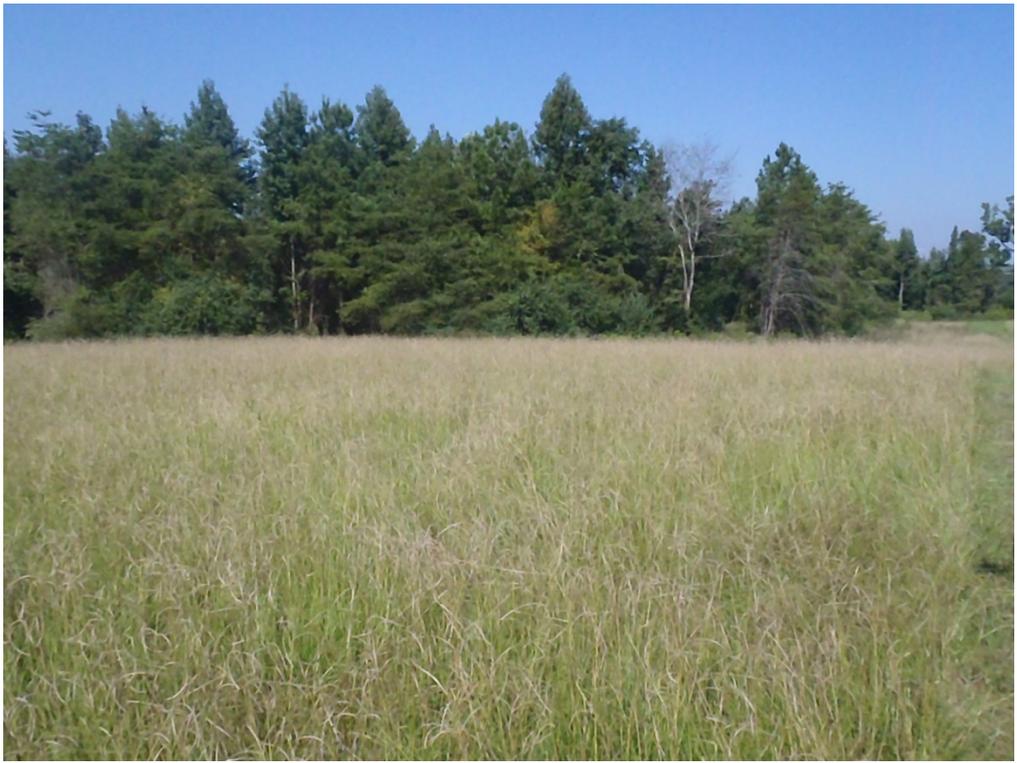
<b>Photo No.</b>	<i>P9110112</i>			
<b>Point No.</b>	<i>D</i>			
<b>Description:</b> This is a view of the vegetation at point 004.				
<b>Dominant Vegetation:</b> Same as above.

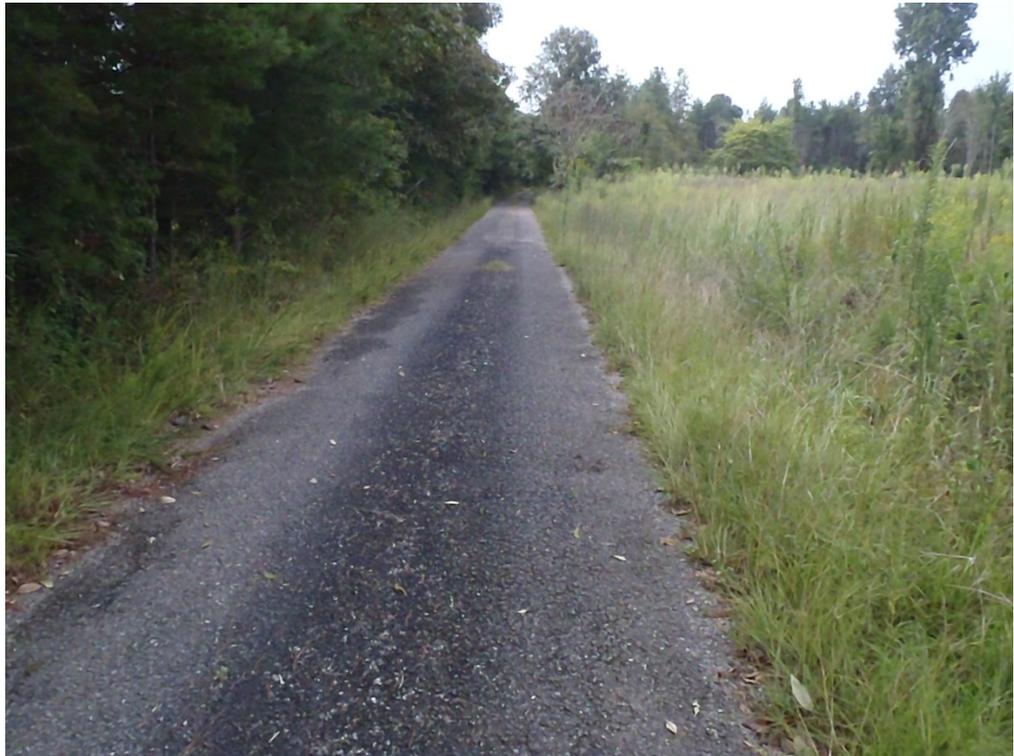
<b>Photo No.</b>	<i>P9130150</i>		
<b>Point No.</b>	<i>F</i>		
<b>Description:</b> This is a view of an existing road at point F.			
<b>Dominant Vegetation:</b>			
<ul style="list-style-type: none"> <li>• <i>Pinus taeda</i></li> <li>• <i>Sorghastrum nutans</i></li> <li>• <i>Tripsacum dactyloides</i></li> <li>• <i>Festuca pratensis</i></li> <li>• <i>Quercus falcata</i></li> <li>• <i>Rhus glabra</i></li> <li>• <i>Conoclinium coelestinum</i></li> </ul>

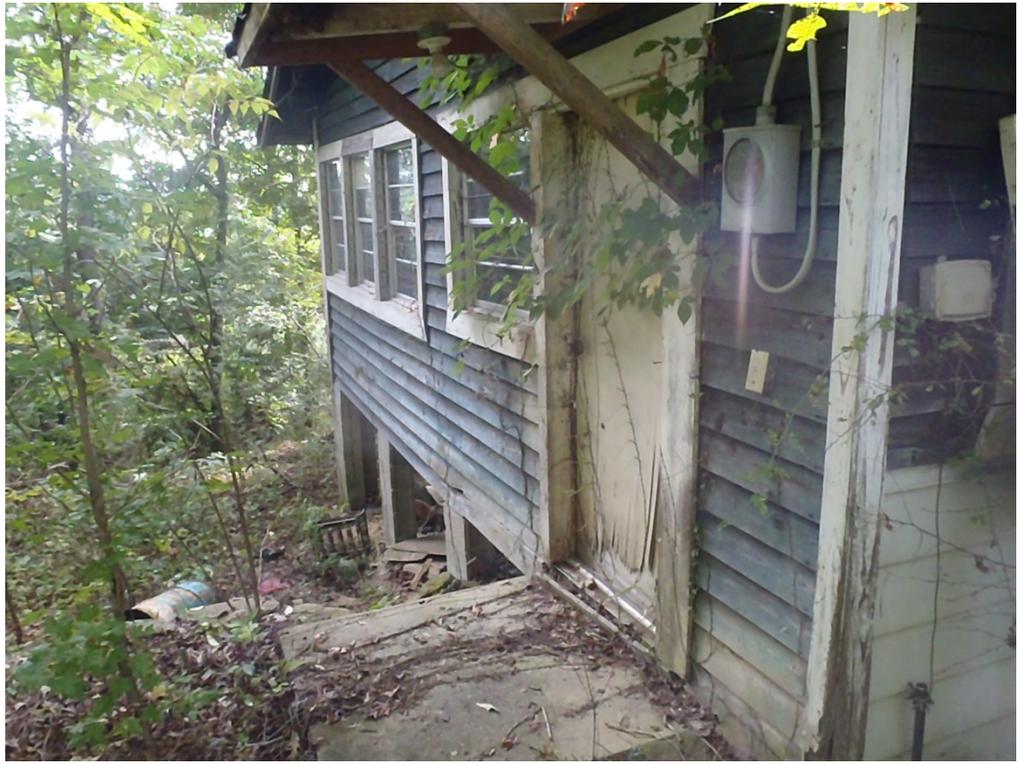
<b>Photo No.</b>	<i>P9130127</i>			
<b>Point No.</b>	<i>G</i>			
<b>Description:</b>				
This is a view of an abandoned house at point G.				
<b>Dominant Vegetation:</b>				
<ul style="list-style-type: none"> <li>• <i>Acer saccharum</i></li> <li>• <i>Parthenocissus quinquefolia</i></li> <li>• <i>Albizia julibrissin</i></li> <li>• <i>Carya tomentosa</i></li> <li>• <i>Ligustrum sinense</i></li> <li>• <i>Quercus alba</i></li> <li>• <i>Q. falcata</i></li> <li>• <i>Liquidambar styraciflua</i></li> </ul>

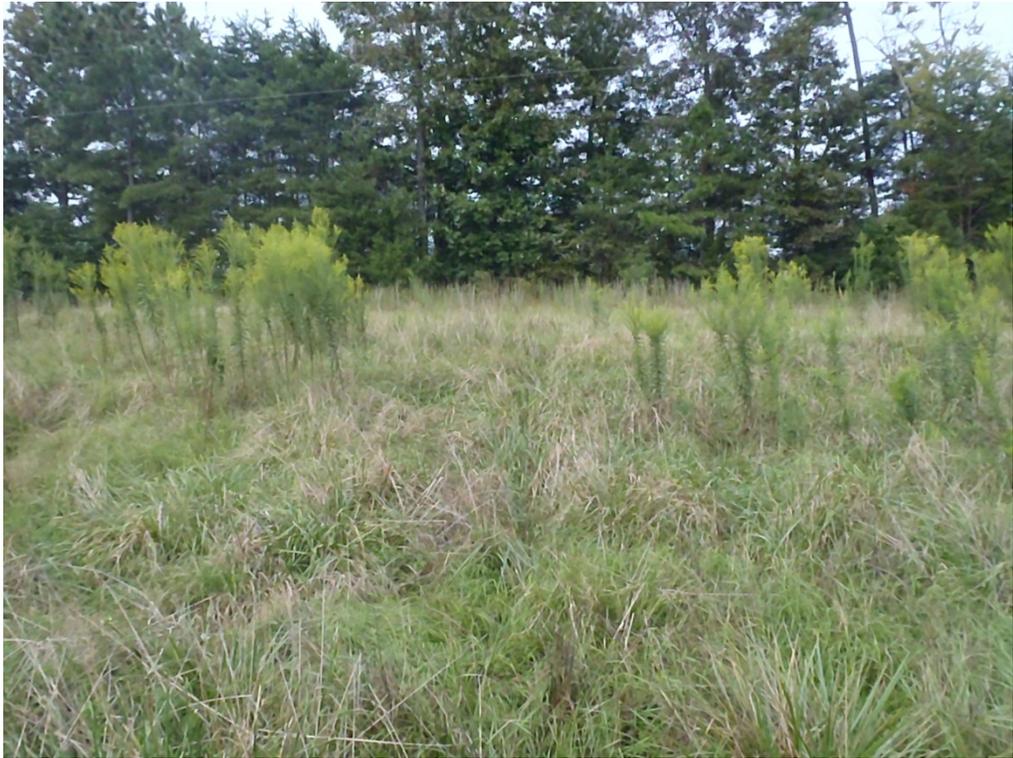
<b>Photo No.</b>	<i>P9130141</i>		
<b>Point No.</b>	<i>H</i>		
<b>Description:</b> This is a view of the upland terrain at point H.			
<b>Dominant Vegetation:</b> <ul style="list-style-type: none"> <li>• <i>Ambrosia artemisiifolia</i></li> <li>• <i>Festuca pratensis</i></li> <li>• <i>Solidago altissima</i></li> <li>• <i>Sorghastrum nutans</i></li> <li>• <i>Tripsacum dactyloides</i></li> </ul>

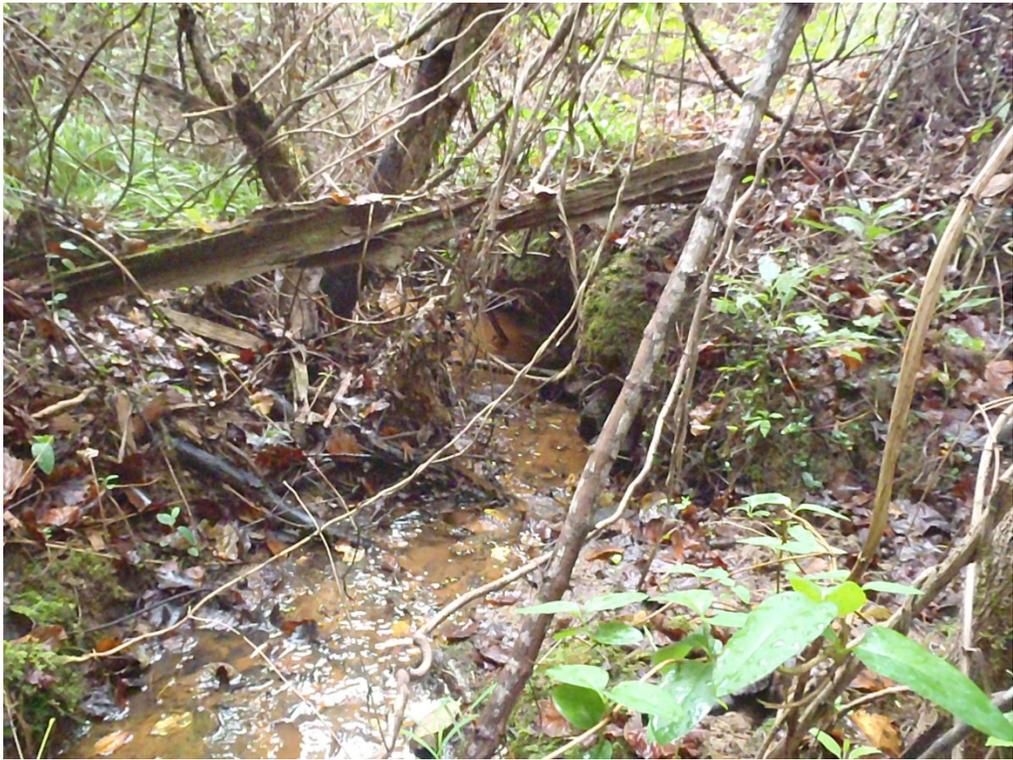
<b>Photo No.</b>	<i>P9130131</i>			
<b>Point No.</b>	<i>I</i>			
<b>Description:</b>				
<p>This is a view of the intermittent drain at point I.</p>				
<b>Dominant Vegetation:</b>				
<ul style="list-style-type: none"> <li>• <i>Acer negundo</i></li> <li>• <i>Aesculus parviflora</i></li> <li>• <i>Vitis rotundifolia</i></li> <li>• <i>Liquidambar styraciflua</i></li> <li>• <i>Liriodendron tulipifera</i></li> <li>• <i>Lonicera japonica</i></li> <li>• <i>Fagus grandifolia</i></li> </ul>

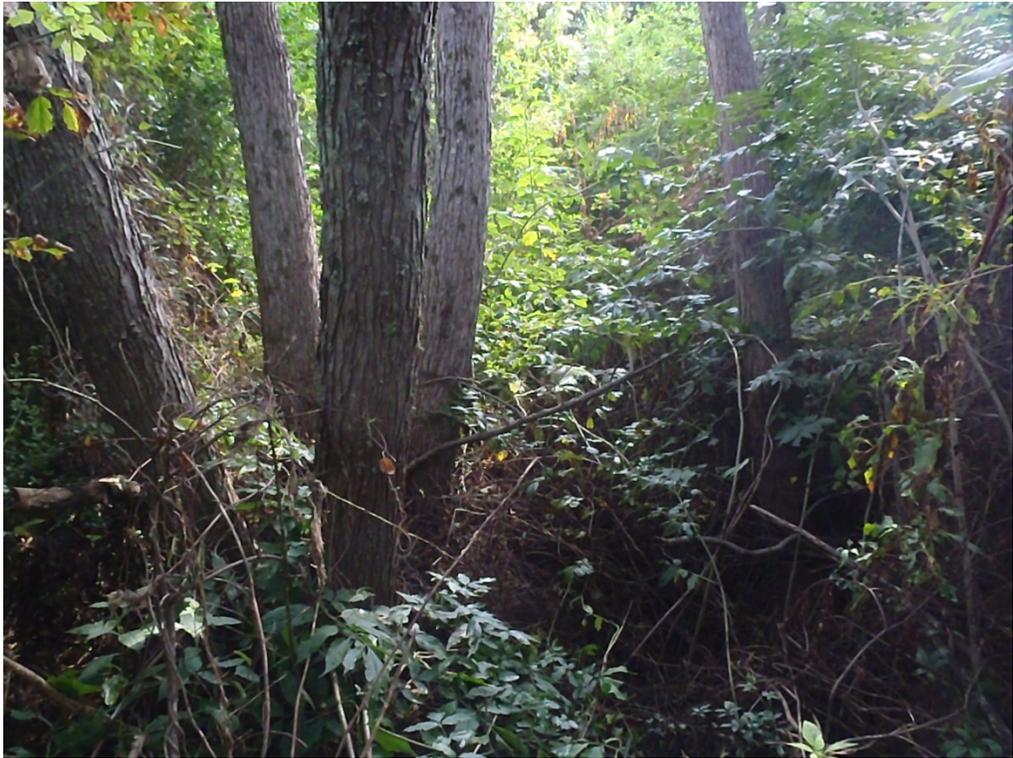
<b>Photo No.</b>	<i>P9130119</i>		
<b>Point No.</b>	<i>J</i>		
<b>Description:</b>  This is a view of the upland terrain at point J.			
<b>Dominant Vegetation:</b>  <ul style="list-style-type: none"> <li>• <i>Ligustrum sinense</i></li> <li>• <i>Polystichum acrostichoides</i></li> <li>• <i>Vitis rotundifolia</i></li> <li>• <i>Salix nigra</i></li> <li>• <i>Phytolacca americanum</i></li> <li>• <i>Sambucus nigra</i></li> </ul>

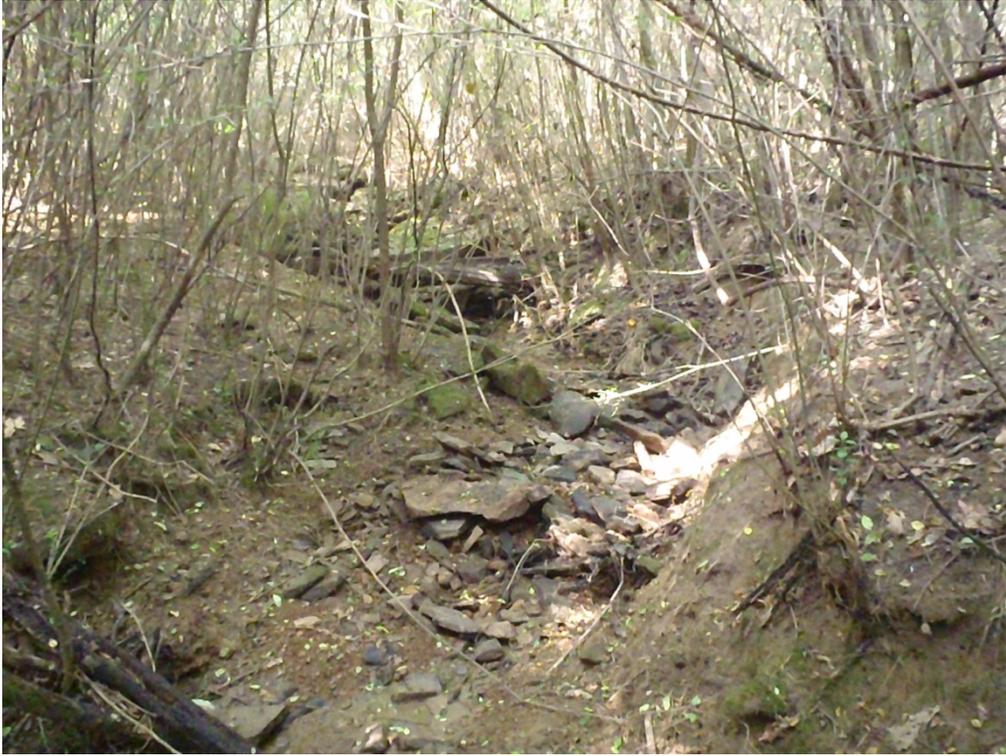
<b>Photo No.</b>	<i>P9180017</i>			
<b>Point No.</b>	<i>K</i>			
<b>Description:</b>				
<p>This is a view of the intermittent drain at point K.</p>				
<b>Dominant Vegetation:</b>				
<ul style="list-style-type: none"> <li>• <i>Ligustrum sinense</i></li> <li>• <i>Carpinus caroliniana</i></li> <li>• <i>Acer rubrum</i></li> <li>• <i>Polystichum acrostichoides</i></li> </ul>

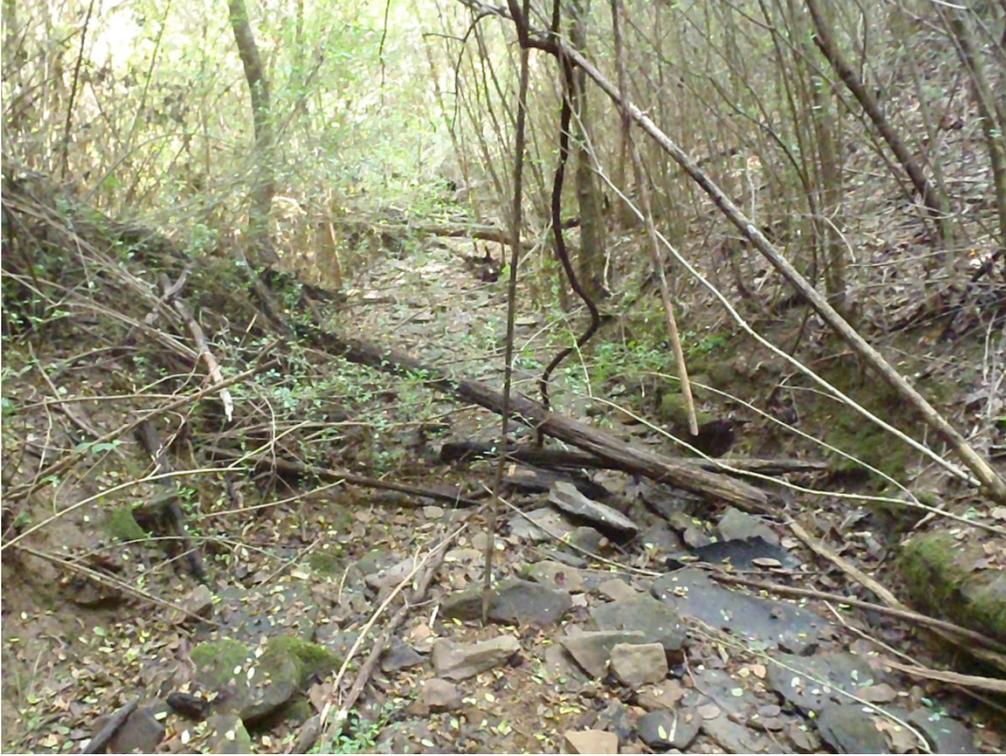
<b>Photo No.</b>	<i>P9180019</i>			
<b>Point No.</b>	<i>K</i>			
<b>Description:</b>				
<p>This is another view of the intermittent drain at point K.</p>				
<b>Dominant Vegetation:</b>				
<p>Same as above along with:</p> <ul style="list-style-type: none"> <li>• <i>Berchemia scandens</i></li> </ul>

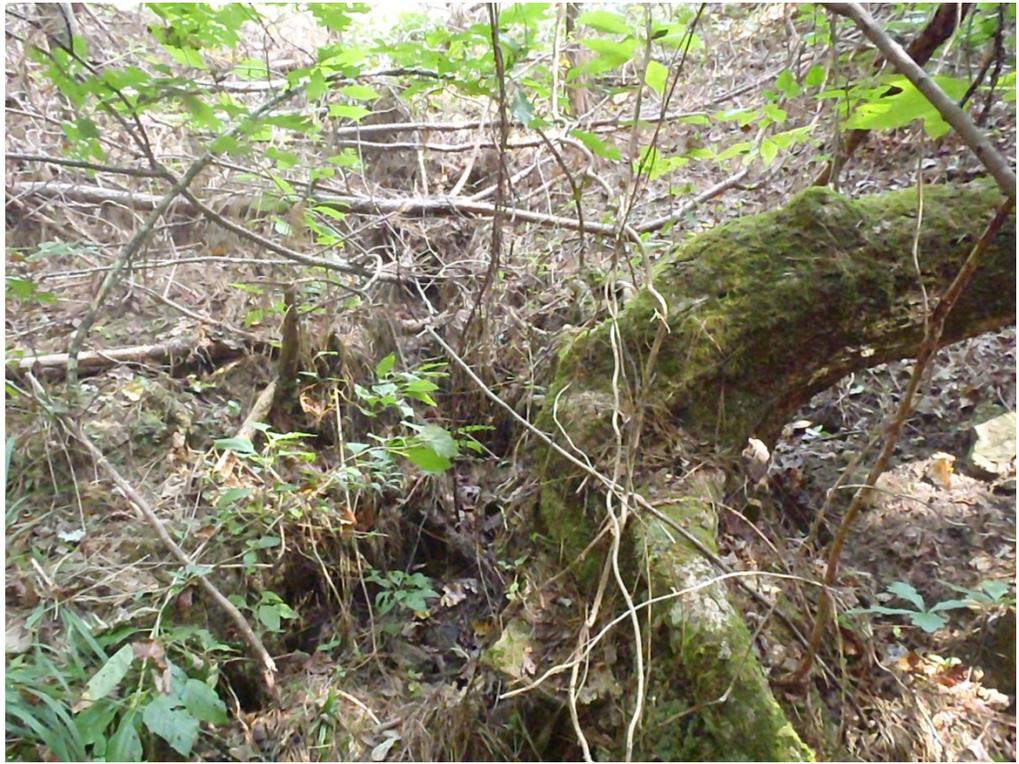
<b>Photo No.</b>	<i>P9180025</i>		
<b>Point No.</b>	<i>L</i>		
<b>Description:</b>  This is a view of the intermittent drain at point L.			
<b>Dominant Vegetation:</b>  <ul style="list-style-type: none"> <li>• <i>Pinus taeda</i></li> <li>• <i>P. virginiana</i></li> <li>• <i>Acer rubrum</i></li> <li>• <i>Fagus grandifolia</i></li> <li>• <i>Polystichum acrostichoides</i></li> <li>• <i>Lonicera japonica</i></li> </ul>

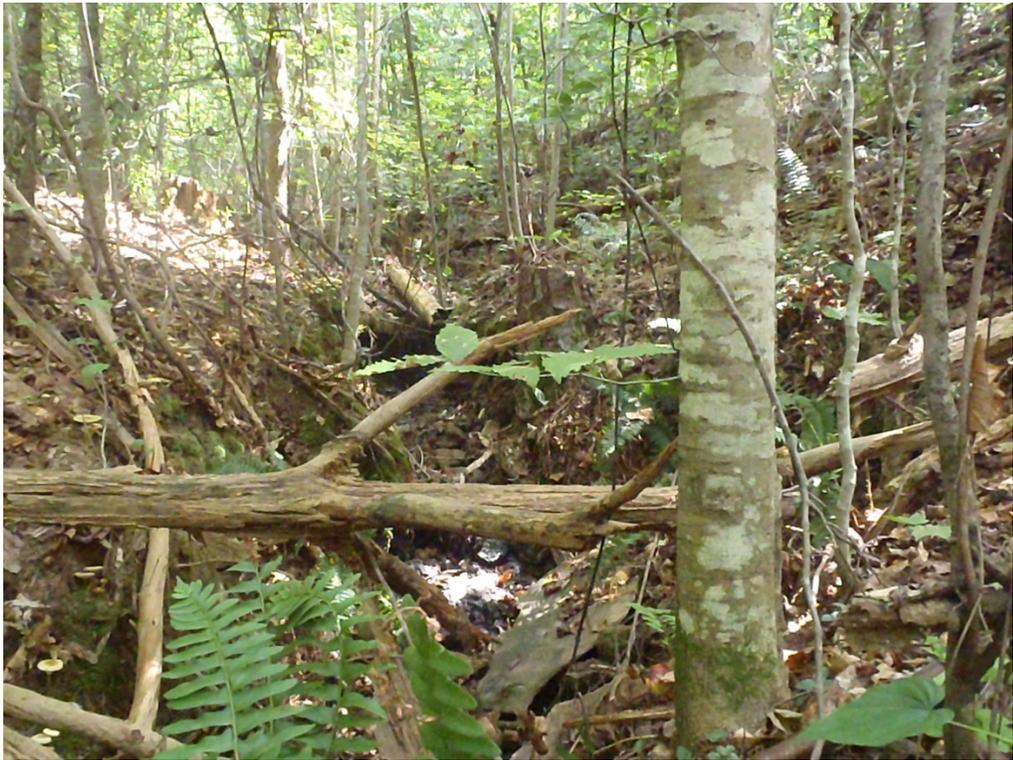
Photo No.	<i>P9180032</i>			
Point No.	<i>M</i>			
<b>Description:</b>				
This is a view of the intermittent drain at point M.				
<b>Dominant Vegetation:</b>				
<ul style="list-style-type: none"> <li>• <i>Acer rubrum</i></li> <li>• <i>Liquidambar styraciflua</i></li> <li>• <i>Lonicera japonica</i></li> <li>• <i>Fagus grandifolia</i></li> <li>• <i>Pinus taeda</i></li> <li>• <i>Polystichum acrostichoides</i></li> <li>• <i>Quercus alba</i></li> </ul>

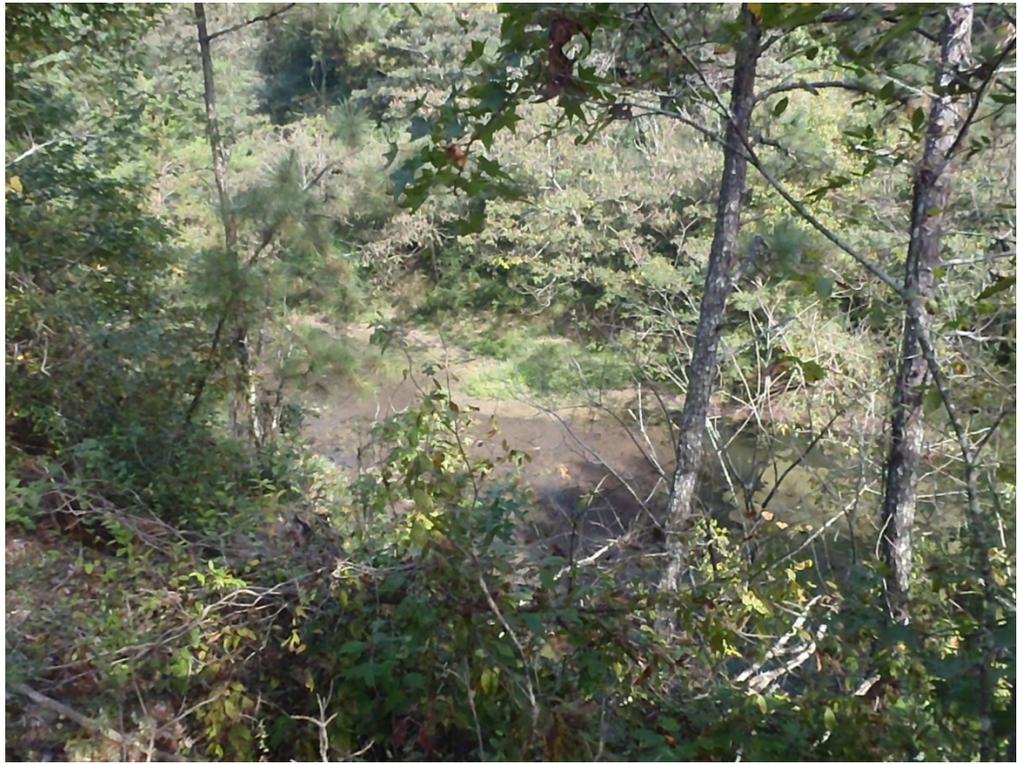
<b>Photo No.</b>	PA020065		
<b>Point No.</b>	N		
<b>Description:</b>			
<p>This is a view of the open water impoundment at point N.</p>			
<b>Dominant Vegetation:</b>			
<ul style="list-style-type: none"> <li>• <i>Pinus taeda</i></li> <li>• <i>P. virginiana</i></li> <li>• <i>Liquidambar styraciflua</i></li> <li>• <i>Ligustrum sinense</i></li> <li>• <i>Albizia julibrissin</i></li> <li>• <i>Lonicera japonica</i></li> <li>• <i>Quercus alba</i></li> </ul>

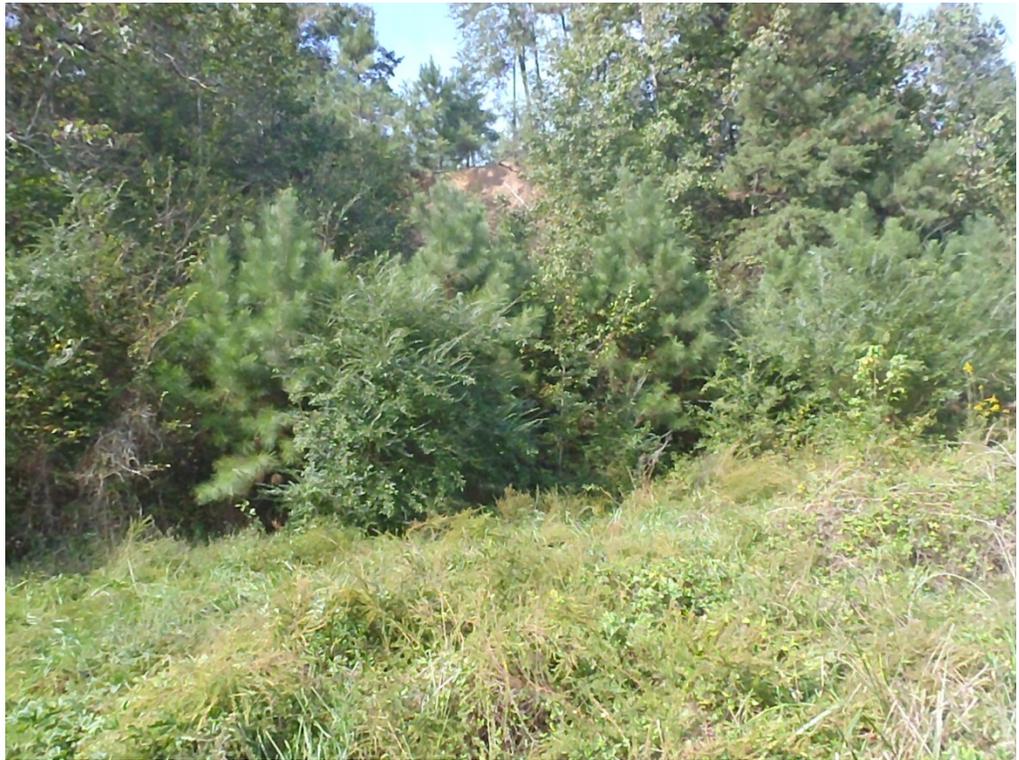
<b>Photo No.</b>	<i>PA020071</i>			
<b>Point No.</b>	<i>O</i>			
<b>Description:</b>				
This is a view of upland terrain at point O.				
<b>Dominant Vegetation:</b>				
<ul style="list-style-type: none"> <li>• <i>Pinus taeda</i></li> <li>• <i>P. virginiana</i></li> <li>• <i>Ligustrum sinense</i></li> <li>• <i>Ambrosia artemisiifolia</i></li> <li>• <i>Solidago altissima</i></li> <li>• <i>Acer negundo</i></li> </ul>

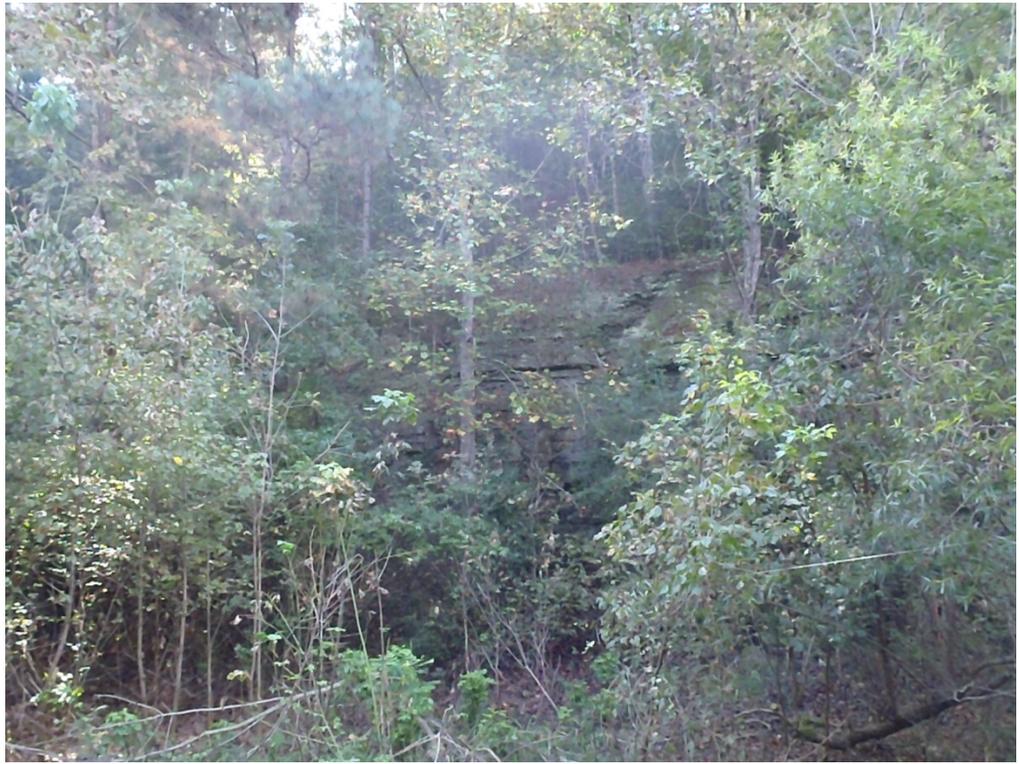
<b>Photo No.</b>	<i>PA020076</i>		
<b>Point No.</b>	<i>P</i>		
<b>Description:</b>  This is a view of an old highwall at point P.			
<b>Dominant Vegetation:</b>  <ul style="list-style-type: none"> <li>• <i>Pinus taeda</i></li> <li>• <i>Pinus virginiana</i></li> <li>• <i>Salix nigra</i></li> <li>• <i>Liquidambar styraciflua</i></li> <li>• <i>Ligustrum sinense</i></li> <li>• <i>Myrica cerifera</i></li> </ul>

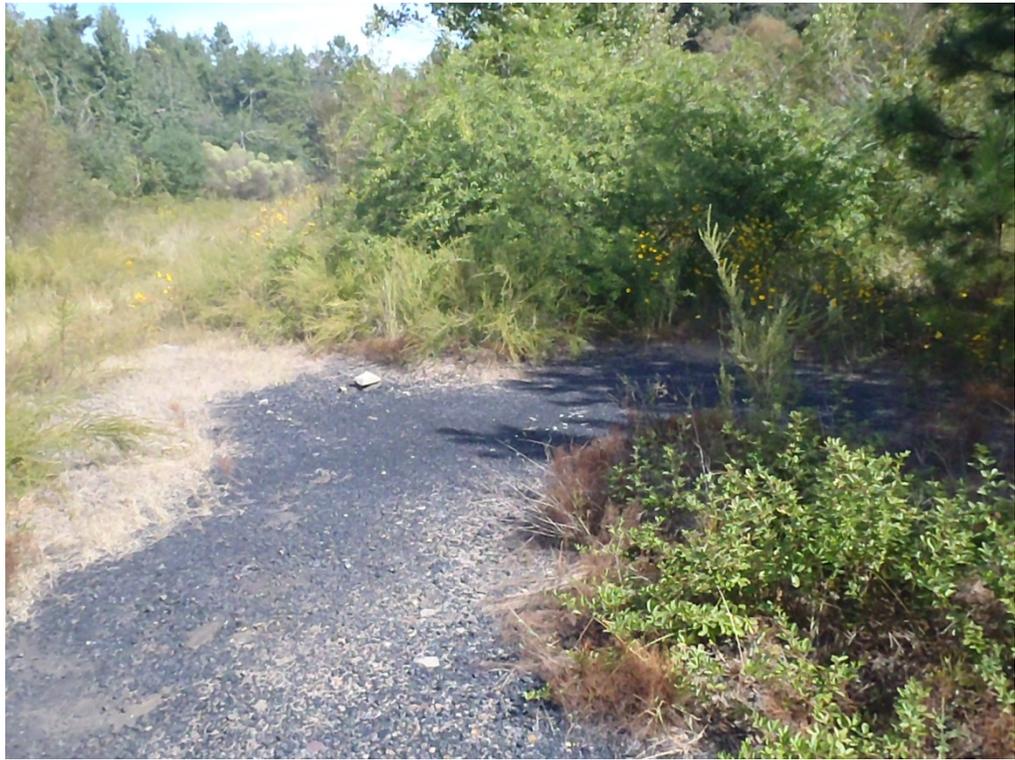
<b>Photo No.</b>	<i>PA020084</i>		
<b>Point No.</b>	<i>Q</i>		
<b>Description:</b>			
<p>This is a view of the upland terrain at point Q.</p>			
<b>Dominant Vegetation:</b>			
<ul style="list-style-type: none"> <li>• <i>Pinus taeda</i></li> <li>• <i>Liquidambar styraciflua</i></li> <li>• <i>Rubus flagellaris</i></li> <li>• <i>Ligustrum sinense</i></li> <li>• <i>Lespedeza cuneata</i></li> <li>• <i>Lonicera japonica</i></li> </ul>

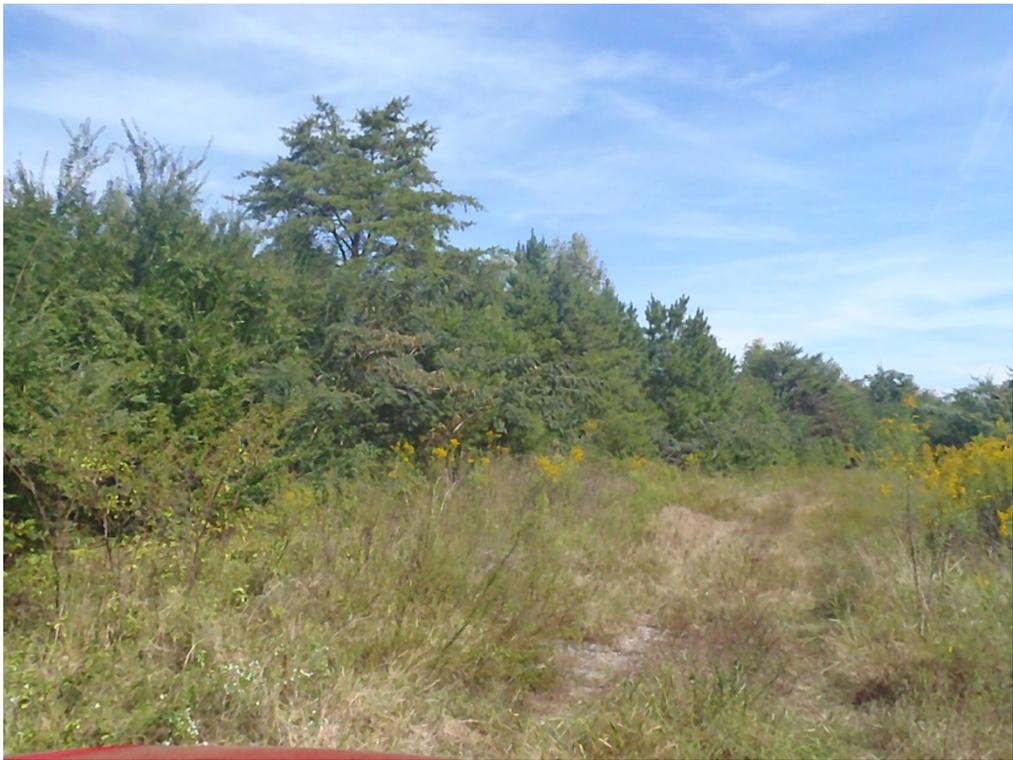
<b>Photo No.</b>	<i>PA020101</i>		
<b>Point No.</b>	<i>R</i>		
<b>Description:</b>  This is a view of an existing road at point R.			
<b>Dominant Vegetation:</b>  <ul style="list-style-type: none"> <li>• <i>Pinus taeda</i></li> <li>• <i>Liquidambar styraciflua</i></li> <li>• <i>Rubus flagellaris</i></li> <li>• <i>Ligustrum sinense</i></li> <li>• <i>Lespedeza cuneata</i></li> <li>• <i>Lonicera japonica</i></li> </ul>

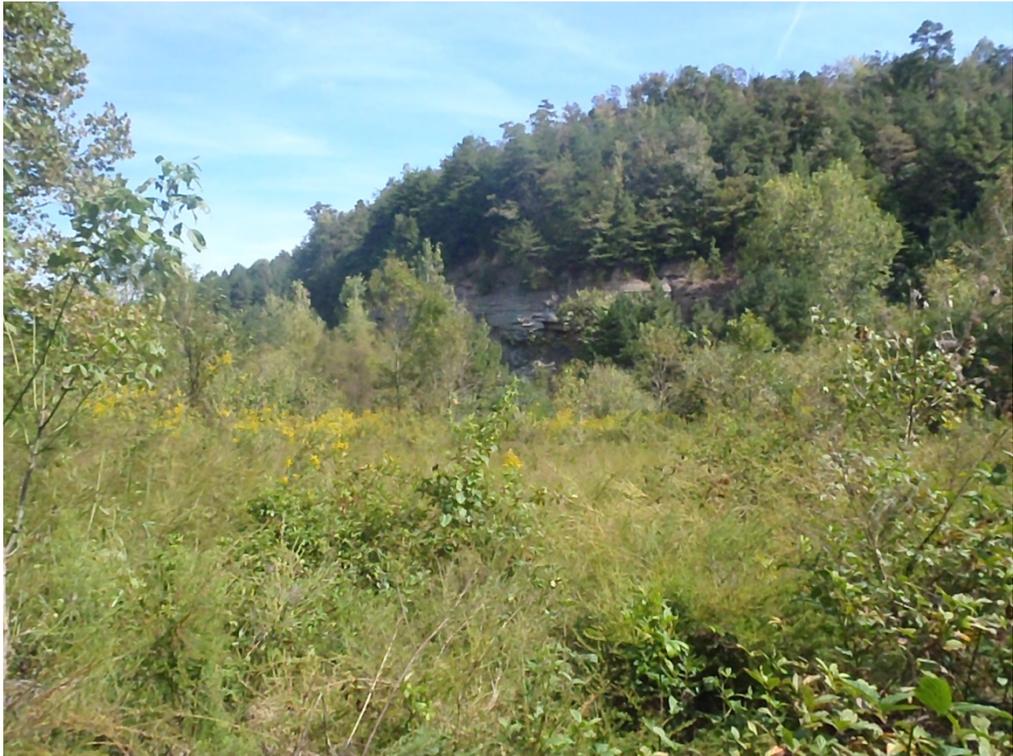
<b>Photo No.</b>	<i>PA020097</i>		
<b>Point No.</b>	<i>R</i>		
<b>Description:</b>  This is a view of the vegetation and an old highwall at point R.			
<b>Dominant Vegetation:</b>  Same as above along with: <ul style="list-style-type: none"> <li>• <i>Conyza canadensis</i></li> <li>• <i>Eupatorium compostifolium</i></li> <li>• <i>Eupatorium capillifolium</i></li> <li>• <i>Acer negundo</i></li> <li>• <i>Pinus virginiana</i></li> </ul>

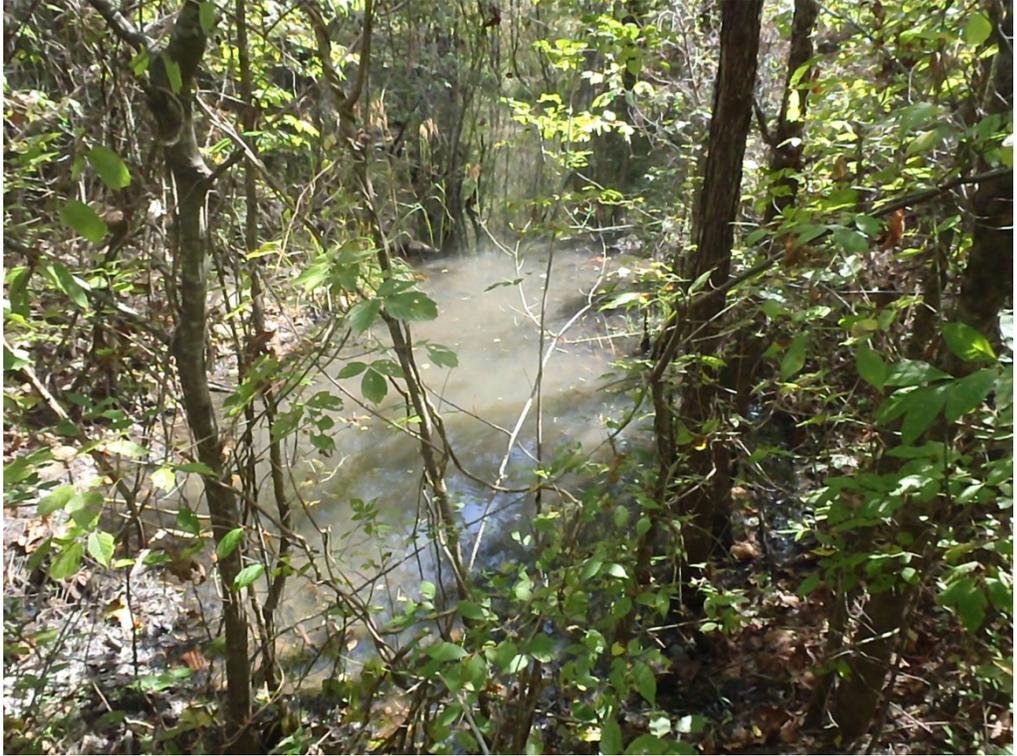
<b>Photo No.</b>	<i>PA020087</i>		
<b>Point No.</b>	<i>S</i>		
<b>Description:</b>  This is a view of an open water at point K.			
<b>Dominant Vegetation:</b>  <ul style="list-style-type: none"> <li>• <i>Pinus taeda</i></li> <li>• <i>Salix nigra</i></li> <li>• <i>Acer negundo</i></li> <li>• <i>Liquidambar styraciflua</i></li> <li>• <i>Rubus flagellaris</i></li> <li>• <i>Lonicera japonica</i></li> </ul>

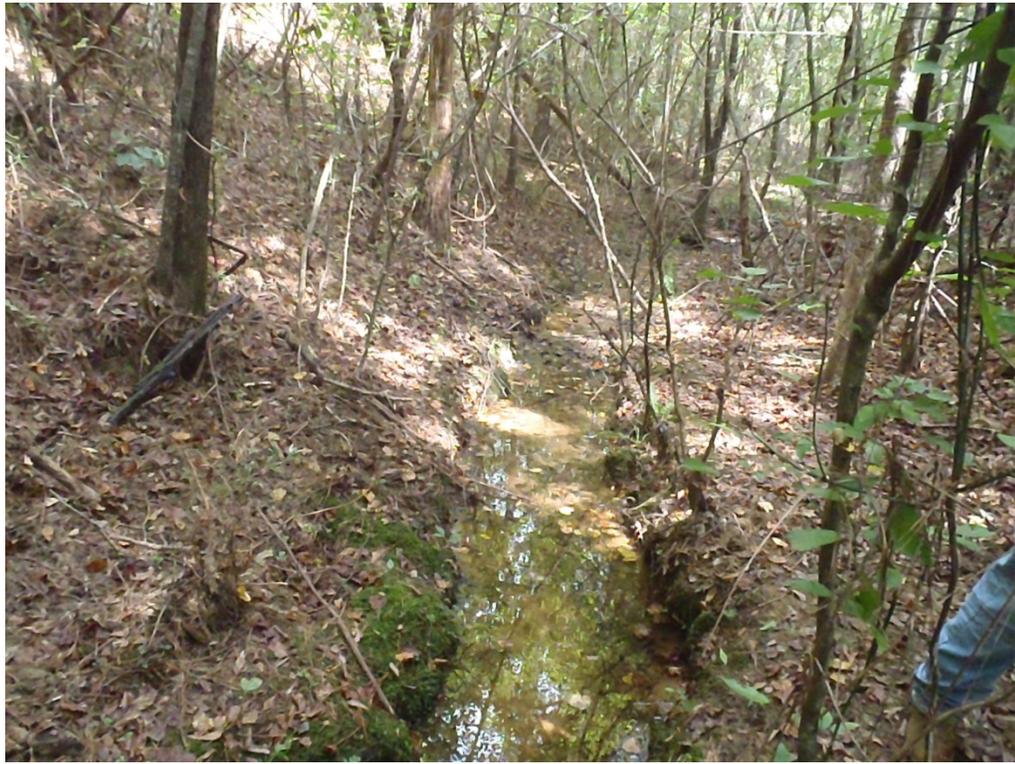
<b>Photo No.</b>	<i>PA020123</i>		
<b>Point No.</b>	<i>T</i>		
<b>Description:</b>  This is a view of the intermittent drain at point T.			
<b>Dominant Vegetation:</b>  <ul style="list-style-type: none"> <li>• <i>Pinus taeda</i></li> <li>• <i>Pinus virginiana</i></li> <li>• <i>Quercus nigra</i></li> <li>• <i>Acer rubrum</i></li> <li>• <i>Carpinus caroliniana</i></li> <li>• <i>Lonicera japonica</i></li> </ul>

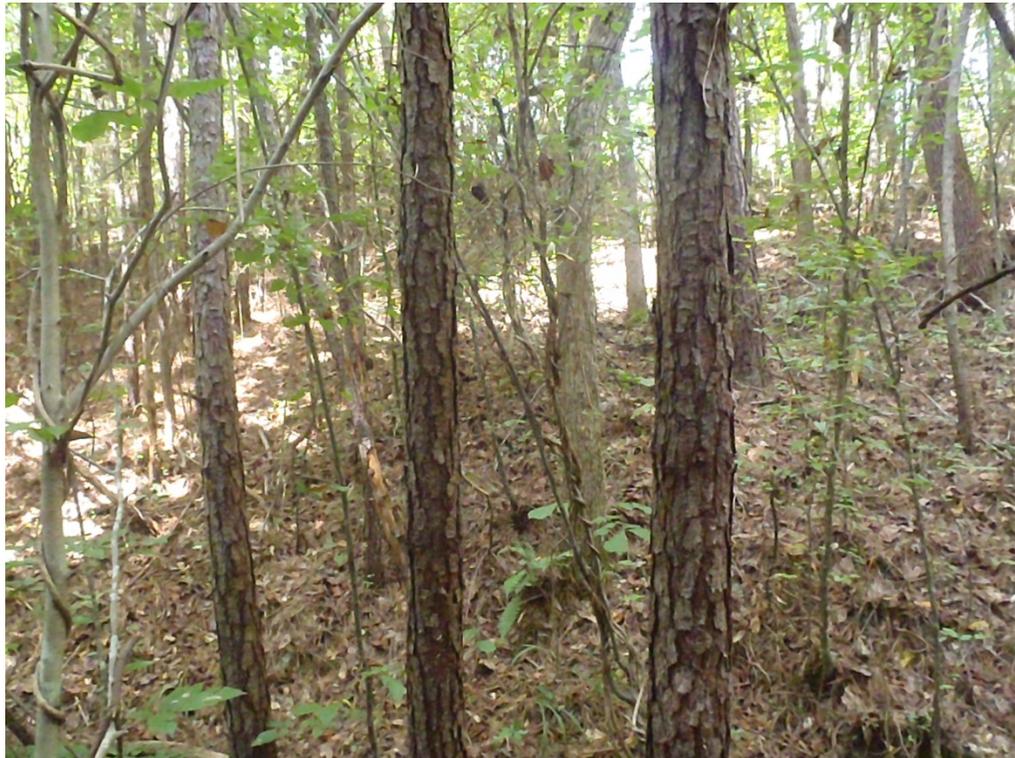
<b>Photo No.</b>	<i>PA020125</i>		
<b>Point No.</b>	<i>T</i>		
<b>Description:</b>  This is a view of the vegetation at point T.			
<b>Dominant Vegetation:</b>  Same as above.
