# **BIOLOGICAL HABITAT ASSESSMENT**

**KIMBERLY MINE**

**Prepared For:  
ALDEN RESOURCES, LLC**

**November 26<sup>th</sup>, 2013**

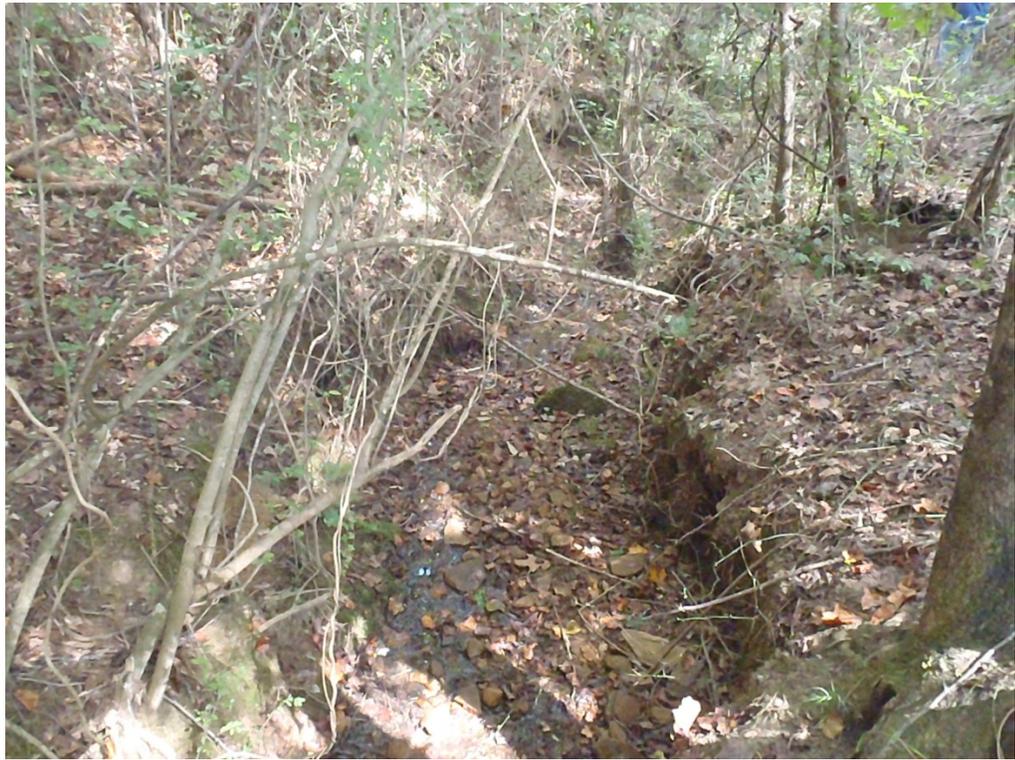
<b>Photo No.</b>	<i>PA020115</i>		
<b>Point No.</b>	<i>U</i>		
<b>Description:</b>			
This is a view of the intermittent drain at point U.			
<b>Dominant Vegetation:</b>			
<ul style="list-style-type: none"> <li>• <i>Pinus taeda</i></li> <li>• <i>Carpinus caroliniana</i></li> <li>• <i>Ligustrum sinense</i></li> <li>• <i>Liquidambar styraciflua</i></li> <li>• <i>Salix nigra</i></li> <li>• <i>Lonicera japonica</i></li> </ul>

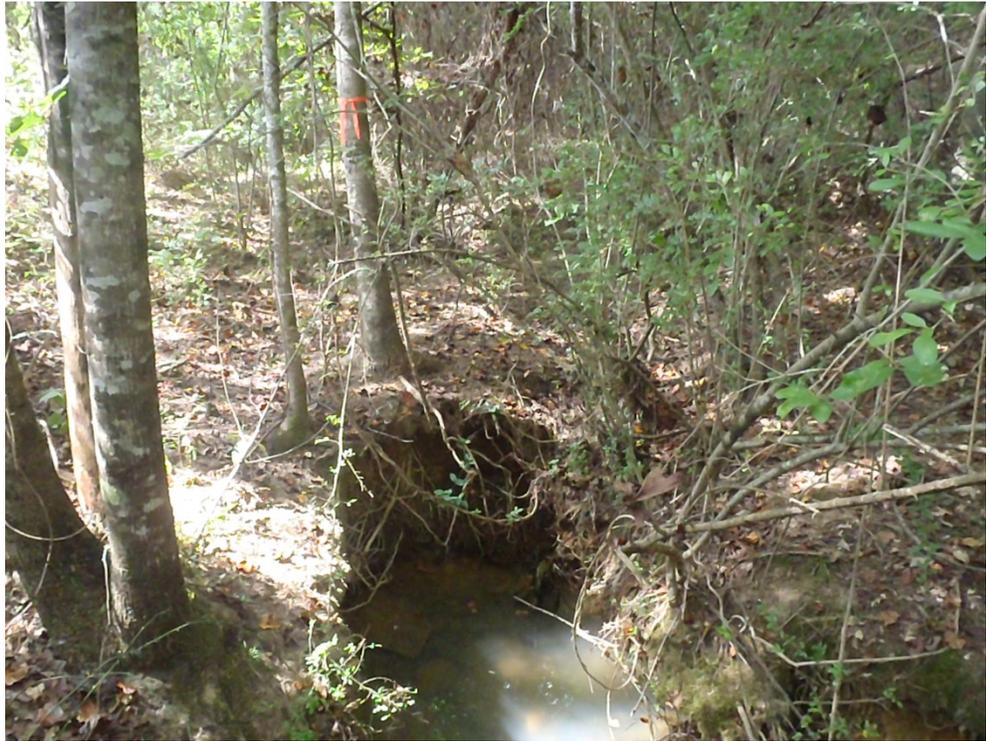
<b>Photo No.</b>	<i>PA020109</i>		
<b>Point No.</b>	<i>U</i>		
<b>Description:</b>			
This is a view of the headcut and vegetation at point U.			
<b>Dominant Vegetation:</b>			
Same as above along with:			
<ul style="list-style-type: none"> <li>• <i>Liriodendron tulipifera</i></li> <li>• <i>Fagus grandifolia</i></li> <li>• <i>Acer rubrum</i></li> </ul>

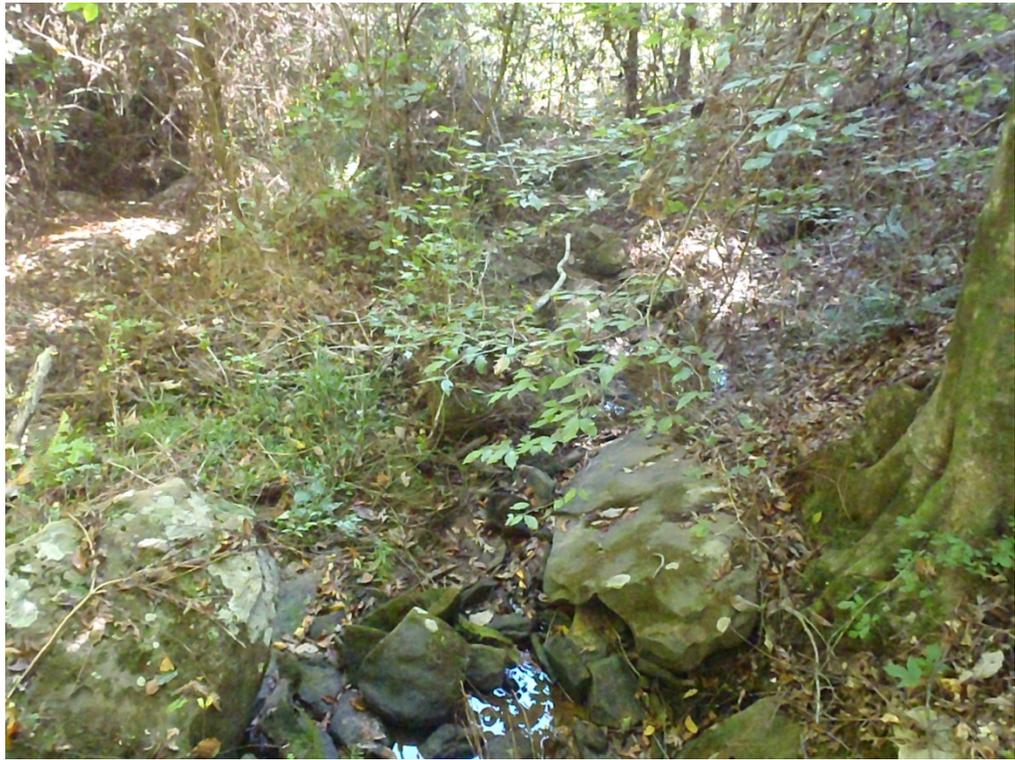
<b>Photo No.</b>	<i>PA070092</i>			
<b>Point No.</b>	V			
<b>Description:</b>				
This is a view of the intermittent drain at point V.				
<b>Dominant Vegetation:</b>				
<ul style="list-style-type: none"> <li>• <i>Fagus grandifolia</i></li> <li>• <i>Ligustrum sinense</i></li> <li>• <i>Liquidambar styraciflua</i></li> <li>• <i>Hydrangea quercifolia</i></li> <li>• <i>Polystichum acrostichoides</i></li> <li>• <i>Lonicera japonica</i></li> </ul>

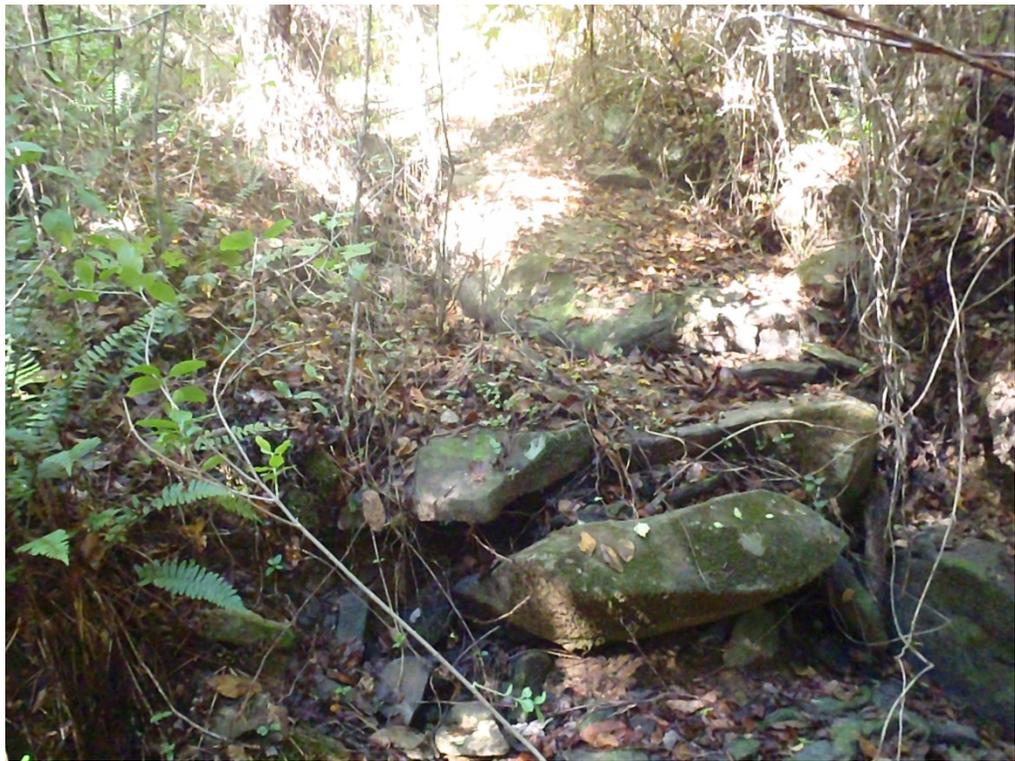
<b>Photo No.</b>	<i>PA070085</i>			
<b>Point No.</b>	V			
<b>Description:</b>				
Same as above...				
<b>Dominant Vegetation:</b>				
Same as above along with:				
<ul style="list-style-type: none"> <li>• <i>Acer rubrum</i></li> <li>• <i>Smilax tamnoides</i></li> <li>• <i>Smilax rotundifolia</i></li> </ul>

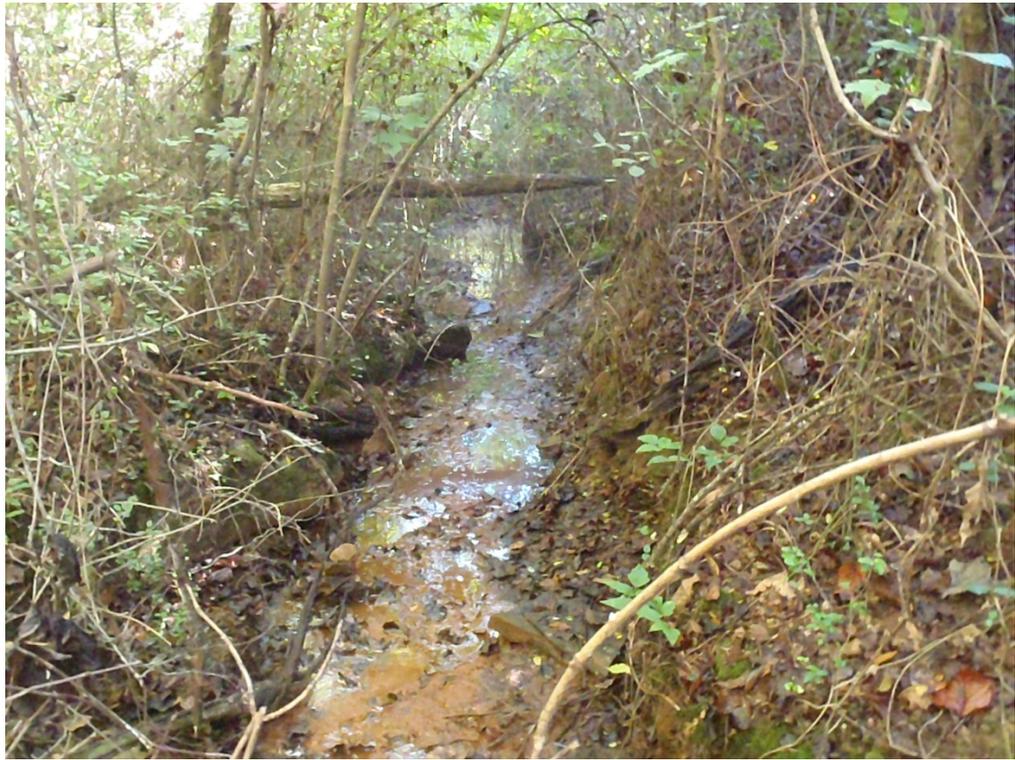
<b>Photo No.</b>	<i>PA070081</i>		
<b>Point No.</b>	<i>W</i>		
<b>Description:</b>			
<p>This is a view of the intermittent drain at point W.</p>			
<b>Dominant Vegetation:</b>			
<ul style="list-style-type: none"> <li>• <i>Fagus grandifolia</i></li> <li>• <i>Ligustrum sinense</i></li> <li>• <i>Liquidambar styraciflua</i></li> <li>• <i>Hydrangea quercifolia</i></li> <li>• <i>Polystichum acrostichoides</i></li> <li>• <i>Lonicera japonica</i></li> </ul>

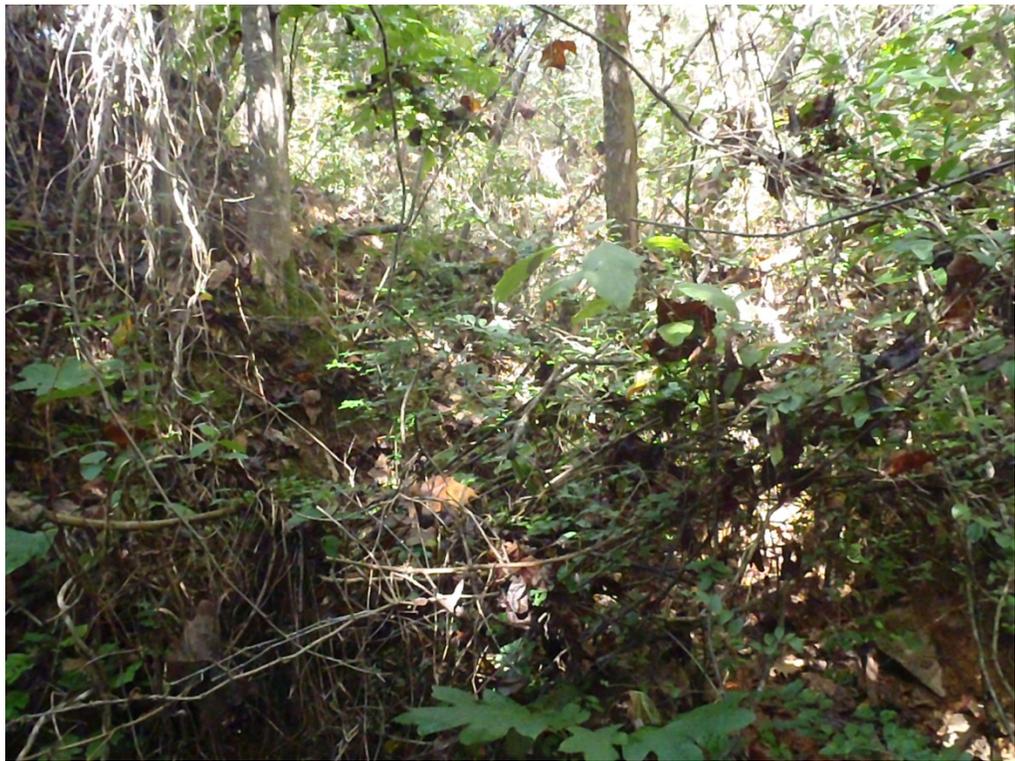
<b>Photo No.</b>	<i>PA070079</i>		
<b>Point No.</b>	<i>W</i>		
<b>Description:</b>			
<p>This is a view of the vegetation at point W.</p>			
<b>Dominant Vegetation:</b>			
<p>Same as above along with:</p> <ul style="list-style-type: none"> <li>• <i>Acer rubrum</i></li> <li>• <i>Smilax tamnoides</i></li> <li>• <i>Smilax rotundifolia</i></li> </ul>

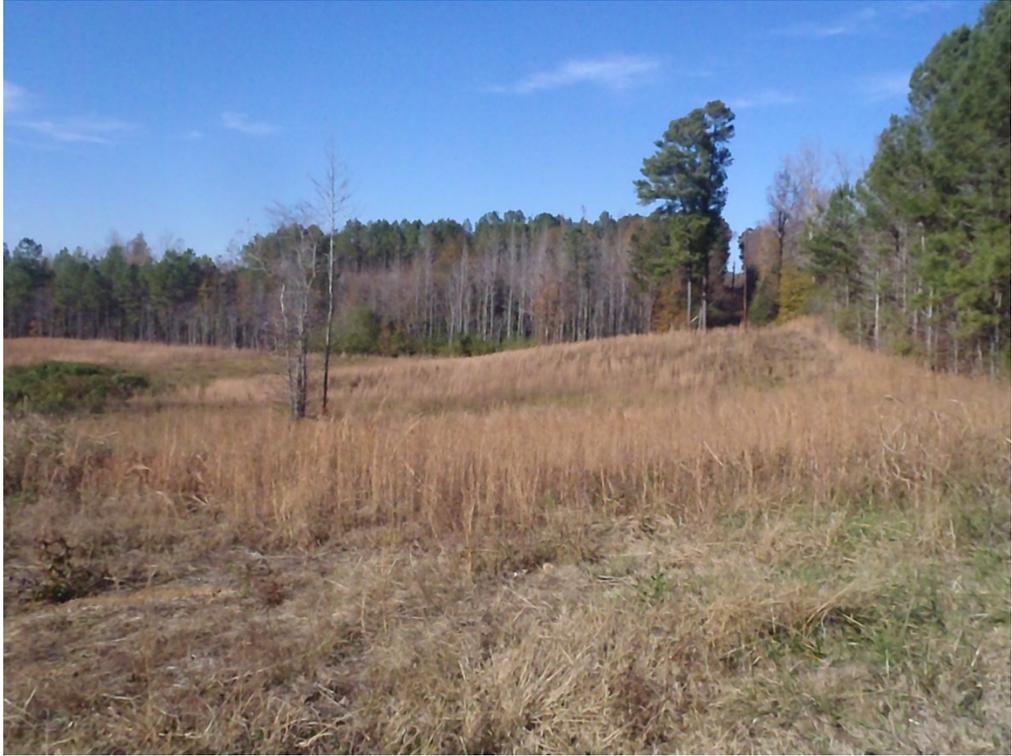
<b>Photo No.</b>	<i>PB200248</i>		
<b>Point No.</b>	<i>X</i>		
<b>Description:</b>			
This is a view of the open field at point X.			
<b>Dominant Vegetation:</b>			
<ul style="list-style-type: none"> <li>• <i>Andropogon virginicus</i></li> <li>• <i>Pinus taeda</i></li> <li>• <i>Liquidambar styraciflua</i></li> <li>• <i>Rubus betulifolius</i></li> <li>• <i>Festuca pratensis</i></li> <li>• <i>Acer rubrum</i></li> </ul>

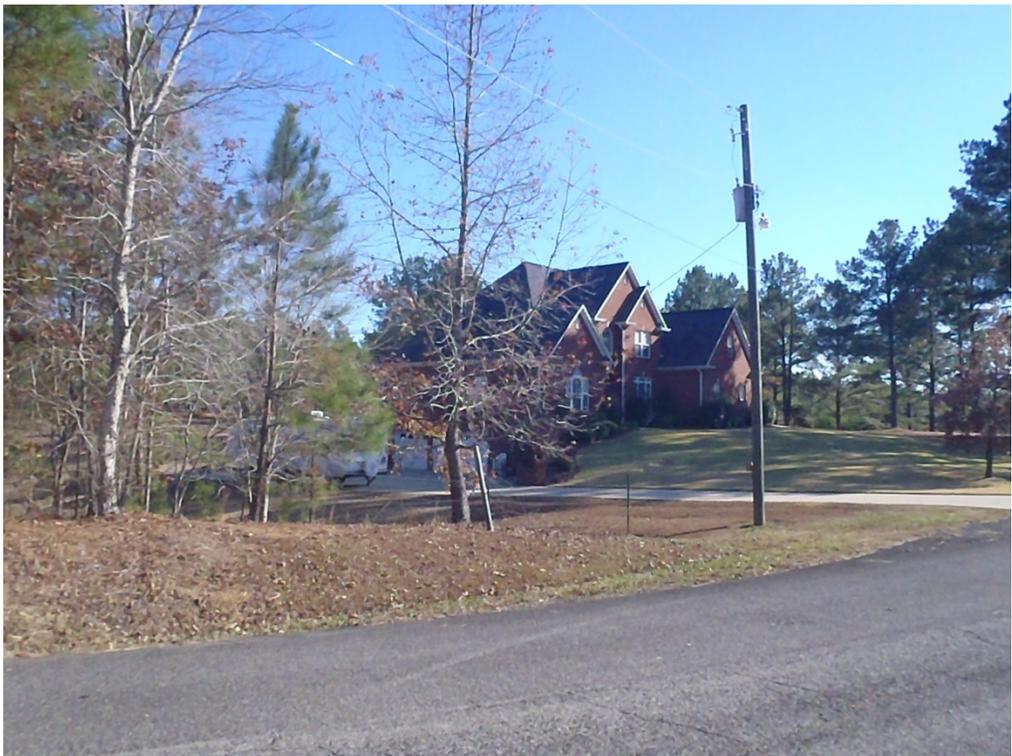
<b>Photo No.</b>	<i>PB200253</i>		
<b>Point No.</b>	<i>X</i>		
<b>Description:</b>			
This is a view of the road and residence at point X.			
<b>Dominant Vegetation:</b>			
Same as above:

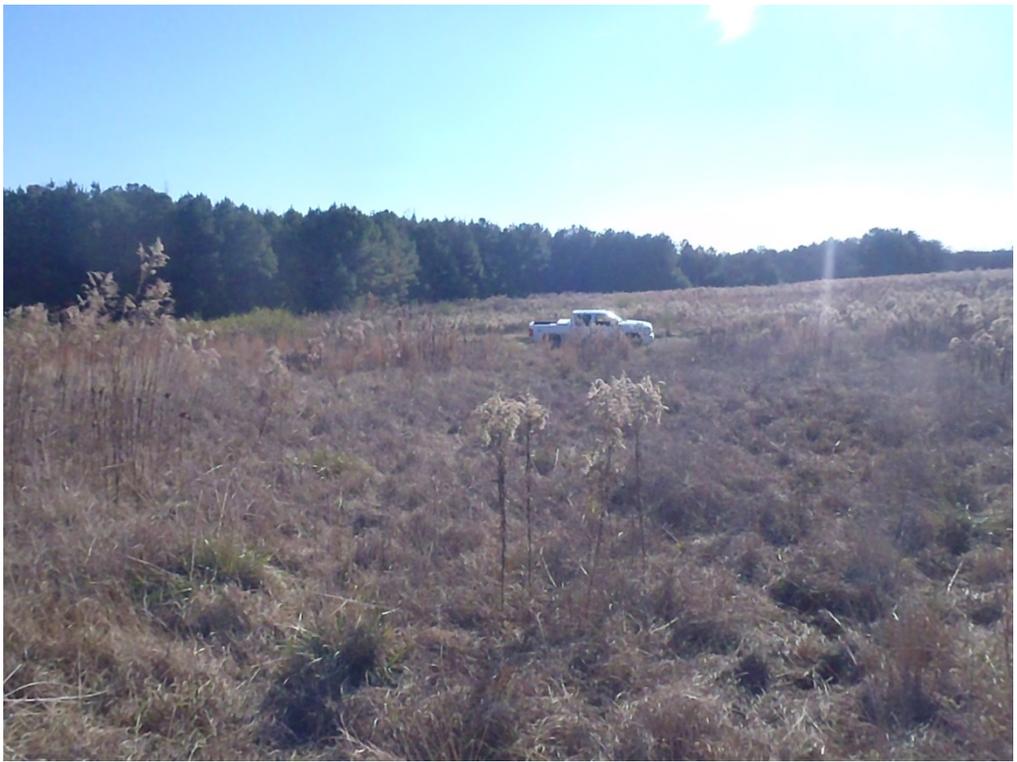
<b>Photo No.</b>	<i>PB200261</i>		
<b>Point No.</b>	<i>Y</i>		
<b>Description:</b>			
This is a view of the open field and access road at point Y.			
<b>Dominant Vegetation:</b>			
<ul style="list-style-type: none"> <li>• <i>Andropogon virginicus</i></li> <li>• <i>Solidago altissima</i></li> <li>• <i>Pinus taeda</i></li> <li>• <i>Liquidambar styraciflua</i></li> <li>• <i>Rubus betulifolius</i></li> <li>• <i>Festuca pratensis</i></li> <li>• <i>Acer rubrum</i></li> </ul>

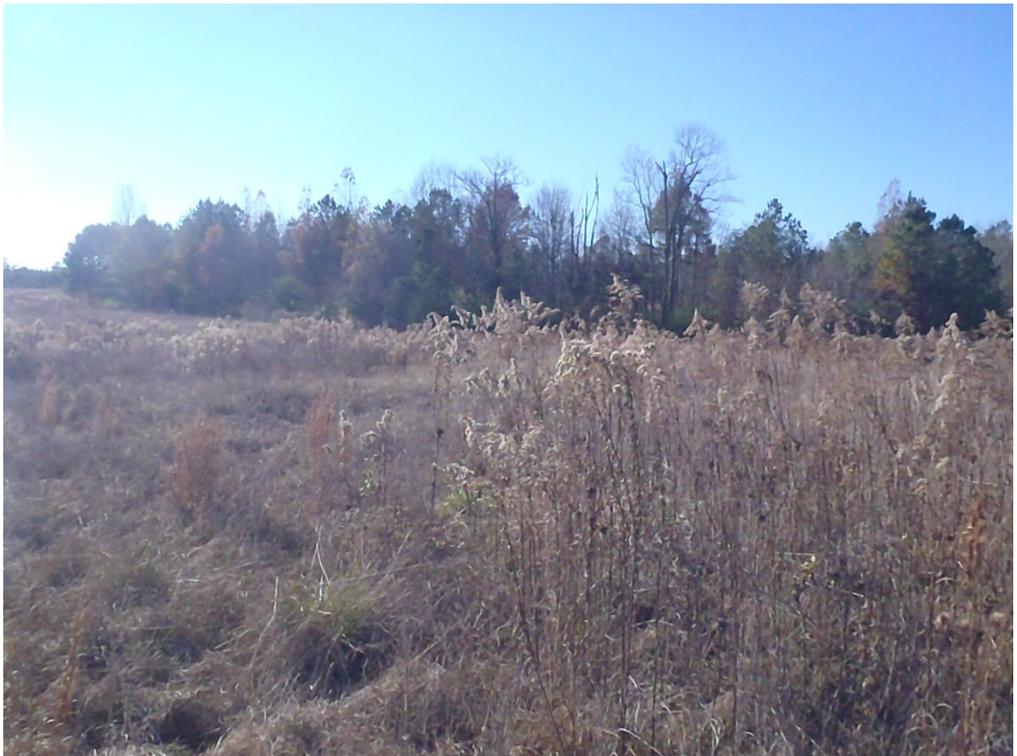
<b>Photo No.</b>	<i>PB200259</i>		
<b>Point No.</b>	<i>Y</i>		
<b>Description:</b>			
This is a view of the vegetation at point Y.			
<b>Dominant Vegetation:</b>			
Same as above:

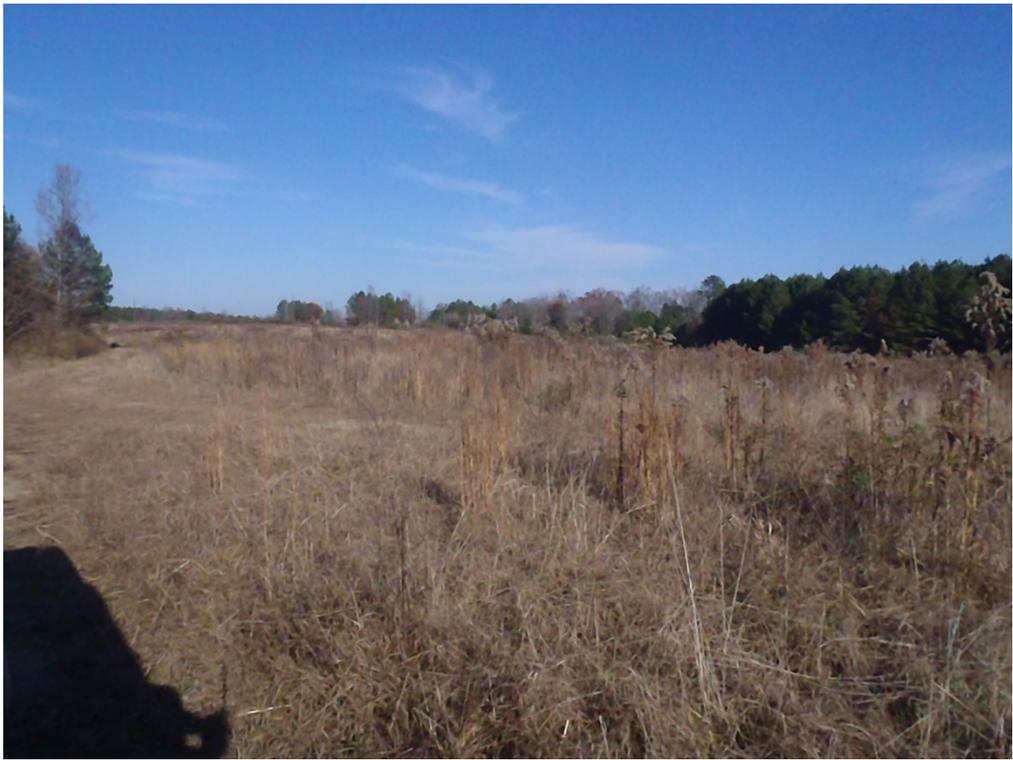
<b>Photo No.</b>	<i>PB200267</i>		
<b>Point No.</b>	<i>Z</i>		
<b>Description:</b> This is a view of the open field and access road at point Z.			
<b>Dominant Vegetation:</b>			
<ul style="list-style-type: none"> <li>• <i>Andropogon virginicus</i></li> <li>• <i>Solidago altissima</i></li> <li>• <i>Pinus taeda</i></li> <li>• <i>Liquidambar styraciflua</i></li> <li>• <i>Rubus betulifolius</i></li> <li>• <i>Festuca pratensis</i></li> <li>• <i>Acer rubrum</i></li> </ul>

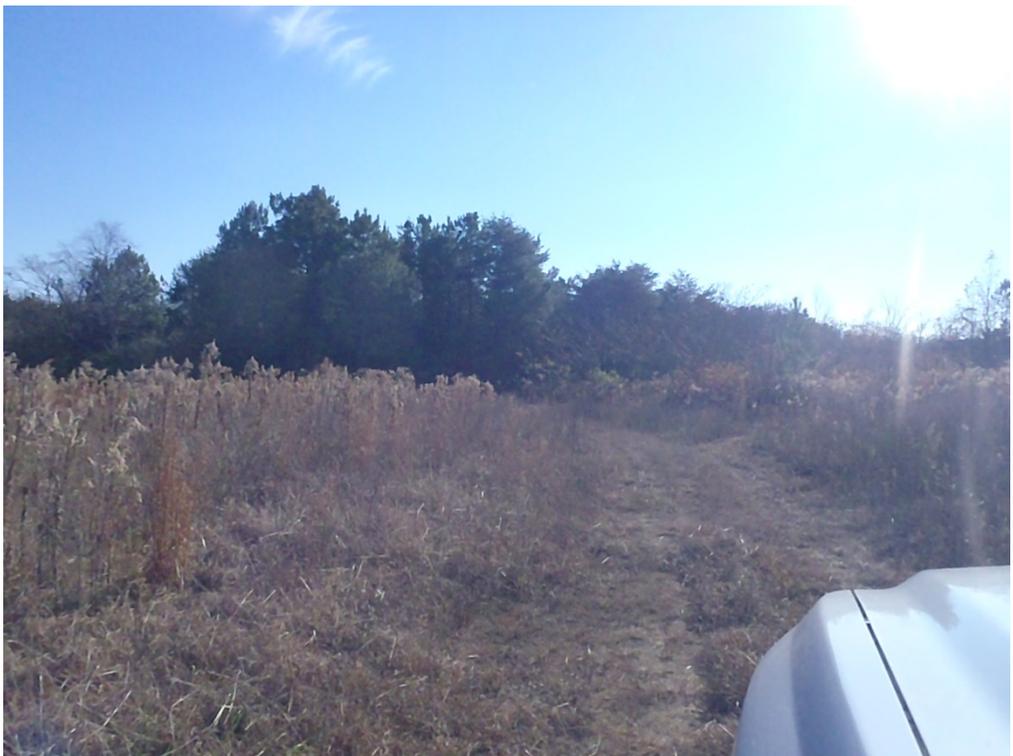
<b>Photo No.</b>	<i>PB200270</i>		
<b>Point No.</b>	<i>Z</i>		
<b>Description:</b> This is a view of the vegetation at point Z.			
<b>Dominant Vegetation:</b>			
Same as above:

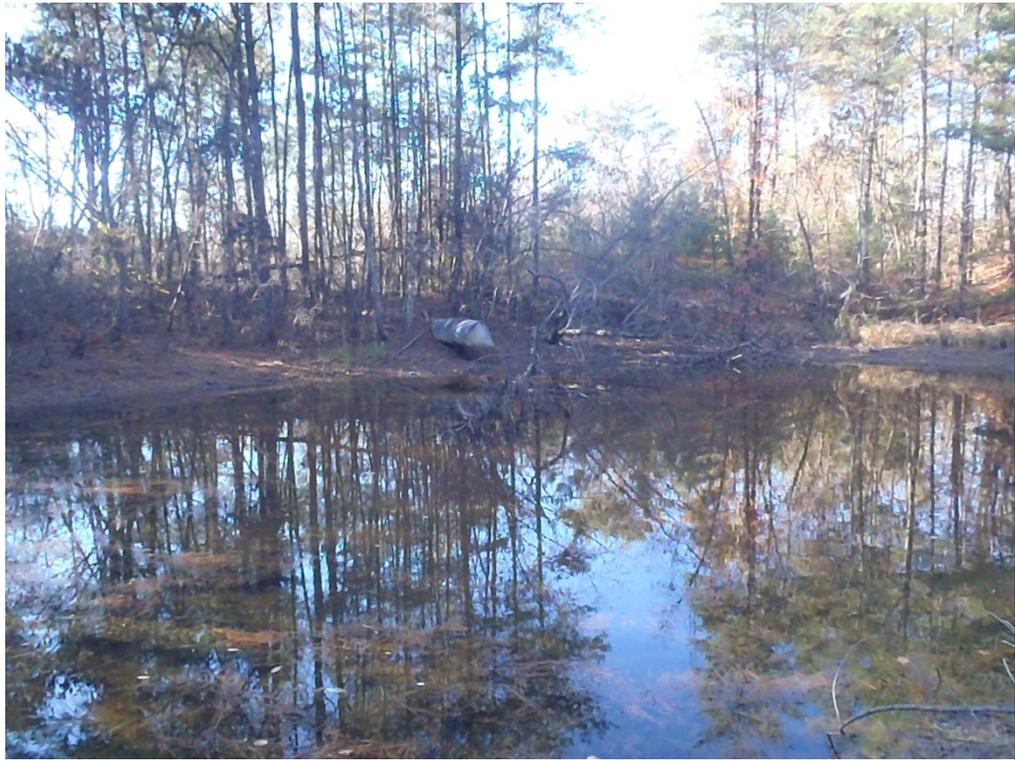
<b>Photo No.</b>	<i>PB200271</i>		
<b>Point No.</b>	<i>AA</i>		
<b>Description:</b>			
This is a view of the upland pond at point AA.			
<b>Dominant Vegetation:</b>			
<ul style="list-style-type: none"> <li>• <i>Pinus taeda</i></li> <li>• <i>Pinus virginiana</i></li> <li>• <i>Liquidambar styraciflua</i></li> <li>• <i>Hydrangea quercifolia</i></li> <li>• <i>Polystichum acrostichoides</i></li> <li>• <i>Lonicera japonica</i></li> </ul>

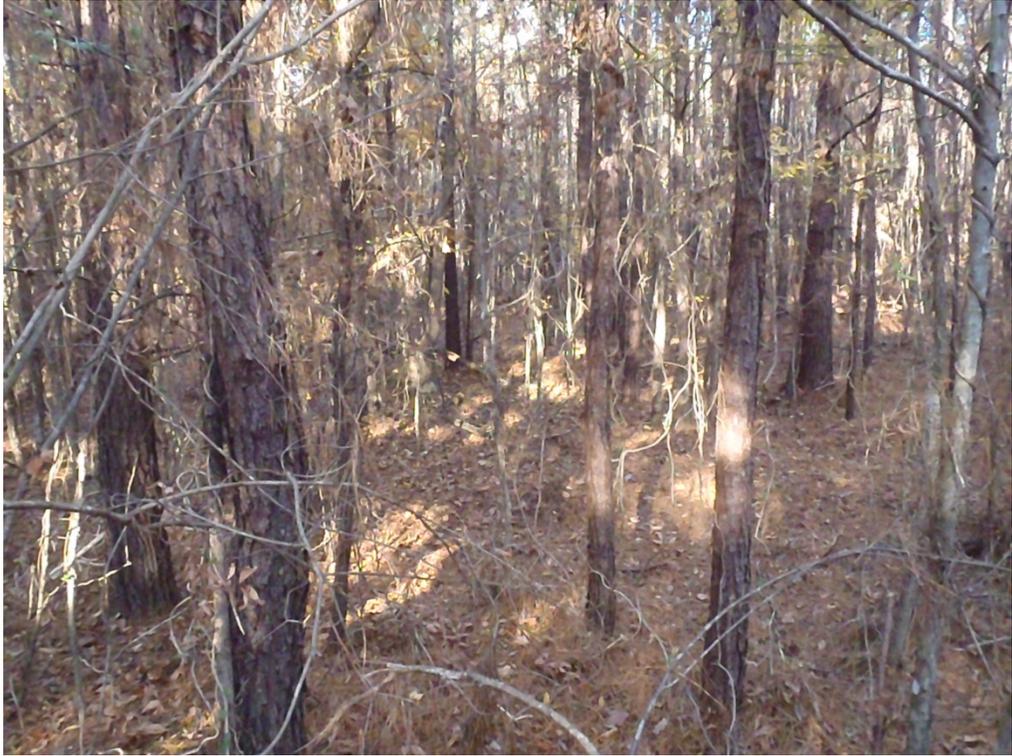
<b>Photo No.</b>	<i>PB200305</i>		
<b>Point No.</b>	<i>BB</i>		
<b>Description:</b>  This is a view of a planted pine thicket at point BB.			
<b>Dominant Vegetation:</b>  <ul style="list-style-type: none"> <li>• <i>Pinus taeda</i></li> <li>• <i>Pinus virginiana</i></li> <li>• <i>Ligustrum sinense</i></li> <li>• <i>Liquidambar styraciflua</i></li> <li>• <i>Acer rubrum</i></li> <li>• <i>Fagus grandifolia</i></li> <li>• <i>Lonicera japonica</i></li> </ul>

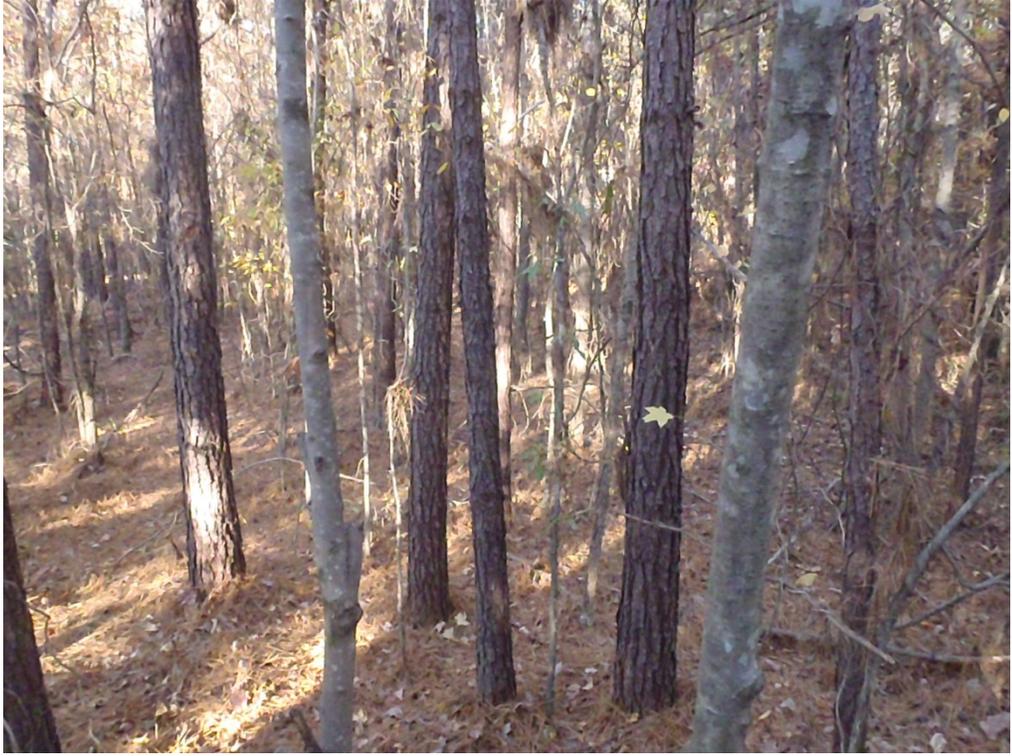
<b>Photo No.</b>	<i>PB200303</i>		
<b>Point No.</b>	<i>BB</i>		
<b>Description:</b>  This is another view of a planted pine thicket at point BB.			
<b>Dominant Vegetation:</b>  Same as above:

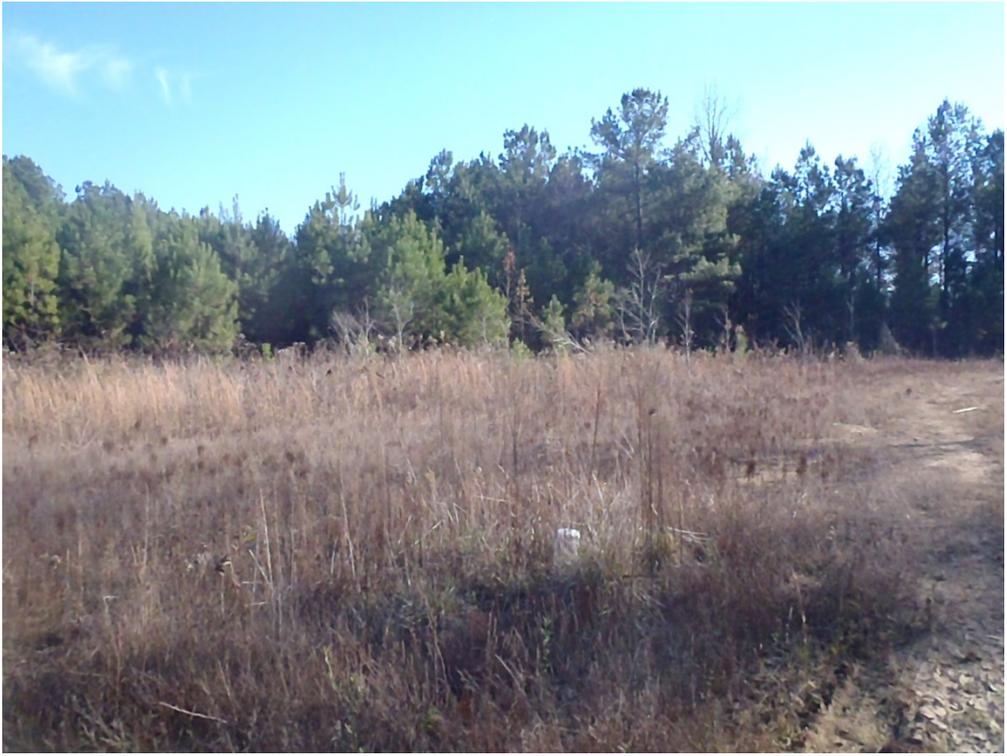
<b>Photo No.</b>	<i>PB200291</i>			
<b>Point No.</b>	<i>CC</i>			
<b>Description:</b>				
This is a view of the open field and access road at point CC.				
<b>Dominant Vegetation:</b>				
<ul style="list-style-type: none"> <li>• <i>Andropogon virginicus</i></li> <li>• <i>Solidago altissima</i></li> <li>• <i>Pinus taeda</i></li> <li>• <i>Liquidambar styraciflua</i></li> <li>• <i>Rubus betulifolius</i></li> <li>• <i>Festuca pratensis</i></li> <li>• <i>Acer rubrum</i></li> </ul>

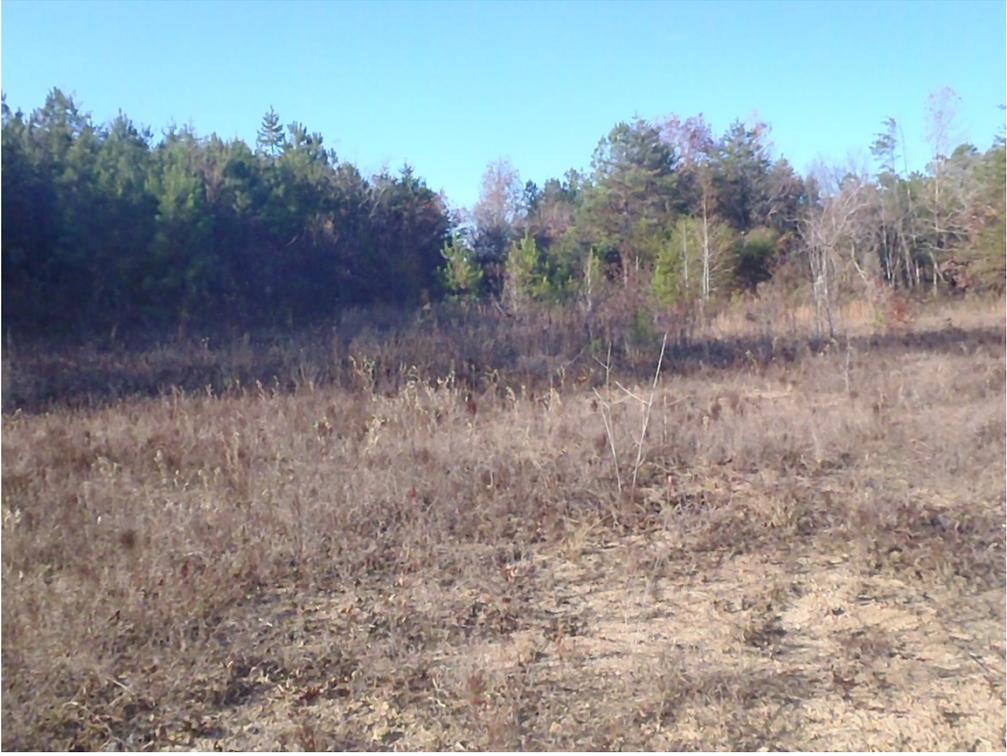
<b>Photo No.</b>	<i>PB200288</i>			
<b>Point No.</b>	<i>CC</i>			
<b>Description:</b>				
This is a view of the open field and access road at point CC.				
<b>Dominant Vegetation:</b>				
Same as above:

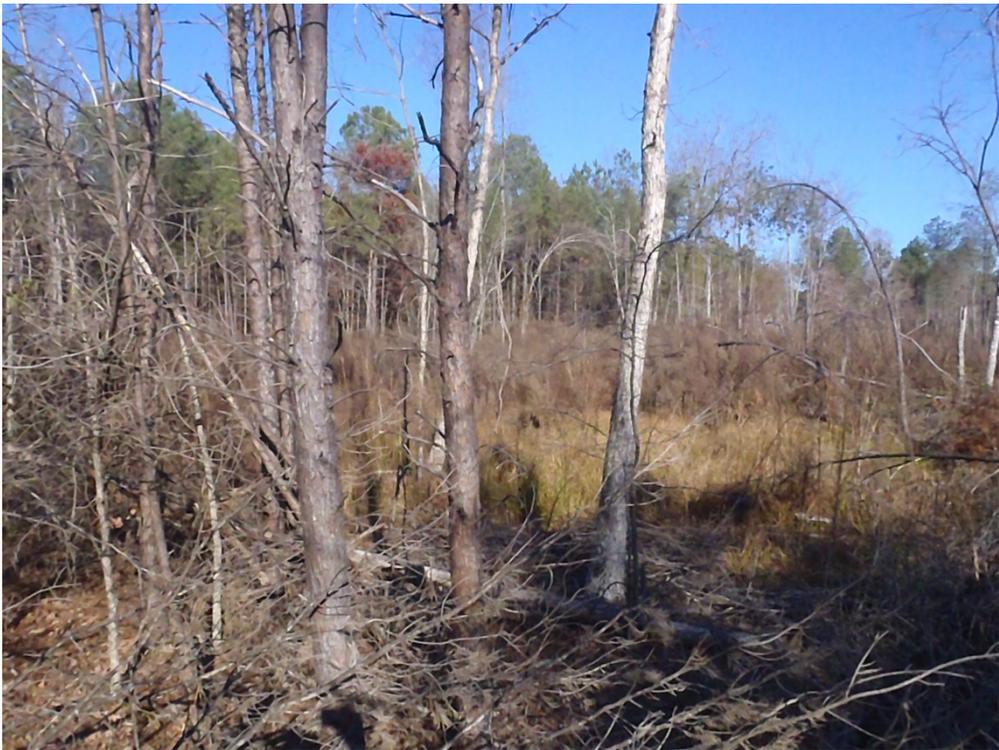
<b>Photo No.</b>	<i>PB200292</i>			
<b>Point No.</b>	<i>DD</i>			
<b>Description:</b>				
This is a view of the clear cut area at point DD.				
<b>Dominant Vegetation:</b>				
<ul style="list-style-type: none"> <li>• <i>Andropogon virginicus</i></li> <li>• <i>Solidago altissima</i></li> <li>• <i>Pinus taeda</i></li> <li>• <i>Liquidambar styraciflua</i></li> <li>• <i>Rubus betulifolius</i></li> <li>• <i>Festuca pratensis</i></li> <li>• <i>Acer rubrum</i></li> </ul>

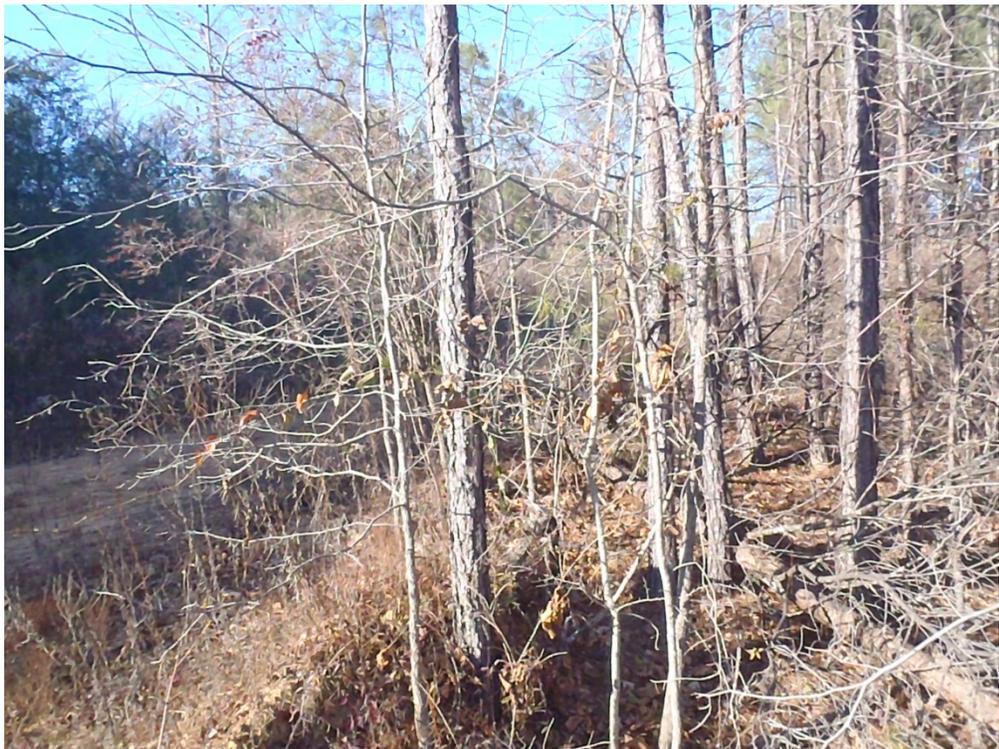
<b>Photo No.</b>	<i>PB200295</i>			
<b>Point No.</b>	<i>DD</i>			
<b>Description:</b>				
This is another view of the clear cut area at point DD.				
<b>Dominant Vegetation:</b>				
Same as above:

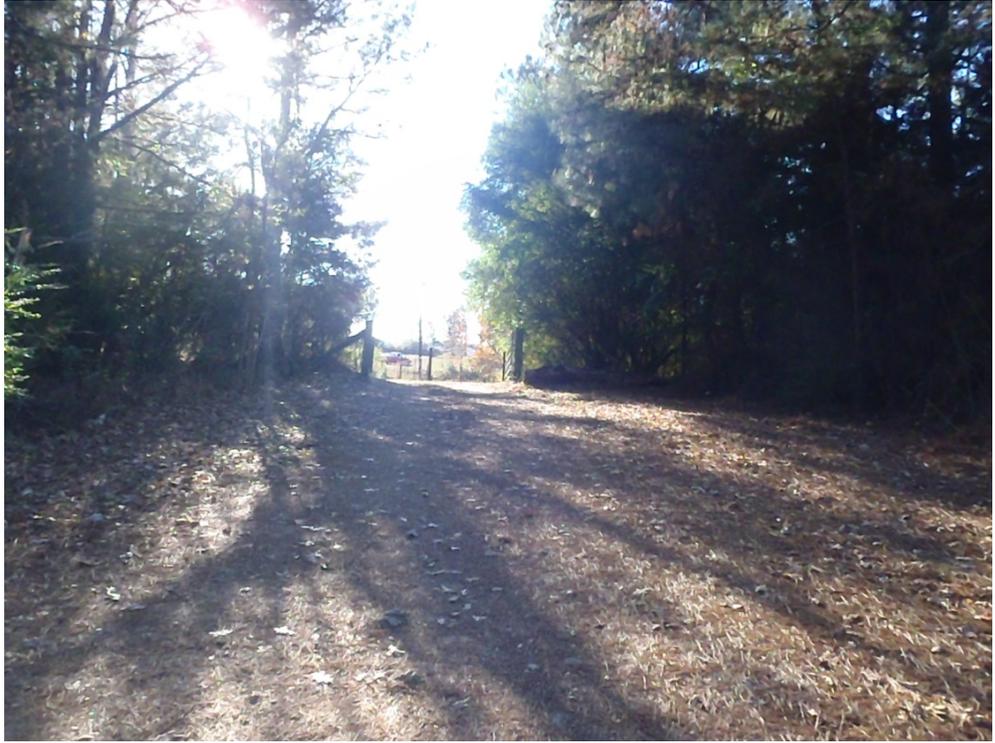
<b>Photo No.</b>	<i>PB200316</i>		
<b>Point No.</b>	<i>FF</i>		
<b>Description:</b>			
This is a view of a gate off of Pritchett Road at point FF.			
<b>Dominant Vegetation:</b>			
<ul style="list-style-type: none"> <li>• <i>Pinus taeda</i></li> <li>• <i>Ligustrum sinense</i></li> <li>• <i>Liquidambar styraciflua</i></li> <li>• <i>Quercus alba</i></li> <li>• <i>Quercus falcata</i></li> <li>• <i>Lonicera japonica</i></li> </ul>

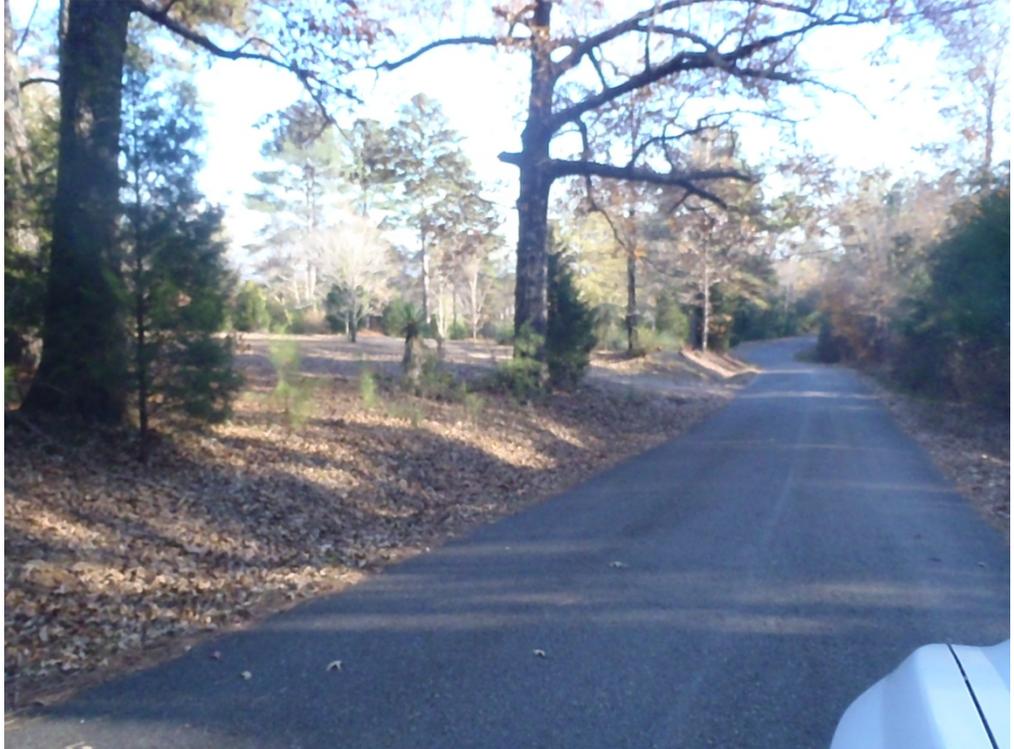
<b>Photo No.</b>	<i>PB200323</i>		
<b>Point No.</b>	<i>FF</i>		
<b>Description:</b>			
This is a view of Pritchett Road at point FF.			
<b>Dominant Vegetation:</b>			
Same as above:

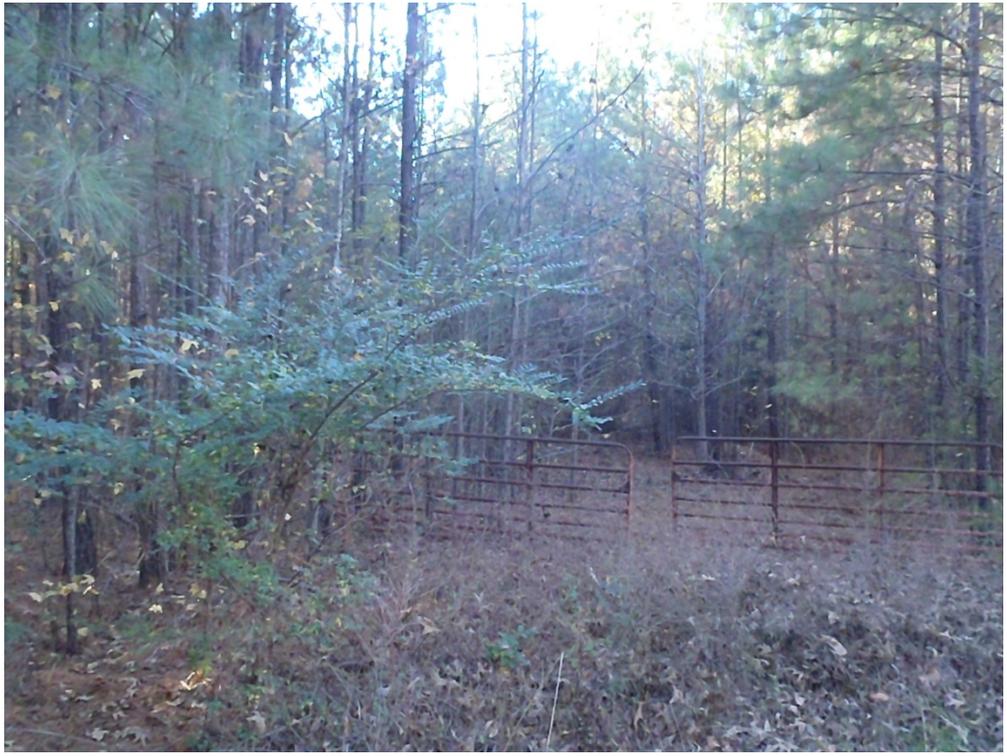
<b>Photo No.</b>	<i>PB200310</i>		
<b>Point No.</b>	<i>GG</i>		
<b>Description:</b>  This is a view of a gate at point GG.			
<b>Dominant Vegetation:</b>  <ul style="list-style-type: none"> <li>• <i>Pinus taeda</i></li> <li>• <i>Ligustrum sinense</i></li> <li>• <i>Liquidambar styraciflua</i></li> <li>• <i>Acer rubrum</i></li> <li>• <i>Quercus falcata</i></li> <li>• <i>Lonicera japonica</i></li> </ul>

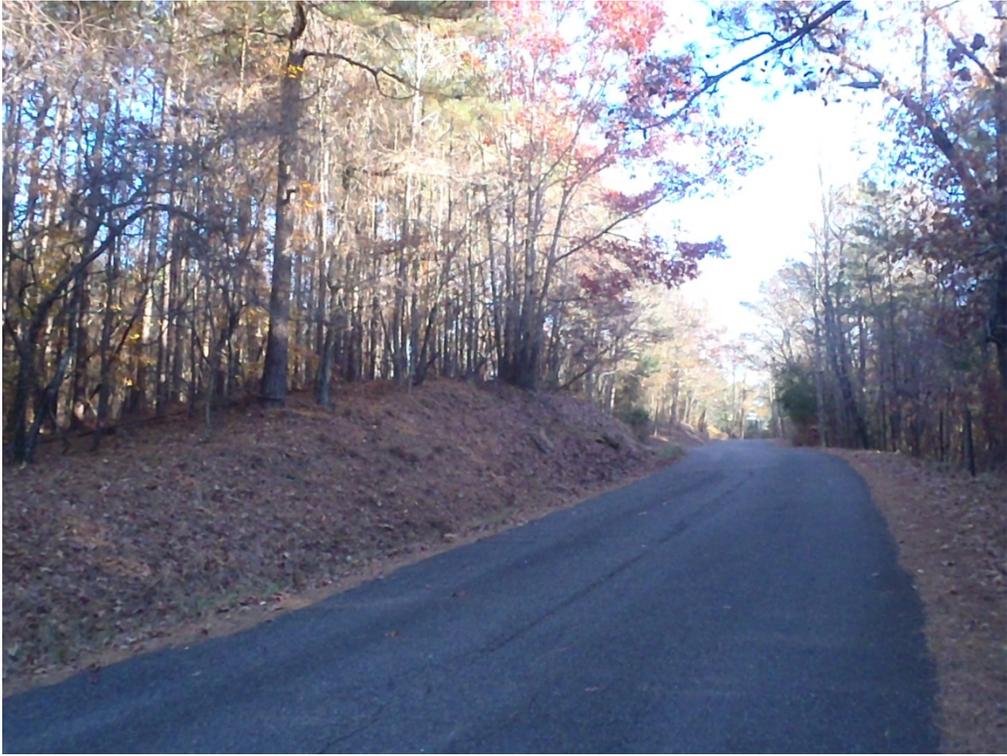
<b>Photo No.</b>	<i>PB200315</i>		
<b>Point No.</b>	<i>GG</i>		
<b>Description:</b>  This is a view of Pritchett Road at point GG.			
<b>Dominant Vegetation:</b>  Same as above along with: <ul style="list-style-type: none"> <li>• <i>Smilax tamnoides</i></li> <li>• <i>Smilax rotundifolia</i></li> </ul>
