# **BIOLOGICAL HABITAT ASSESSMENT**

**BLACK WARRIOR MINERALS, INC.**

**MINE NO. 2**

**April 10<sup>th</sup>, 2015**

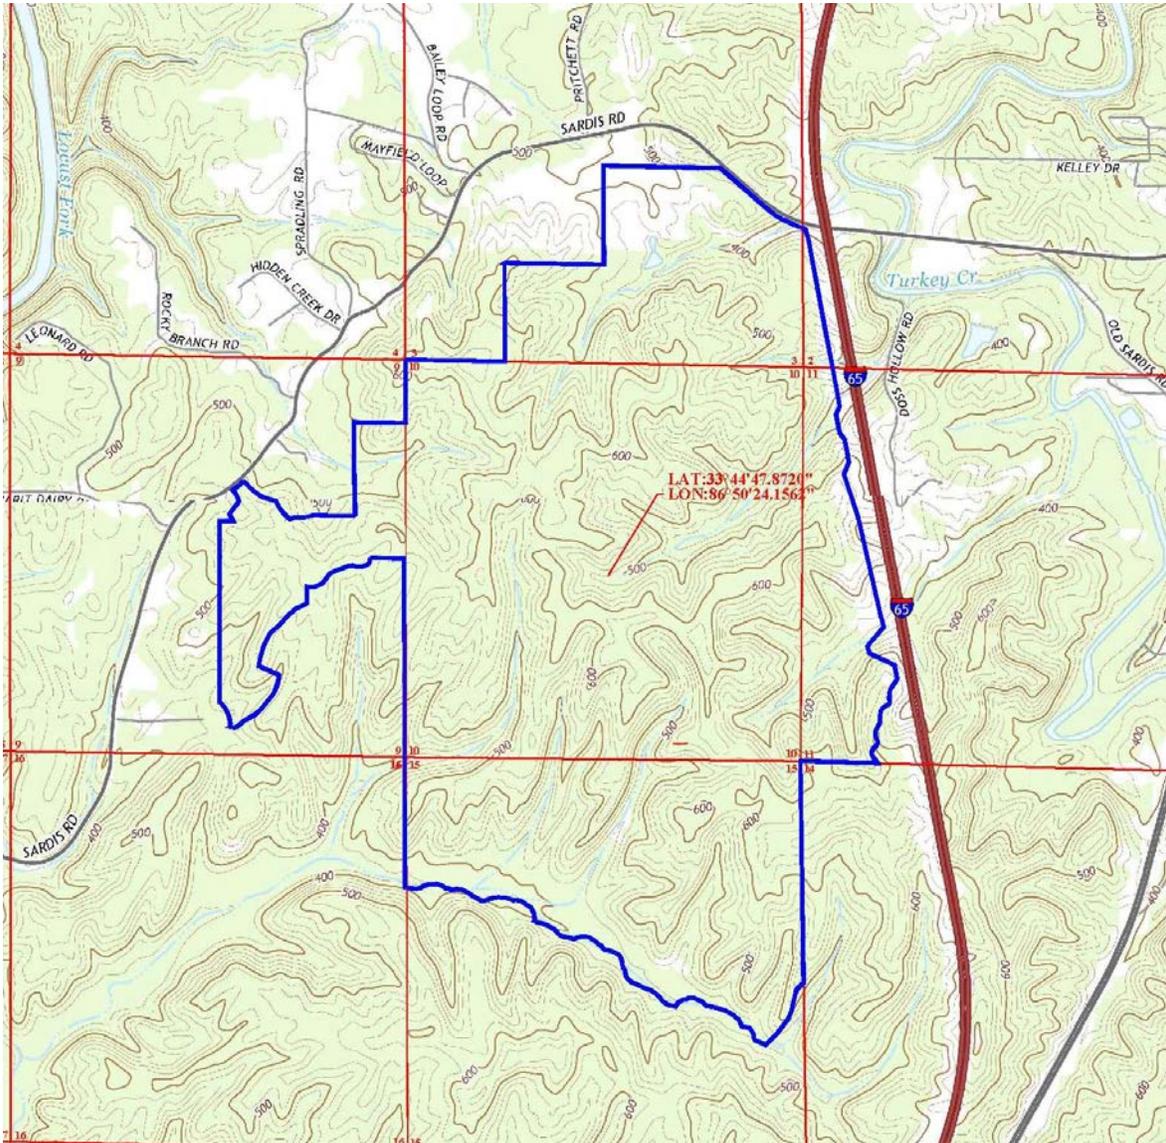
**Figure 1. Project Area Map.** (not to scale)

Black Warrior Minerals, Inc. – Mine No. 2 consists of approximately 1,368 acres and is located in Section 2, 3, 9, 10, 11 and 15, Township 15 South, Range 3 West as located in Jefferson County, Alabama on the Gardendale and Warrior, Alabama U.S.G.S Quadrangle. The proposed site location is shown below on the attached project area map Figure 1. (Appendix “A”)

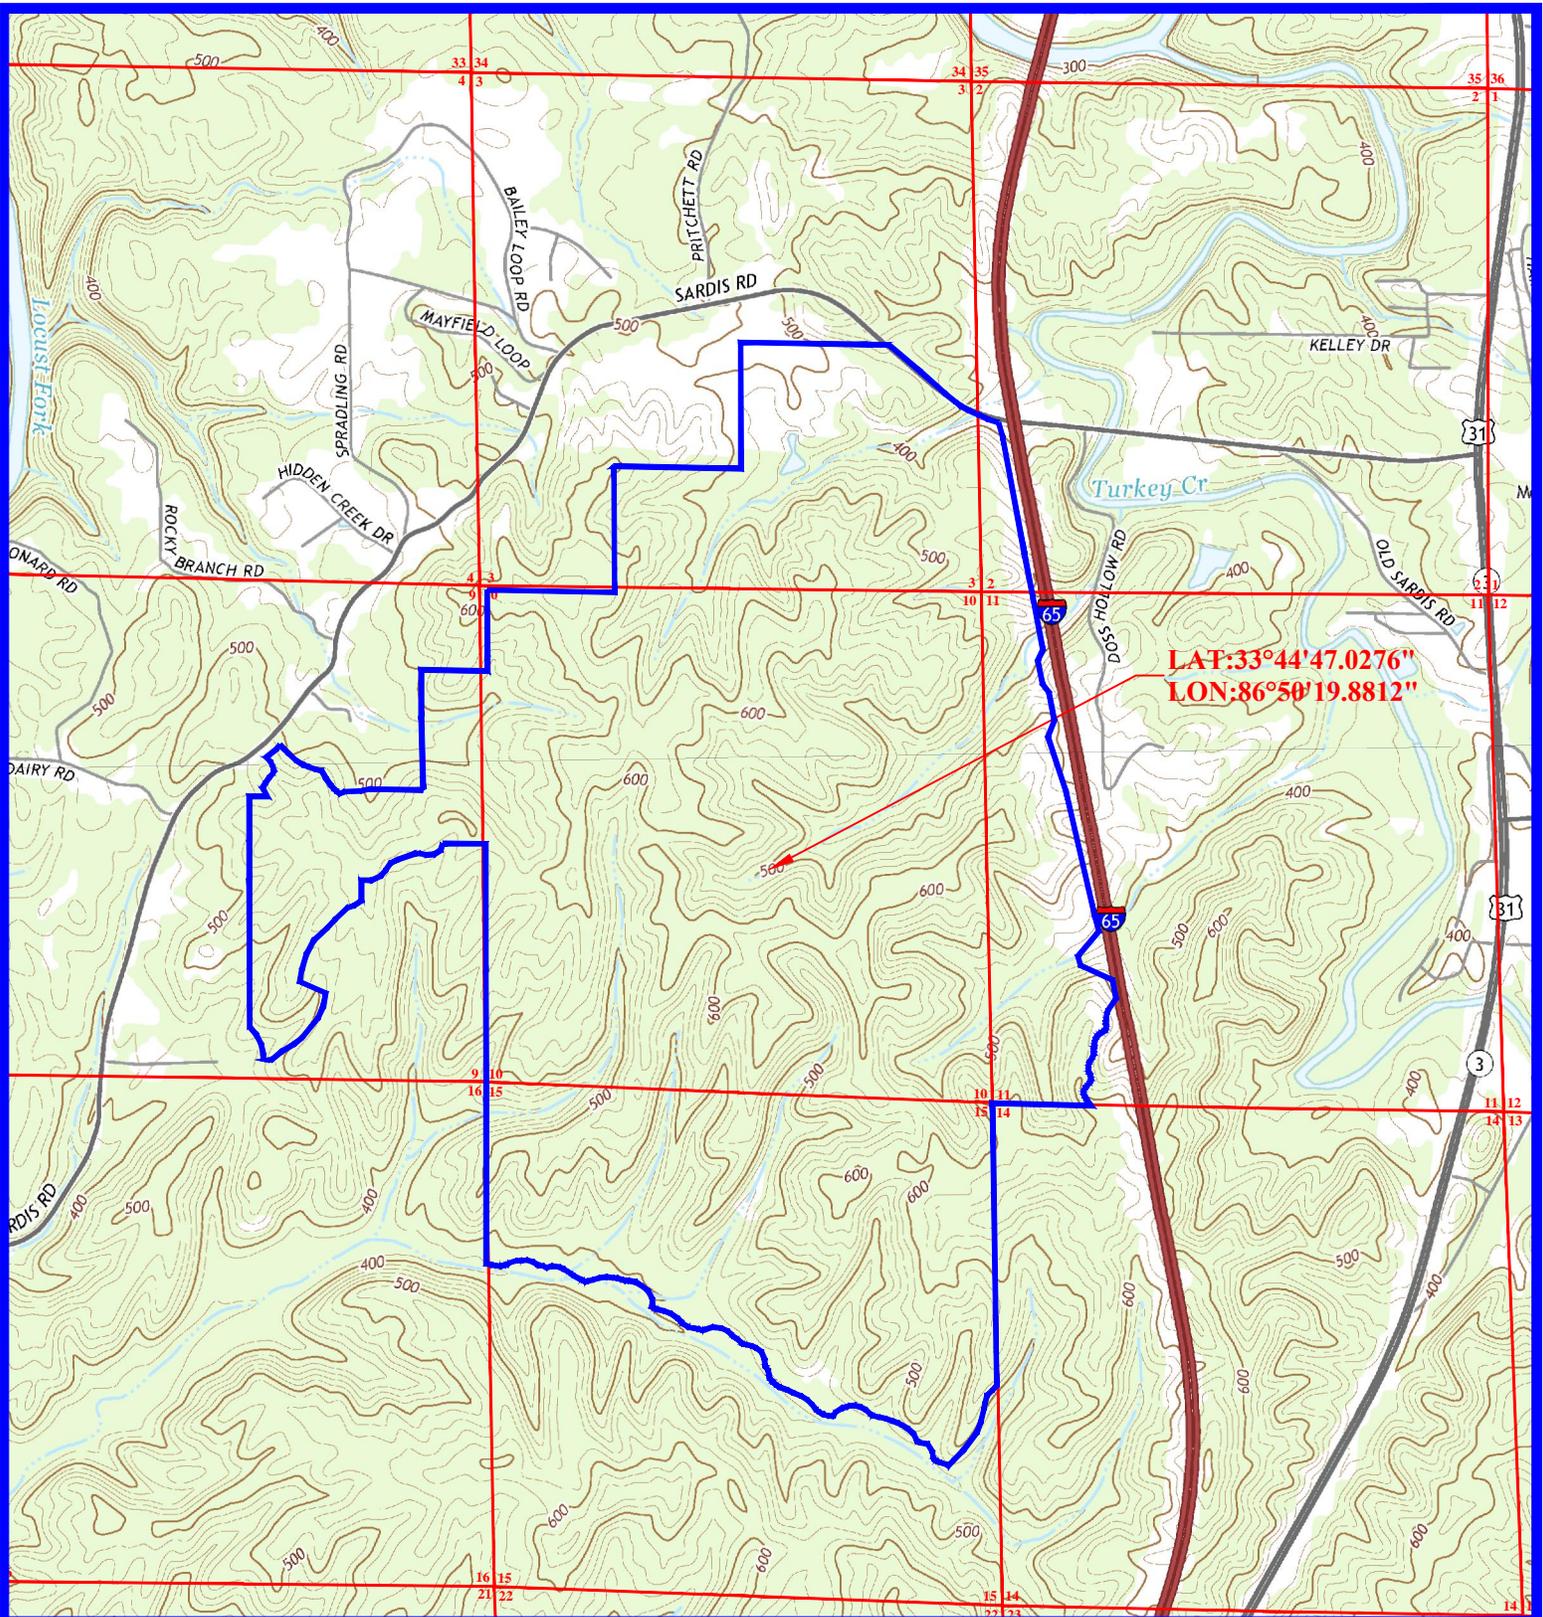
**BLACK WARRIOR MINERALS, INC.**  
**MINE NO. 2**  
 (APPROXIMATELY 1,368 ACRES TOTAL)

SECTIONS 2, 3, 9, 10, 11, & 15, TOWNSHIP 15 SOUTH, RANGE 3 WEST,  
 ALL IN JEFFERSON COUNTY, ALABAMA  
 AS FOUND ON THE GARDENDALE & WARRIOR, ALABAMA USGS QUAD.

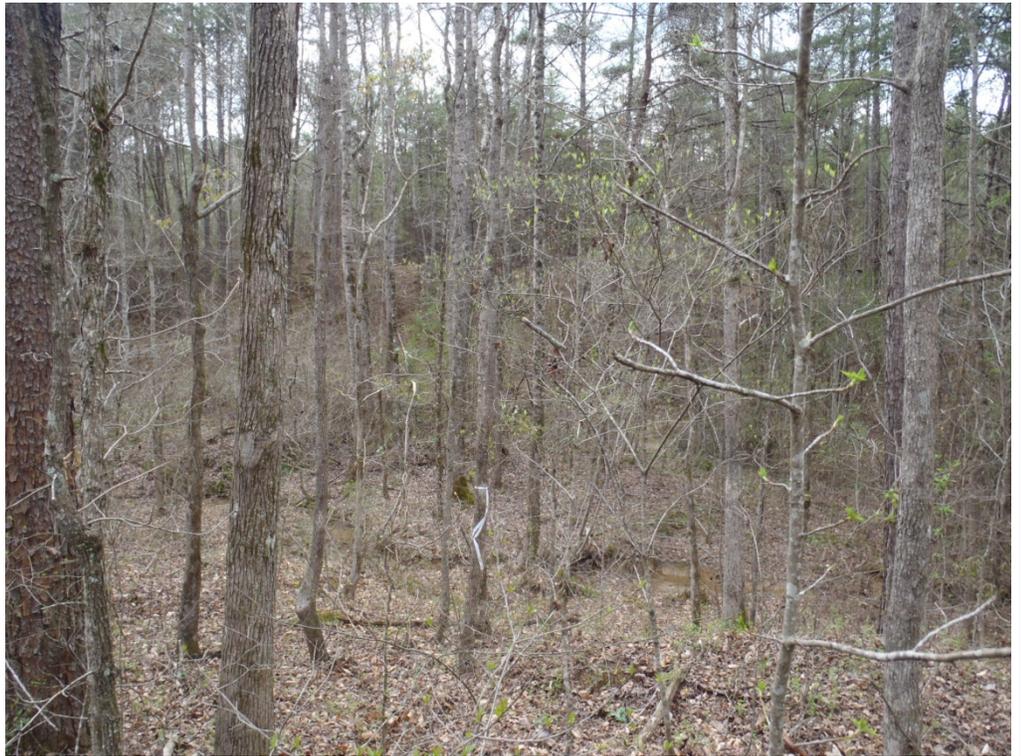
**Description:**  
This is a view of mixed hardwood/ pine valley at point 036.

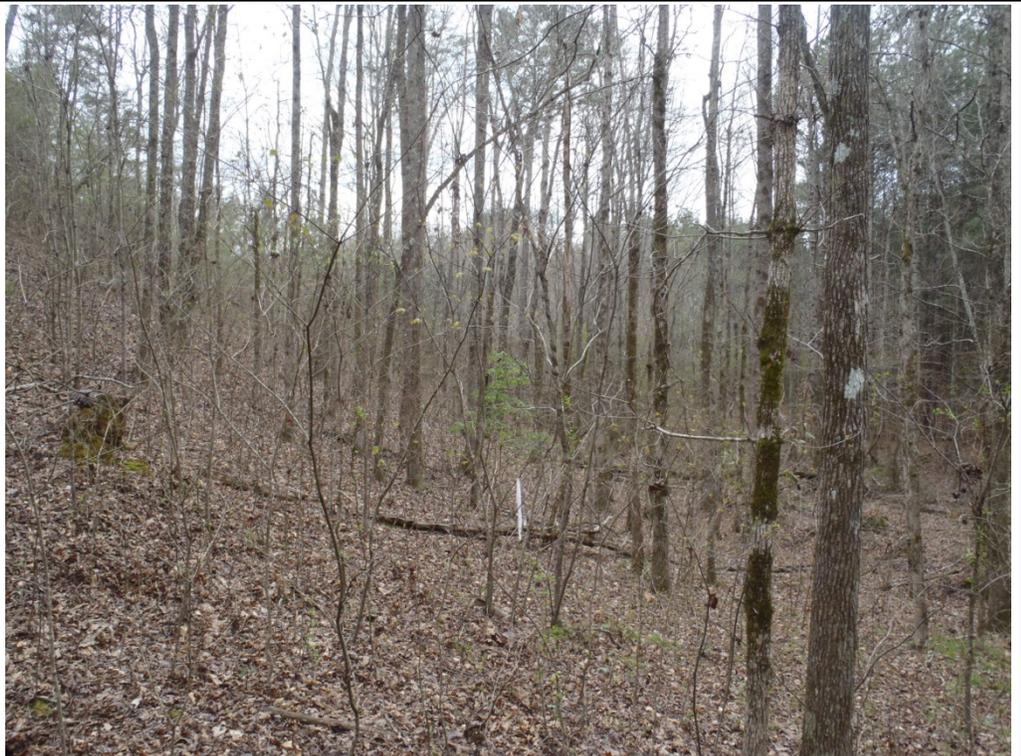
**Description:**  
This is a view of mixed hardwood/ pine valley at point 036.

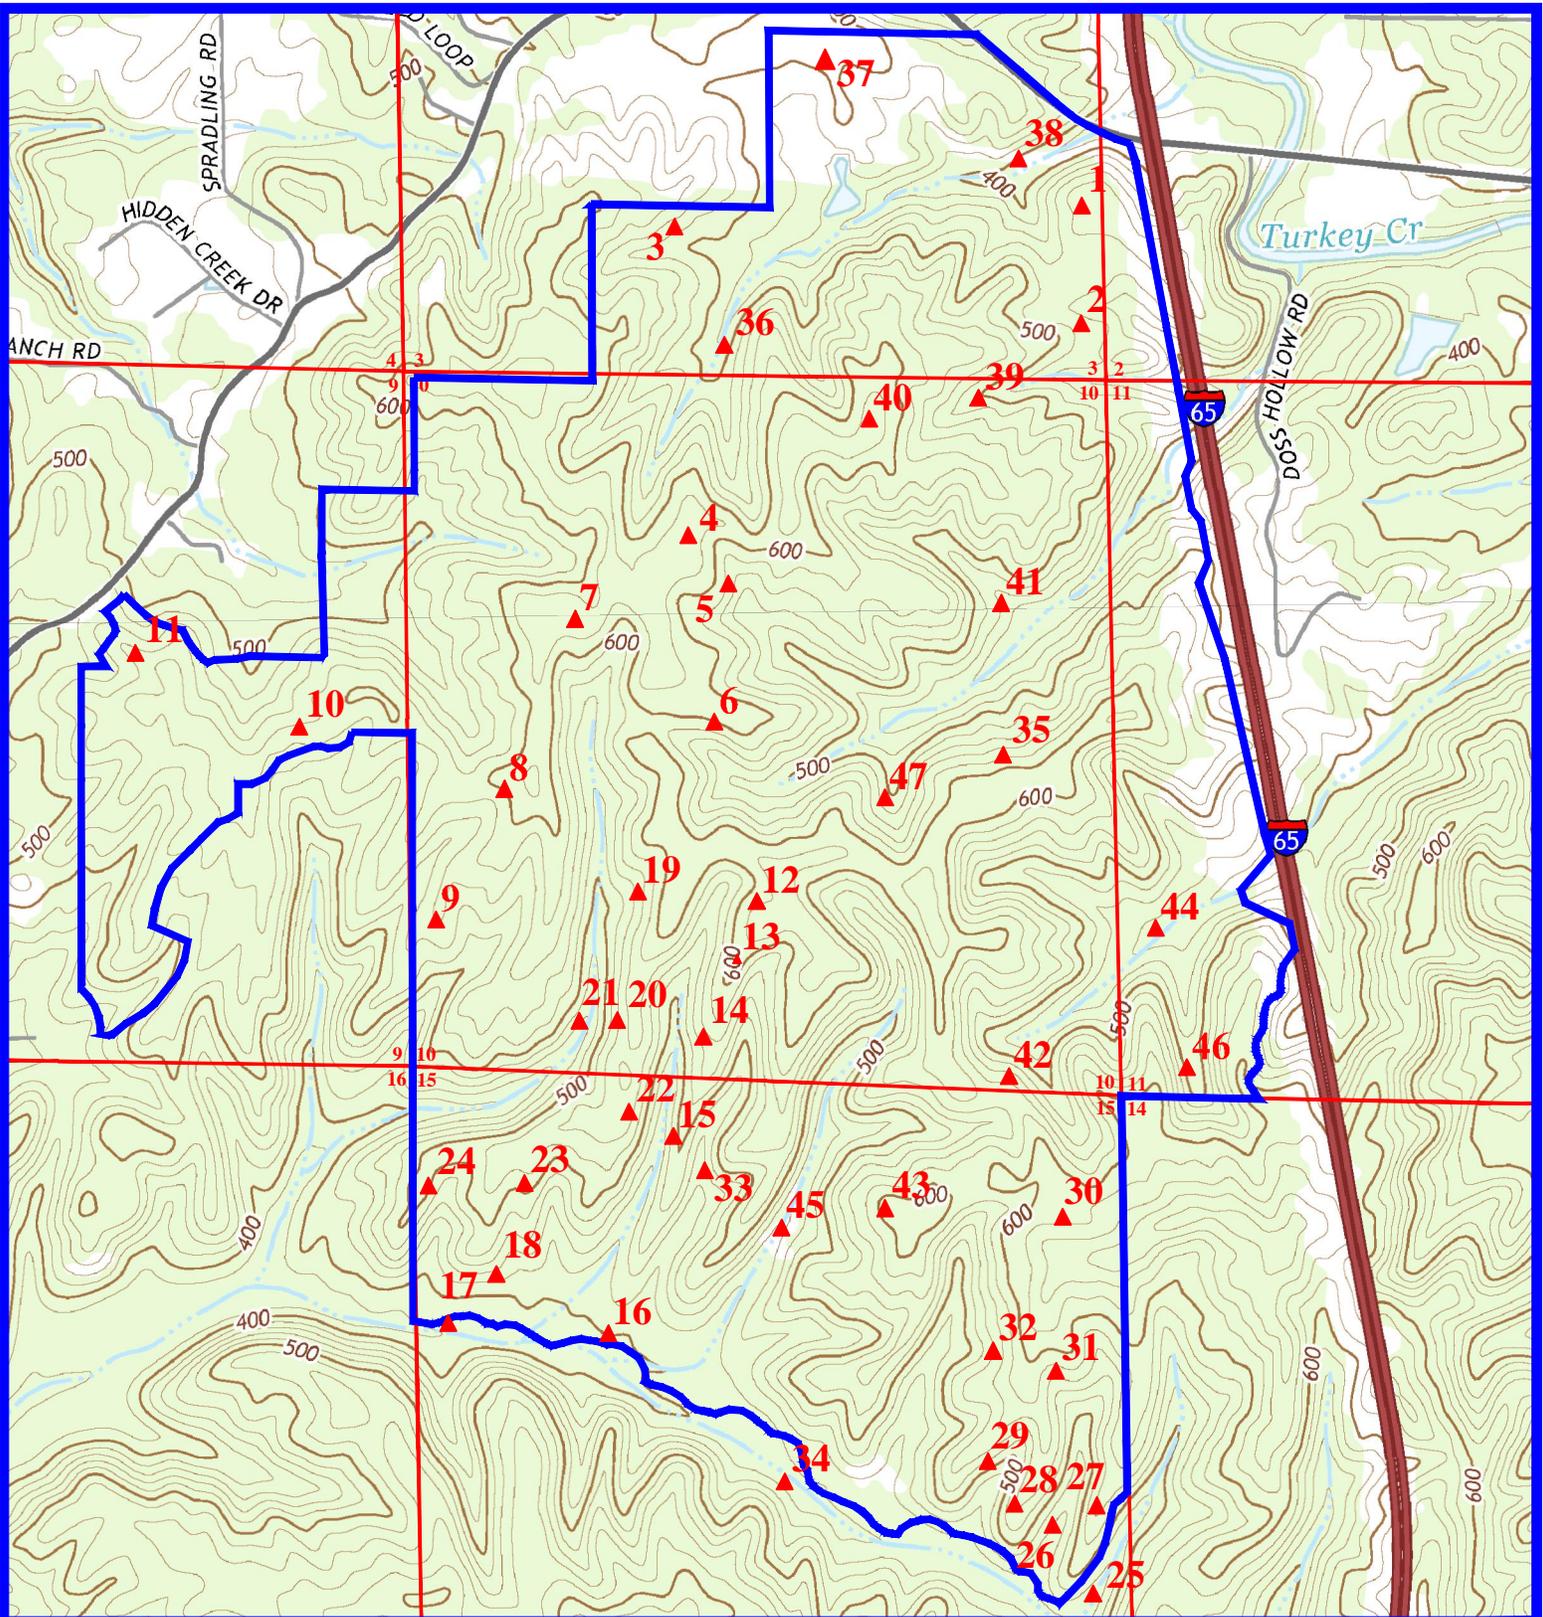
# **Appendix C — Photo Log Point Location Map**

SECTIONS 2, 3, 9, 10, 11, & 15, TOWNSHIP 15 SOUTH, RANGE 3 WEST,  
 ALL IN JEFFERSON COUNTY, ALABAMA  
 AS FOUND ON THE GARDENDALE (2014) & WARRIOR (2014)  
 ALABAMA USGS QUAD.

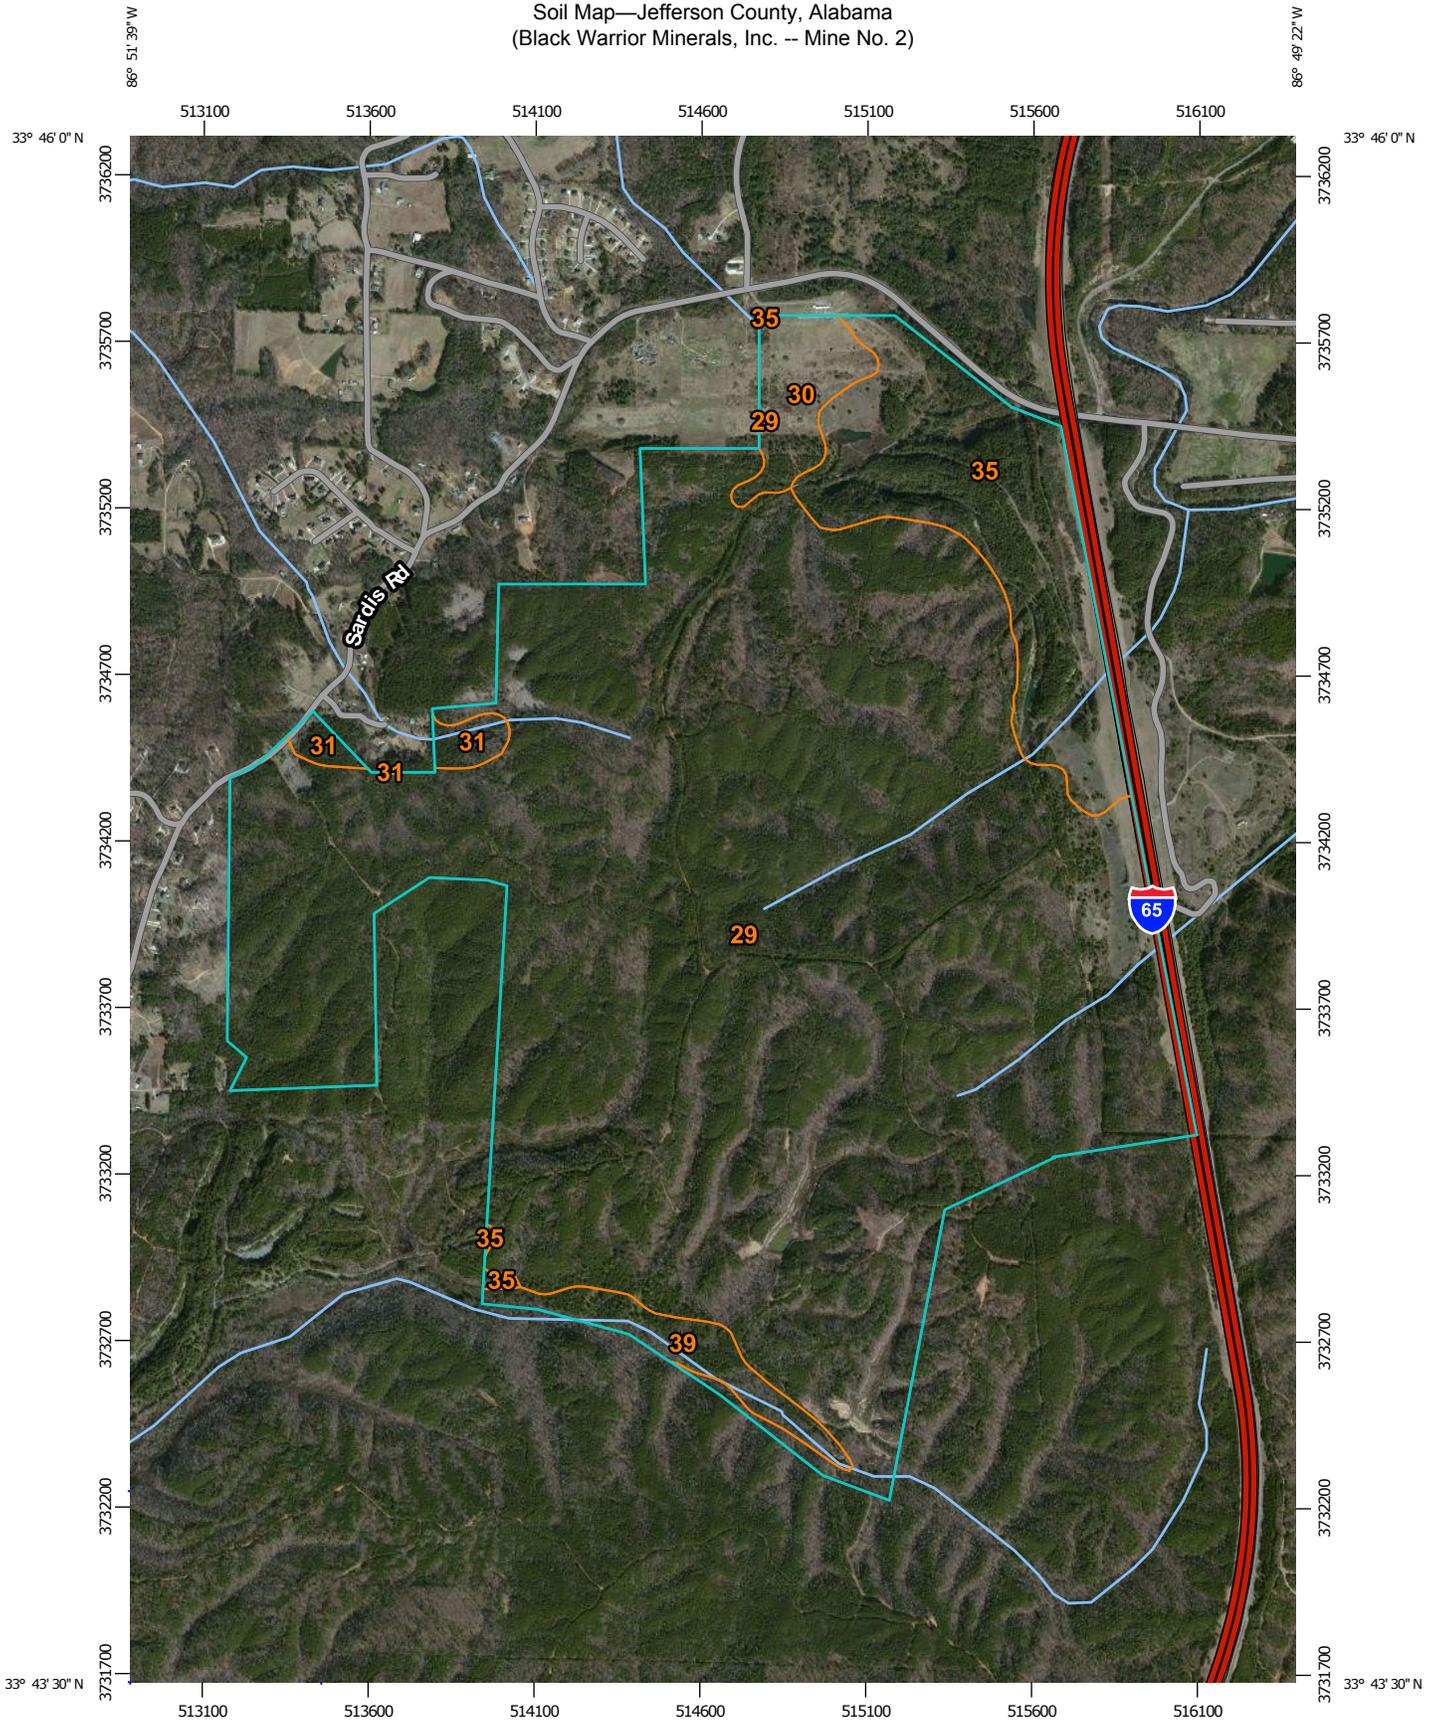
Soil Map—Jefferson County, Alabama  
(Black Warrior Minerals, Inc. -- Mine No. 2)

There are several soil groups within the project. The first is Montevallo-Nauvoo association, steep that are well drained. The second is Palmerdale complex, steep which are somewhat excessively drained. The third is Nauvoo fine sandy loam, 2 to 15 percent slopes which are well drained. The fourth is Sullivan-State complex, 0 to 2 percent slopes which are also well drained. All soil types are predominantly non hydric. The soils identified in the field matched the USDA Soil data profile therefore a more detailed description of the soil as well as the soil maps can be found in Appendix C.

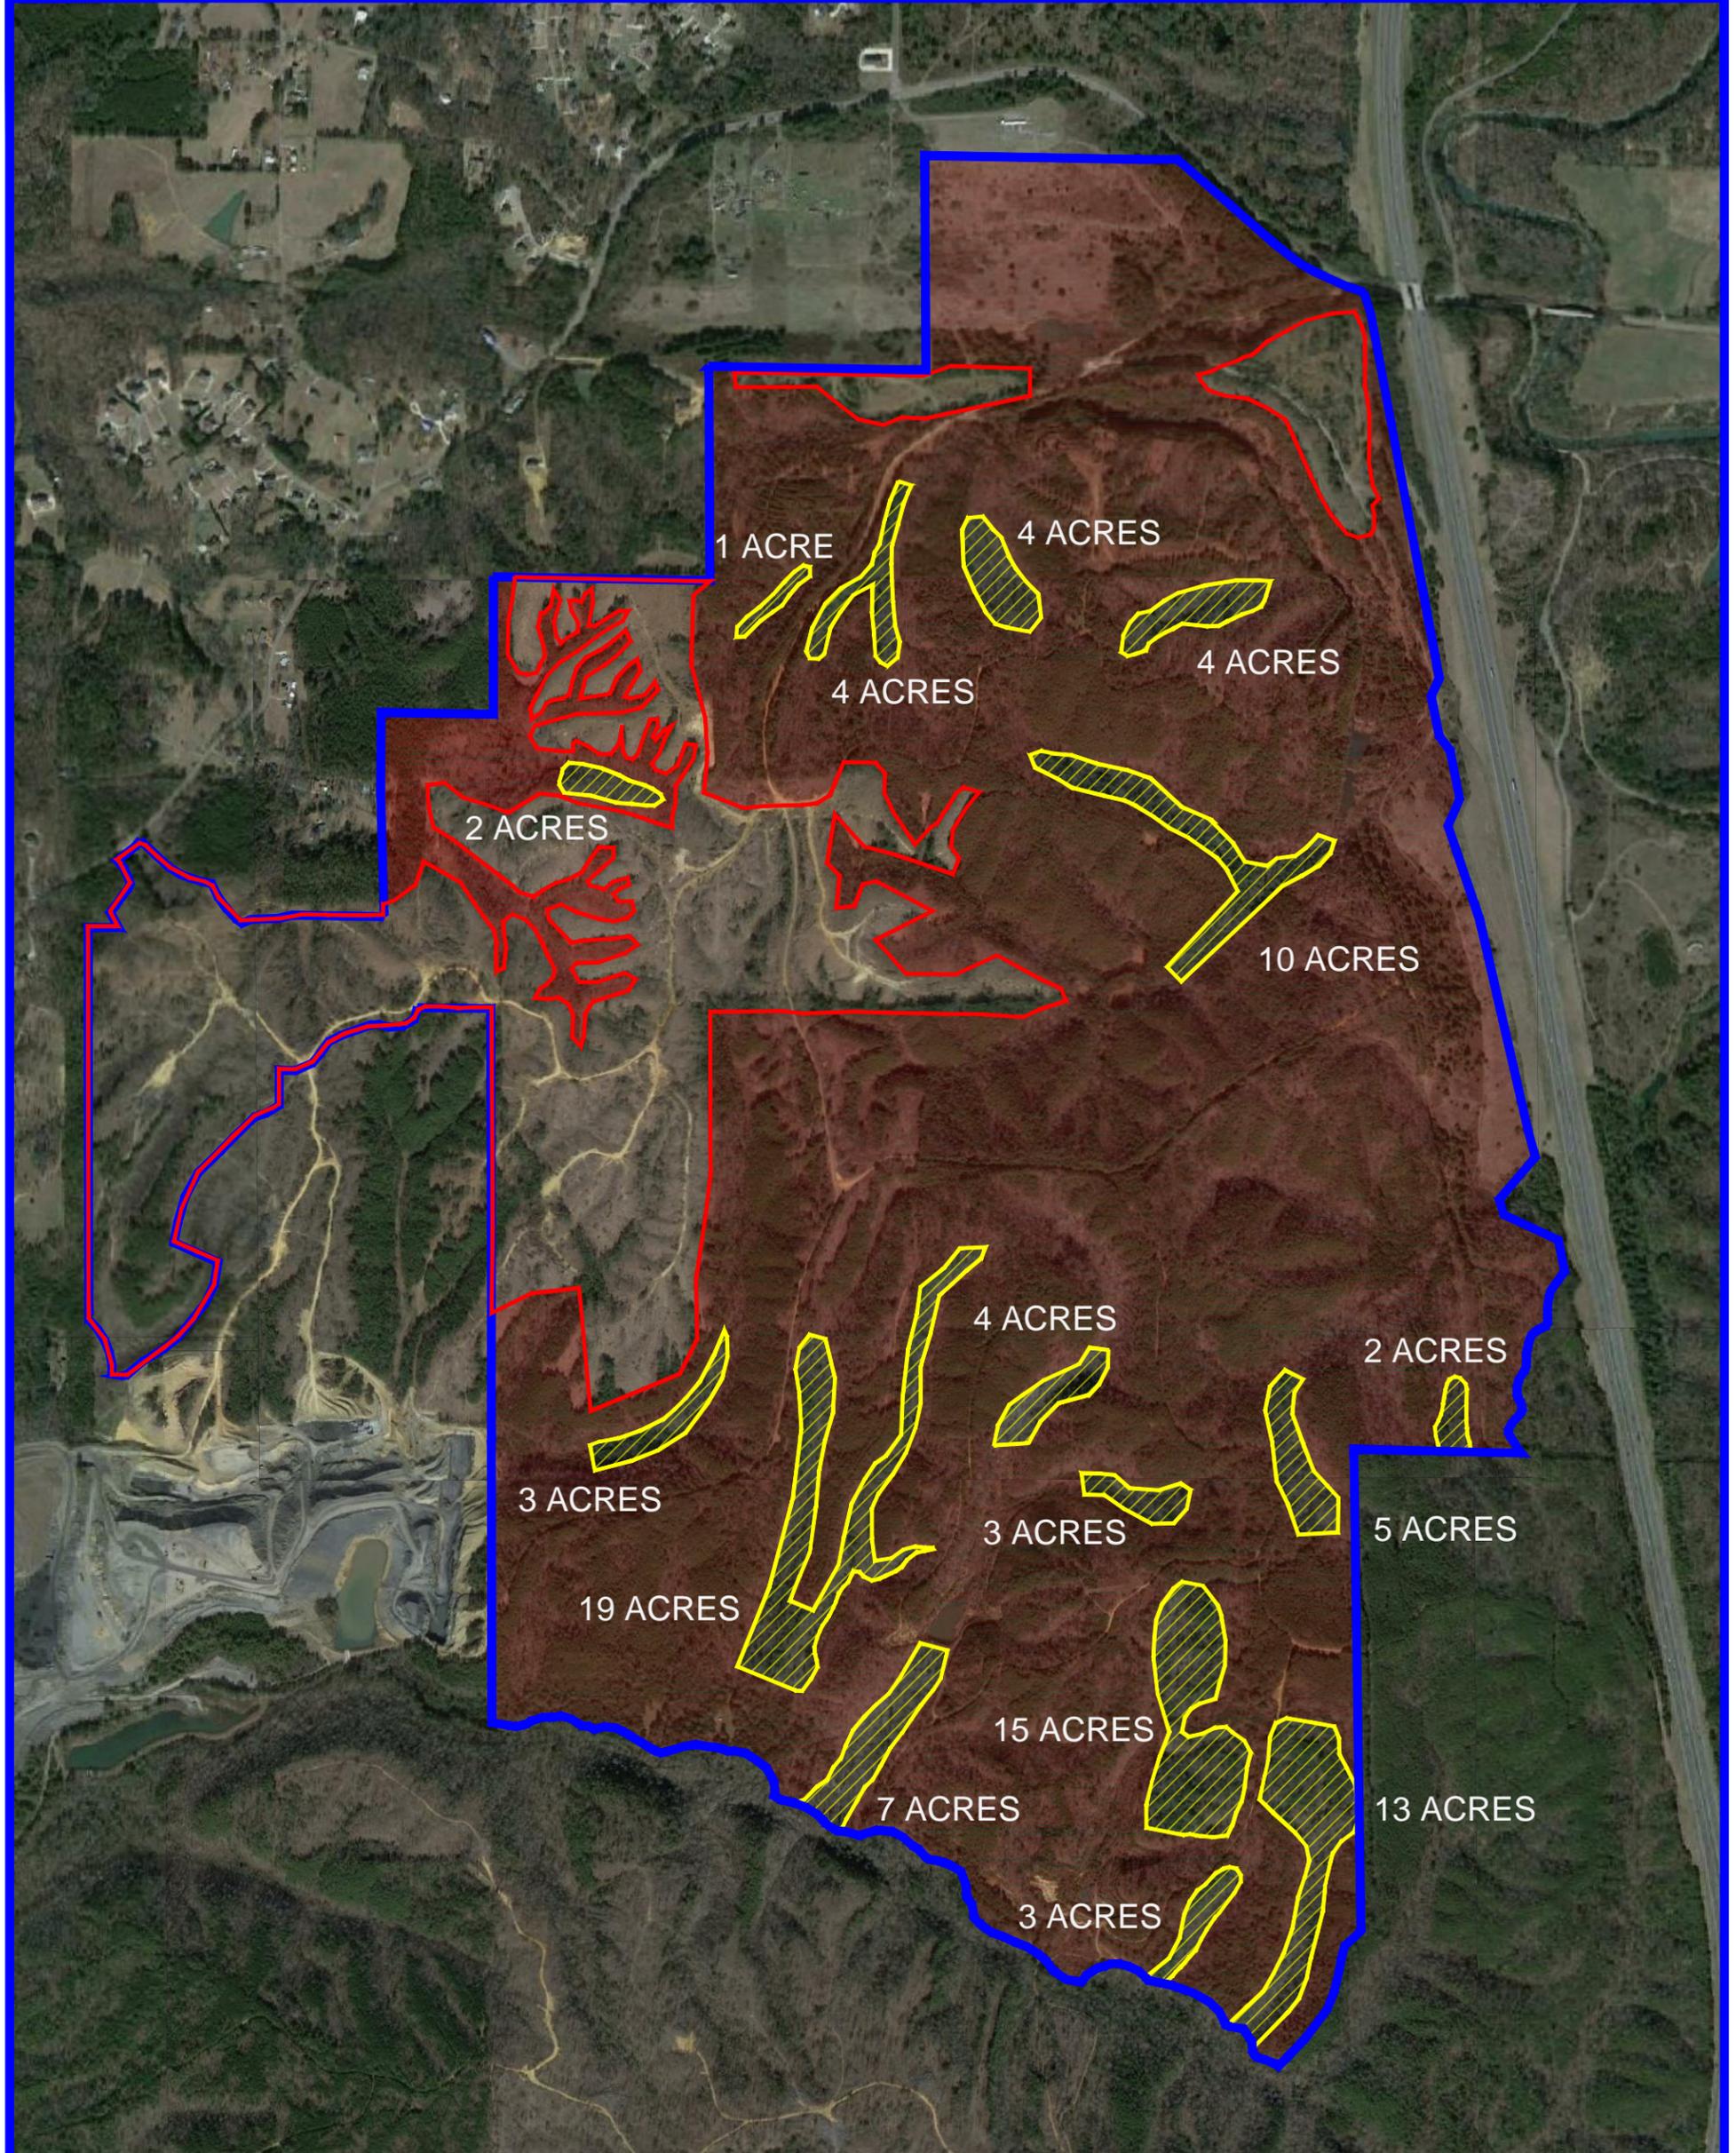
Potential summer roost habitat for Indiana and Northern Long-eared bats is present within the proposed project boundary and is detailed in the attached plot summary and maps. No habitat was found for the remainder of the listed, threatened and endangered terrestrial species. No evidence was found or observed for the presence or possible presence of these listed species.

SECTIONS 2, 3, 9, 10, 11, & 15, TOWNSHIP 15 SOUTH, RANGE 3 WEST,  
 ALL IN JEFFERSON COUNTY, ALABAMA  
 AS FOUND ON THE GARDENDALE (1979) & WARRIOR (1986)  
 ALABAMA USGS QUAD.
